Date : 02/19/2024  
Project No : 2023C180  
Client Company : Artisan Communities  
Arrival Time : 02/19/2024  
Onsite Hours :

ASEC Report ID : 64214  
Name of the Project : Lakeside Sub., Calhoun  
Project Location : Calhoun  
Weather : sunny  
Departure Time :  
ASEC Technician Name : Russell Hendrix

1. Introduction: a site visit was conducted by a representative from AS Engineering and Consulting (ASEC) to provide quality control inspection and testing services for the Lakeside project located at Lovers Lane Rd in Calhoun. The purpose of the visit was to verify compliance with project drawings/specifications, applicable codes, and materials submittals using visual observation techniques.

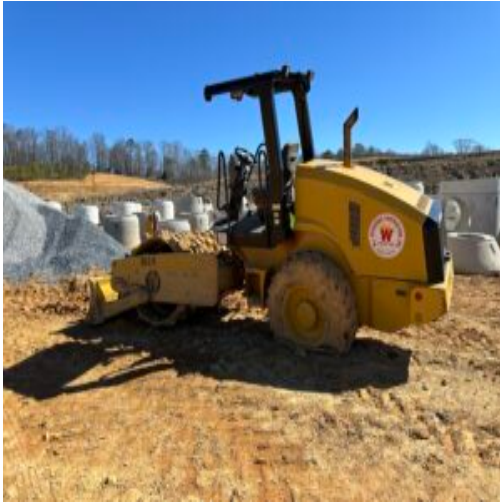
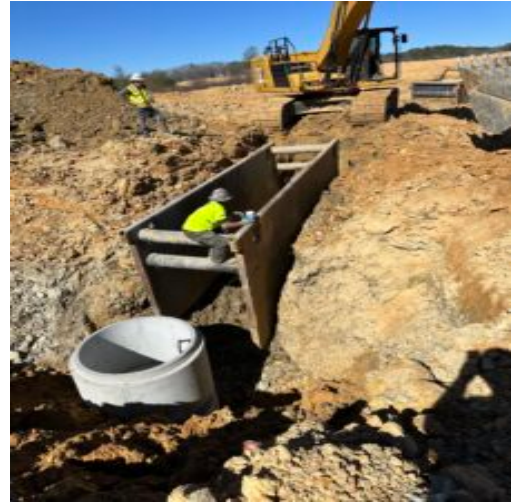
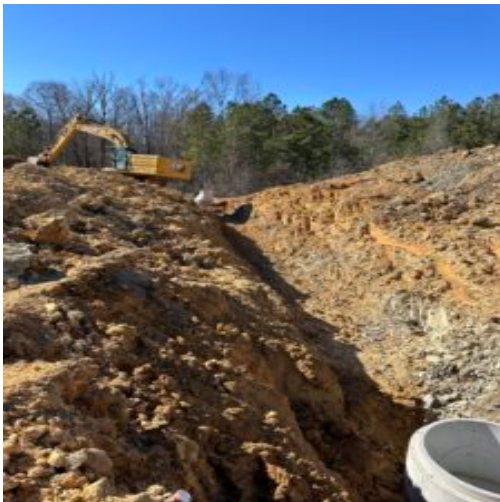
3. Observations: During the site visit, the following observations were made: a. Sanitation Line Installation: The foreman, Daniel, informed that the sanitation line between manhole 4.0 and 1.4 had been installed the previous day (unobserved by ASEC representatives). The first lift of backfill, approximately 3 feet in depth, was placed between manhole 1.3 and 1.4. b. Backfilling Recommendations: A recommendation was made to limit the depth of lifts to 6 inches for the trench packer and 12 inches for the ride-on sheep's foot vibratory compactor. c. Testing Challenges: Previous underground blasting had mixed soil and rock, making it challenging to conduct compaction testing. Testing could not be completed due to this issue. d. Subsequent Backfilling: Backfilling for the next 3 lifts between manhole 1.3 and 1.4 was completed, with each lift approximately 1-2 feet in depth. The recommendation to keep lifts at 12 inches or less was reiterated. e. Probing Challenges: Probing for the second lift was ineffective due to the concentration of rock fragments. f. Trench Box Usage: A trench box was being utilized due to concerns regarding cave-ins during excavation (see photo).

4. Recommendations: Based on the observations, the following recommendations are made: a. Limit Lift Depth: Ensure that backfilling lifts do not exceed 12 inches in depth to facilitate effective compaction and minimize the risk of settlement. b. Monitor Probing Effectiveness: Continuously monitor the effectiveness of probing activities and adjust methods as necessary to ensure accurate assessments of soil conditions.
