Date : 02/20/2024  
Project No : 2023C180  
Client Company : Artisan Communities  
Arrival Time : 02/20/2024  
Onsite Hours :

ASEC Report ID : 64226  
Name of the Project : Lakeside Sub., Calhoun  
Project Location : Calhoun  
Weather : Sunny  
Departure Time :  
ASEC Technician Name : Russell Hendrix

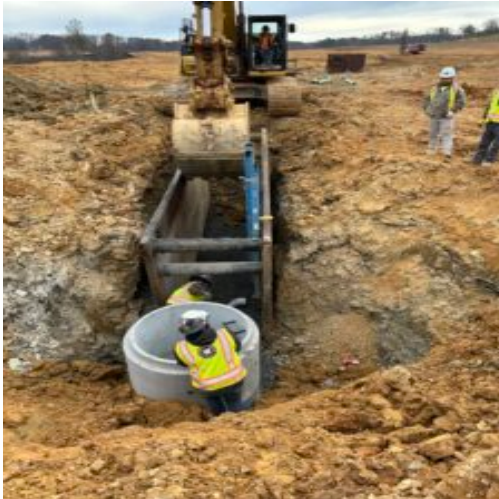
- 032-02: The first lift was approximately 2-3 feet of soil.
  - Manhole Area: Approximately 3 feet lift of soil was placed around the manhole at 1.4 and compacted with a trench roller.

trench box at 1.4

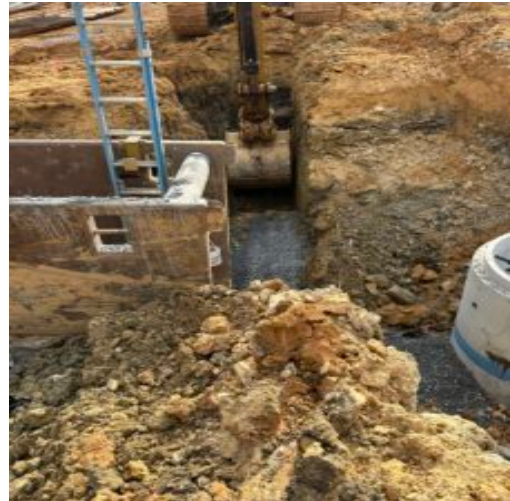
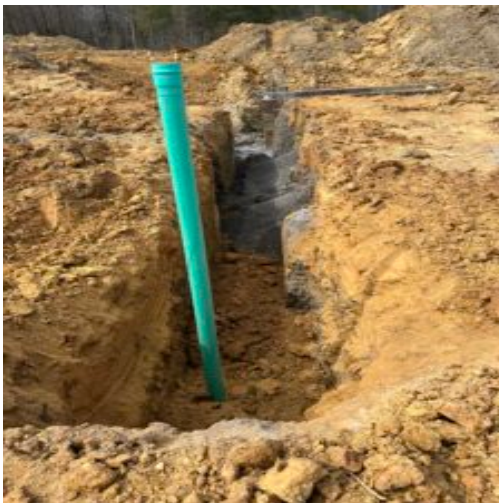
- Laterals: Three laterals (078-02, 032-02, 033-02) were excavated and installed.
  - Lift Sizes:
    - 078-02: The first lift was approximately 2 feet in depth, with Graded Aggregate Base (GAB) used only under the future roadway, while the remaining area was filled with soil.

078-02 lateral sanitation

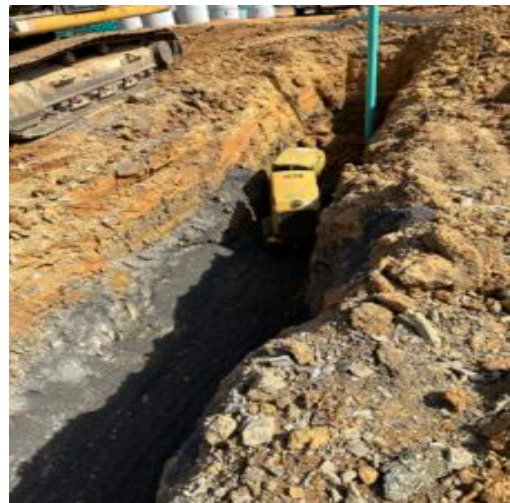
- Water Usage: No water was added to the initial 2-foot lift or the two subsequent 12-inch lifts of GAB during the site visit.
    - Compaction: Each lift was compacted with a trench packer.

compacting 078-02 lateral
