Date : 03/08/2024  
Project No : 2023C180  
Client Company : Artisan Communities  
Arrival Time : 03/08/2024  
Onsite Hours :

ASEC Report ID : 64848  
Name of the Project : Lakeside Sub., Calhoun  
Project Location : Calhoun  
Weather : couldy  
Departure Time : 03/08/2024  
ASEC Technician Name : Russell Hendrix

**Location:** Headwall BA1 site

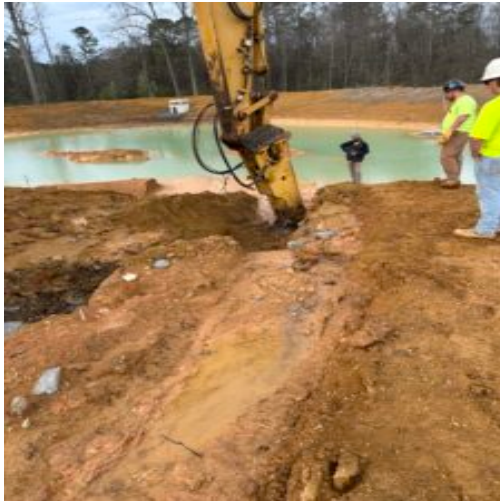
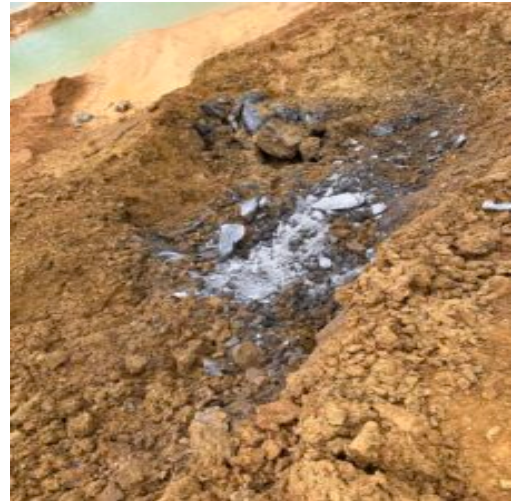
**Description of Activity:** An attempt was made to excavate at the designated location for Headwall BA1. However, upon excavation, it was discovered that rock was present at the site, hindering the placement of the headwall.

- An excavation was initiated at the designated site for Headwall BA1.
- During the excavation process, it became apparent that rock was obstructing the intended placement area.

- In response to the encountered obstacle, a Hoe-ram was deployed in conjunction with an excavator.
- The Hoe-ram was used to break and remove the rock hindering the placement of Headwall BA1.

- Despite efforts to remove the obstructing rock, Headwall BA1 could not be successfully placed on the designated day.
- No further progress was made due to the encountered difficulties.

**Conclusion:** The attempted excavation at the Headwall BA1 site was impeded by the presence of rock, necessitating the use of specialized equipment for removal. Despite efforts, the headwall could not be

placed as planned, resulting in a halt in progress. Moving forward, a comprehensive evaluation and strategic planning will be essential to overcome the encountered obstacle and resume project activities.

- Conduct a thorough assessment of the site to determine the extent of the rock obstruction and plan the next steps accordingly.

- Evaluate the need for additional equipment or resources to effectively address the rock hindrance.

- Coordinate with relevant stakeholders to communicate the encountered challenge and discuss potential solutions.
