Date : 03/11/2024  
Project No : 2023C180  
Client Company : Artisan Communities  
Arrival Time : 03/11/2024  
Onsite Hours :

ASEC Report ID : 64858  
Name of the Project : Lakeside Sub., Calhoun  
Project Location : Calhoun  
Weather : overcast  
Departure Time : 03/11/2024  
ASEC Technician Name : Russell Hendrix

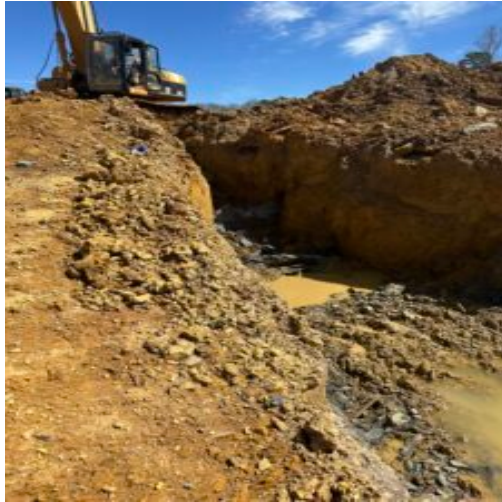
**Rock Removal at Headwall Location BA1:** Continued efforts were made to remove rock at the headwall location BA1. The following summarizes the progress:

- The Hoe-Ram was employed for rock removal, ensuring the site remains conducive to further construction activities.

BA1 headwall and storm pipe location

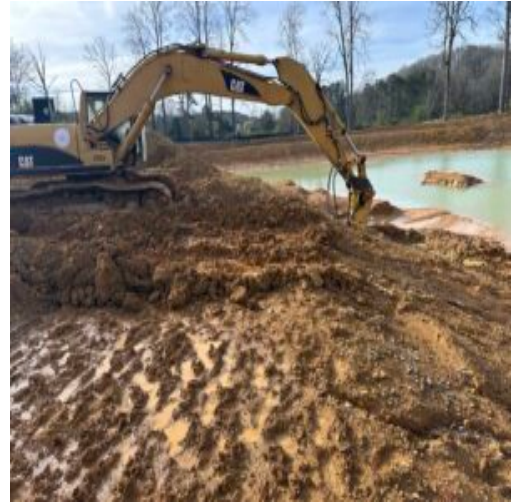
BA1 headwall location

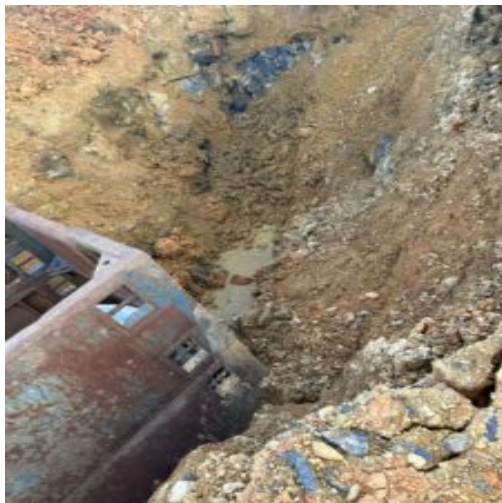
- Water intrusion into the excavated trench was encountered during the installation process.
- The water was not removed. Approximately 12 inches of 57 stone bedding was placed in the trench to provide support and drainage.

4.2 water intrusion

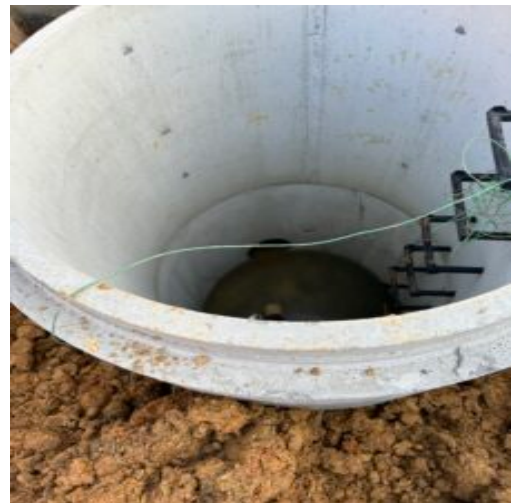
**Sanitation Sewer Main Installation:** An 8-inch Ductile iron pipe was placed between stations 4.2 and 4.3, moving north. The following key points summarize the installation process:
