Date : 03/14/2024  
Project No : 2023C180  
Client Company : Artisan Communities  
Arrival Time : 03/14/2024 07:45  
Onsite Hours : -3:30

ASEC Report ID : 64967  
Name of the Project : Lakeside Sub., Calhoun  
Project Location : Calhoun  
Weather : Clear and Sunny  
Departure Time : 03/14/2024 05:15  
ASEC Technician Name : Devon Hall

Our AS Engineering & Consulting, LLC representative was on site to observe construction activities, specifically the placement of backfill soils for the sanitation line. The following were noted this day:

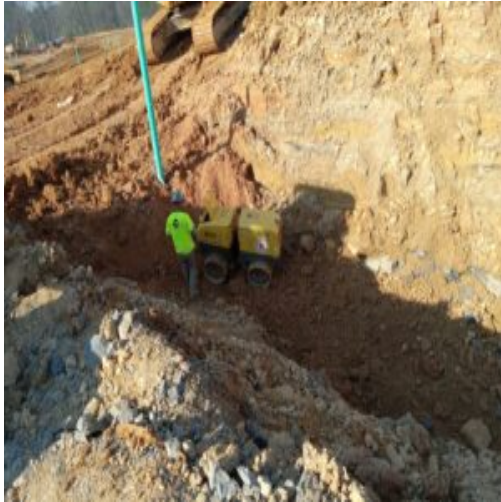
- 3.) Area 3 consisted of the area in between manholes 4.2 and 4.3. A mix of soil and rock was used on top of a 6" iron ductile pipe. First lift thickness on top of pipe was approximately 3 ft. Advised the crew to do a smaller lift approximately six inches thickness of uncompacted soil. The area probed over 1 ft deep after compaction with trench packer RTSC3 using a 3/8" diameter probe rod. The lift was found to be uneven when finished compacting. Excavator added a 2nd lift of approximately 3 ft of uncompacted soil and rock and compacted with RTSC3. Used approximately 3 ft of soil for a 3rd lift and compacted with riding vibratory sheepsfoot Caterpillar 1024. Bulldozer Komatsu 61PX applied lifts of approximately 3 ft of soil and was compacted with Caterpillar 1024 until even with the surrounding soil level. All lift thicknesses placed this day were per contractor's choosing and against ASEC's recommendations for lift thicknesses of 6 inches.

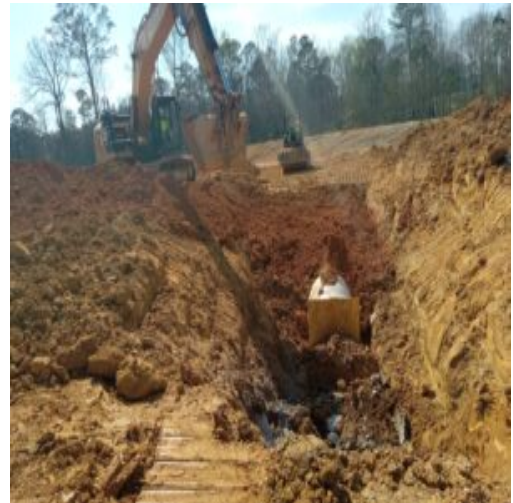
- 2.) Area 2 was a storm drain leading to a retention pond. A lot of rock was encountered in the excavated area. Work could not continue with the CAT336E. as the hammer was broken and when our representative had arrived, the rock couldn't be broken by other means. Headwall BA-1 to BA-2 was the storm drain in question according to construction crew on site. Hammer was fixed and operational by approximately 12:45 pm. Used the hammer from approximately 12:45 to approximately 1:00 pm and again between approximately 1:30 pm to approximately 2:00 pm. Alternated using hammer and excavator to remove rock and soil. Approximately 20 feet of storm pipe was installed around 2:30 pm. Hauled away rock and excavated soils with a dump truck. Brought in red clay material. Covered storm pipe with approximately 2-foot lifts of red clay material and compacted with Caterpillar 1024 riding vibratory sheepsfoot. Bulldozer Komatsu 61PX applied approximately 2 ft lifts of red clay material and compacted with Caterpillar 1024 until even with the surrounding soil level. Our representative continued to recommend that fill lift thicknesses be kept to 6 inches but the contractor elected to keep with the thicker (2 to 3 feet) lifts.

Area 2 after 20 ft of storm drain pipe was installed

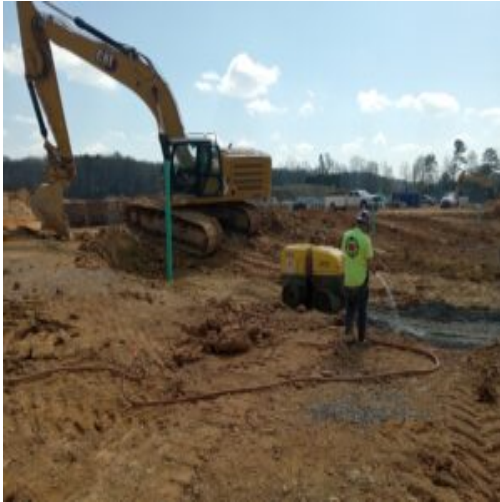
- 1.) Lateral going under road just south of manhole 4.3. Approximately 6" of No. 57 stone placed in the excavated area underneath the 6-inch diameter sanitation pipe. Approximately 6" of No. 57 stone was placed on top of pipe. Our representative spoke to the city inspector (Kevin) regarding lift sizes of backfill placement. Recommended approximately 6" lifts and compaction with the trench compactor RTSC3. Approximately 2 ft of GAB was placed on top of 6" of No. 57 stone. Approximately 2-3 ft of soil was placed on top of the lateral pipe in an area beyond the width of the road. Area was compacted with trench compactor RTSC3. Another approximately 2-foot lift of GAB was placed on top and compacted with RTSC3. Soil was then placed in approximately 2 ft lifts on the area wider than the width of the road. Contractor added water to GAB with hose and compacted with RTSC3.

Area 1 adding water to GAB

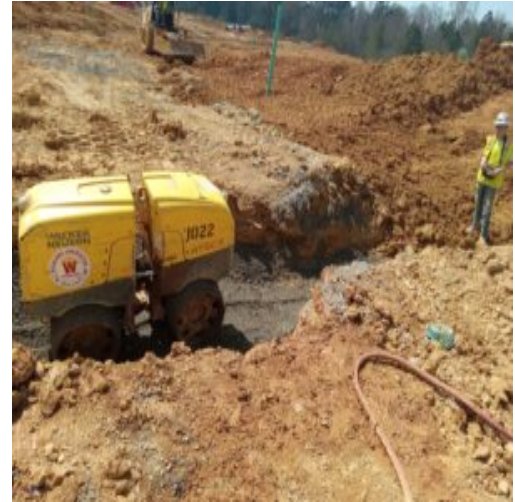
Area 1 Lateral Sanitation Pipe going under road

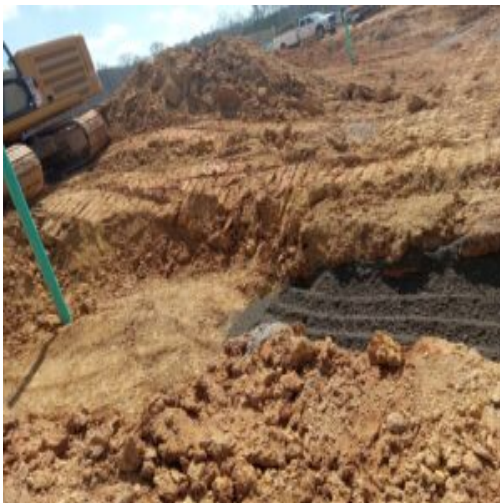
Area 1 Lateral Sanitation Pipe

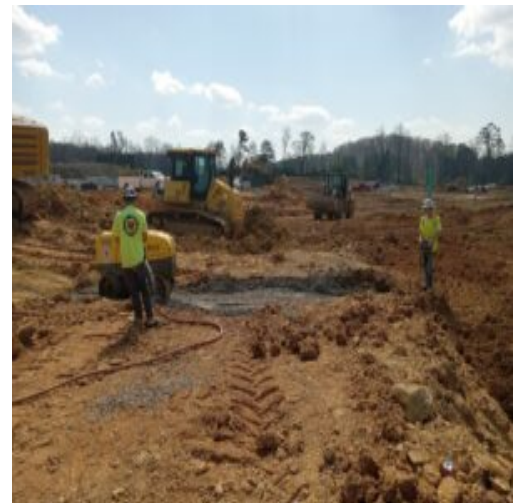
Area 1 Lateral Sanitation Pipe

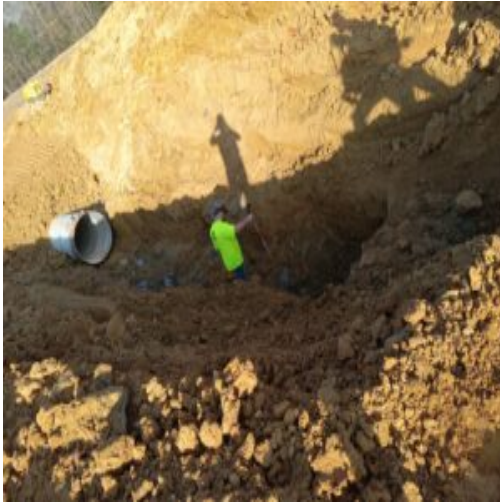
Area 2 before 20 ft of storm drain pipe was installed
