Date : 03/18/2024  
Project No : 2023C180  
Client Company : Artisan Communities  
Arrival Time : 03/18/2024  
Onsite Hours :

ASEC Report ID : 65369  
Name of the Project : Lakeside Sub., Calhoun  
Project Location : Calhoun  
Weather : overcast  
Departure Time : 03/18/2024  
ASEC Technician Name : Russell Hendrix

As requested, the site was visited by our AS Engineering and Consulting (ASEC) representative for the purpose of providing quality control inspection and testing services. Visual observation techniques were employed to verify compliance with project drawing/specifications, applicable codes, and materials submittals. The following observations were observed on site this day.

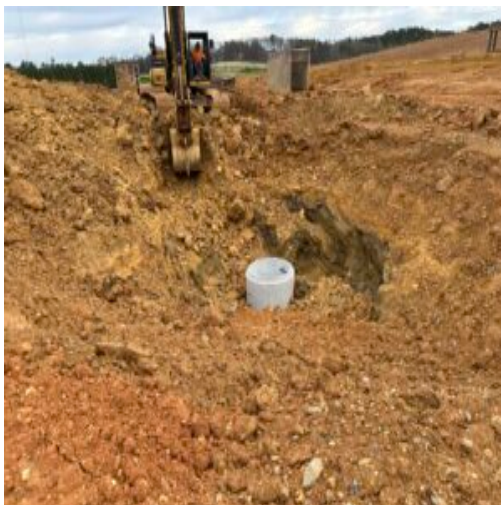
sanitation sewer manhole

- Water intrusion issues were also encountered in the sanitation sewer between depths 4.3 to 4.4.
- Varying depths of 57 stone bedding were employed to stabilize the pipe in affected areas.
- Some rock remained intact after blasting, requiring 1.5 hours of Hoe-hammer work for removal.

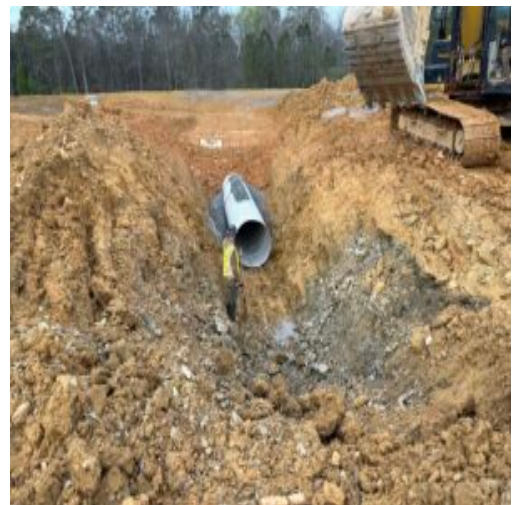
storm drain BA1-BA2

- Excavation activities persisted between BA1-BA2 for the storm drain.
- Water intrusion was encountered in the trench, as depicted in the attached photo.

- Approximately 2-3 feet of #57 stone bedding was utilized to stabilize the 48-inch metal corrugated pipe placed in the trench..

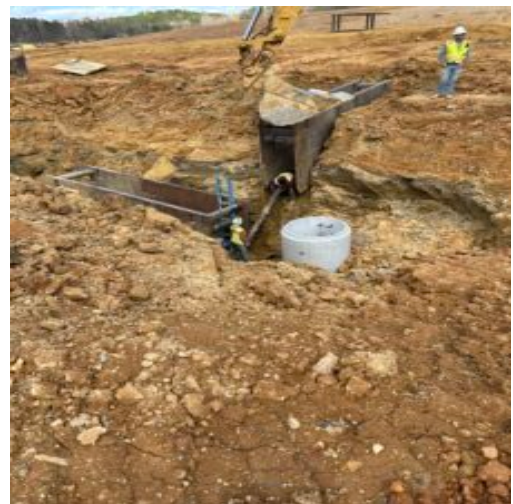
Trench box for sanitation sewer
