Date : 03/13/2024  
Project No : 2023C180  
Client Company : Artisan Communities  
Arrival Time : 03/13/2024  
Onsite Hours :

ASEC Report ID : 65334  
Name of the Project : Lakeside Sub., Calhoun  
Project Location : Calhoun  
Weather : sunny  
Departure Time : 03/13/2024  
ASEC Technician Name : Russell Hendrix

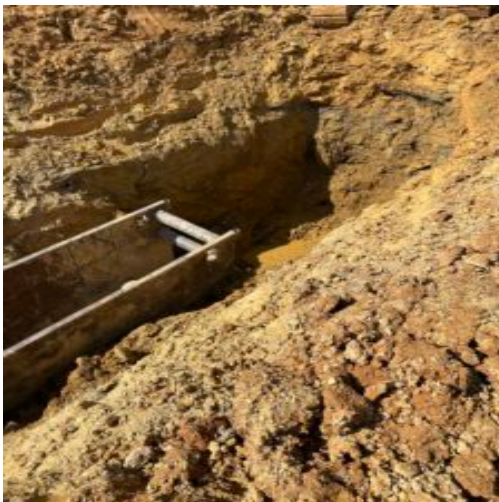
Tench box

- The placement of the sanitation pipe was impeded by rock between depths 4.2 to 4.3.
- Despite previous blasting, the rock remained intact, requiring approximately 5 hours of work using a Hoe-hammer.
- Lifts between depths 4.2 and 4.3 were approximately 3 to 4 feet in thickness.
- Testing in this area was not feasible due to safety concerns within the trench.

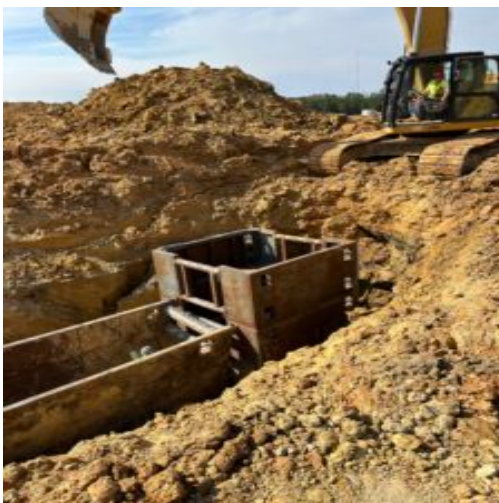
4.3 manhole box

- Water intrusion occurred at manhole 4.3, necessitating the use of approximately 2 feet x 6 feet x 6 feet of 57 stone to stabilize the area for manhole placement.
- It was recommended to the foreman to remove water at 4.3 using a pump. However, the foreman stated that the intrusion could not be entirely stopped.

- Continued monitoring and management of water intrusion are essential to prevent delays and ensure worksite safety.

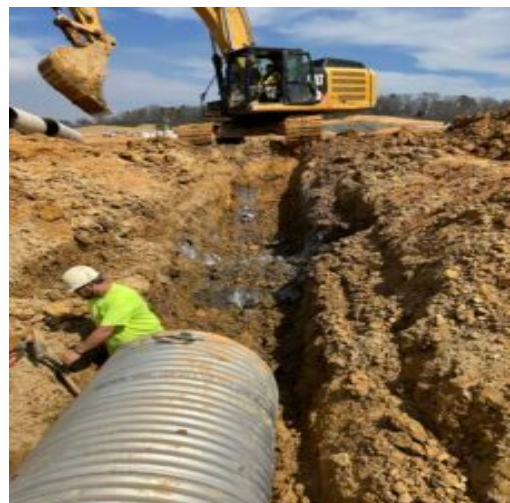
storm drain BA1 to BA2

- Rock was encountered at a depth of 60 to 80 feet from the headwall.
- An approximate 4-foot lift was placed and compacted around the storm drainpipe, extending 20 to 30 feet from the headwall.

- A surface penetration test using a 3/8 inch probe indicated a penetration of approximately 5 inches.
- Troxler radiation testing could not be completed due to proximity to the metal storm drainpipe.
- It was recommended to the foreman to remove the 4-foot lift and replace it with 6-inch lifts to ensure proper compaction. However, this recommendation was disregarded, and the next lift was initiated.

- Strict adherence to compaction procedures, including utilizing smaller lifts for better compaction results, should be observed to maintain structural integrity.
