Date : 03/25/2024  
Project No : 2023C180  
Client Company : Artisan Communities  
Arrival Time : 03/25/2024  
Onsite Hours :

ASEC Report ID : 65743  
Name of the Project : Lakeside Sub., Calhoun  
Project Location : Calhoun  
Weather : overcast  
Departure Time : 03/25/2024  
ASEC Technician Name : Russell Hendrix

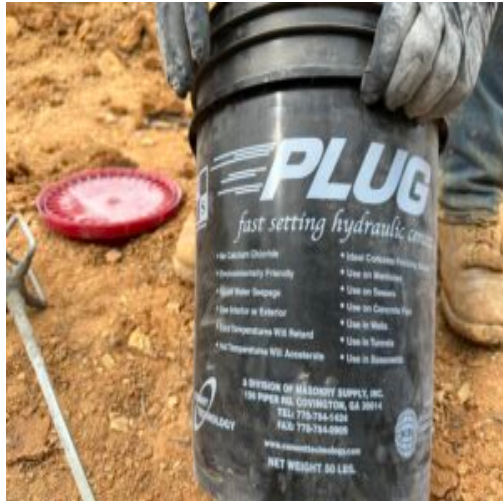
- Between CE3 to CE2, 24-inch Reinforced Concrete Pipe (RCP) was used without rubber gaskets due to fitting issues.
- Two 24-inch sections of pipe were sealed from the inside using waterproof hydraulic cement, with the remaining sections sealed with mortar. Concerns were raised regarding the waterproofing capability of mortar, but no remediation was observed.

Used instead of gaskets on 2 storm drain pipes  
E2-E3

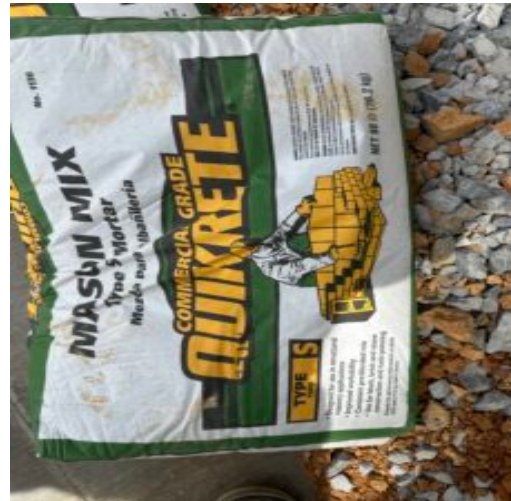
used instead of regular gaskets NON-waterproof  
material used inside to seal remaining storm drain  
pipes E2-E3

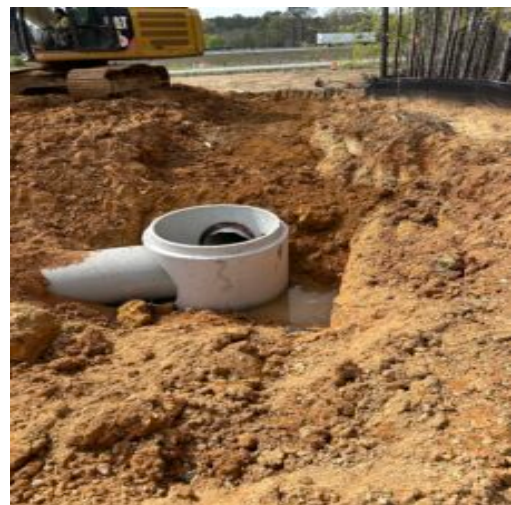
On this day, excavation, placement, and backfilling of storm drain components were conducted from CE3 to CE1, terminating at ST 0.00. Notably, the section between CE3 and CE2 traversed beneath the future road and entrance to the development. Challenges arose due to water intrusion during the installation process, particularly at Manhole CE-2.

- Storm drain was excavated, placed, and backfilled from CE3 to CE1, terminating at ST 0.00.
- CE3 to CE2 section encountered water intrusion.
- Recommendation made to add a bedding of 6 inches of 57 stone to support CE-2 was not followed, despite probing indicating a shallow soil depth with natural rock beneath.
- CE3 was placed with approximately 6 inches of 57 stone bedding.

E2 storm drain manhole

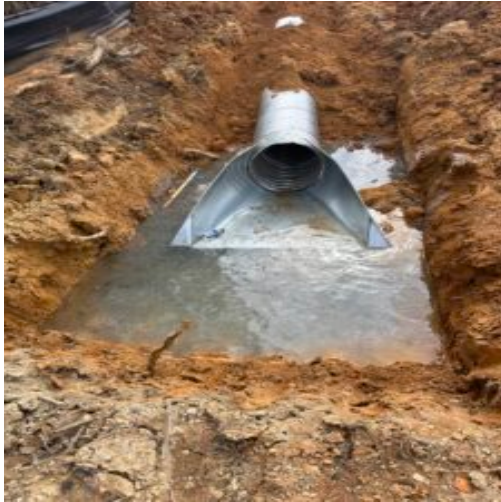
termination of storm drain to roadway

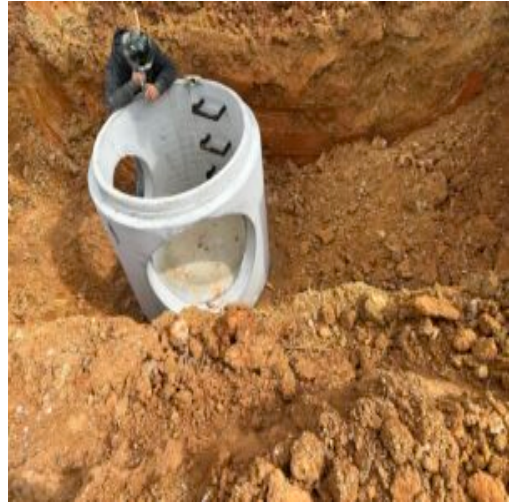
E2 manhole

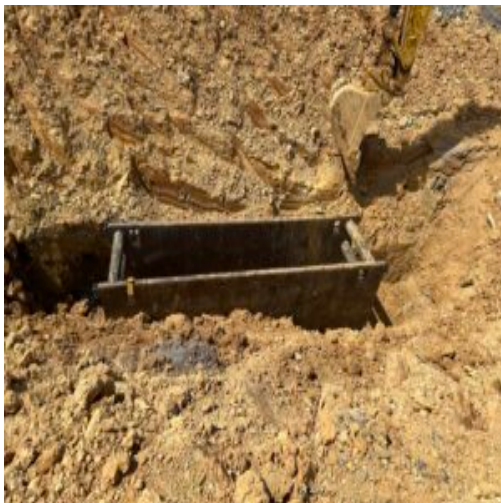
4.3 to 4.4 sanitation sewer

- A piece of Ductile Iron Pipe between 4.3 to 4.4 had to be removed due to blasting activities on the previous day altering the elevation.
