Date : 04/02/2024  
Project No : 2023C180  
Client Company : Artisan Communities  
Arrival Time : 04/02/2024  
Onsite Hours :

ASEC Report ID : 65896  
Name of the Project : Lakeside Sub., Calhoun  
Project Location : Calhoun  
Weather : overcast  
Departure Time : 04/02/2024  
ASEC Technician Name : Russell Hendrix

1. This report documents the activities carried out during the installation of sanitation laterals and sewer lines and storm drain at the specified location.

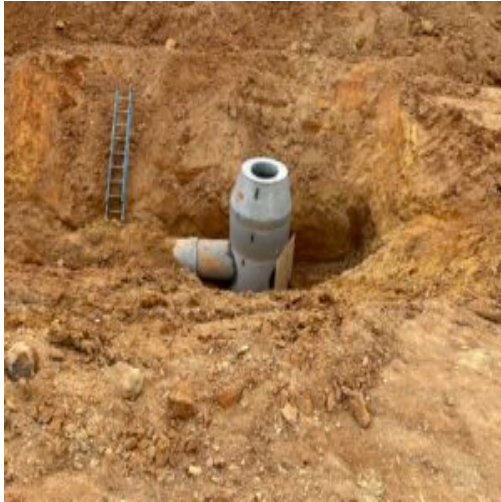
AH6 storm drain manhole

5. Installation of Reinforced Concrete Pipe (RCP): Between points AH5 and AH6, 24-inch x 8 feet reinforced concrete pipes (RCP) were installed. No stone bedding was utilized during this installation. Gaskets were observed being used, and lifts ranged from 3 to 4 feet in depth. Additionally, the RCP at AH6 was found to have a busted bell housing, which was promptly repaired upon request.

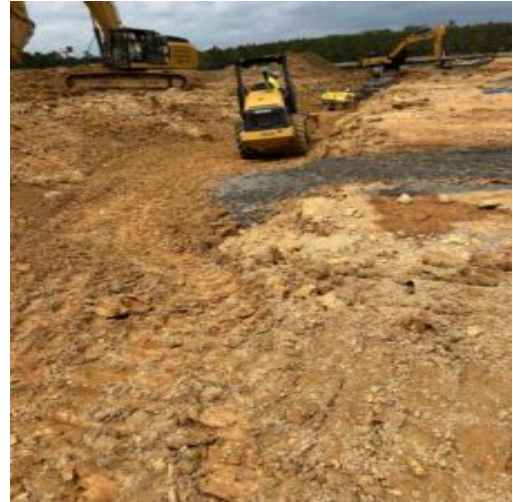
between AH5-AH6 storm drain

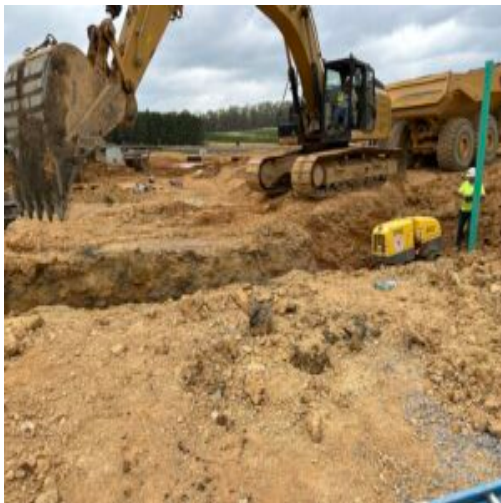
6. Testing and Compaction: Due to the depth or a mix of soils with rock, testing could not be completed on this day. However, it was noted that the lifts compacted on this day probed approximately 6 inches with a 3/8 probe rod. Despite a recommendation to remove soil and use 12-inch lifts, this approach was not followed.

using Trench packer between AH5-AH6 on  
approximately 4 foot lift

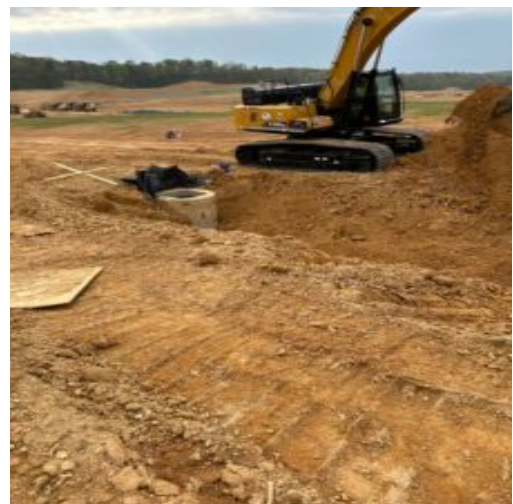
AH5 with approximate 4 foot lift

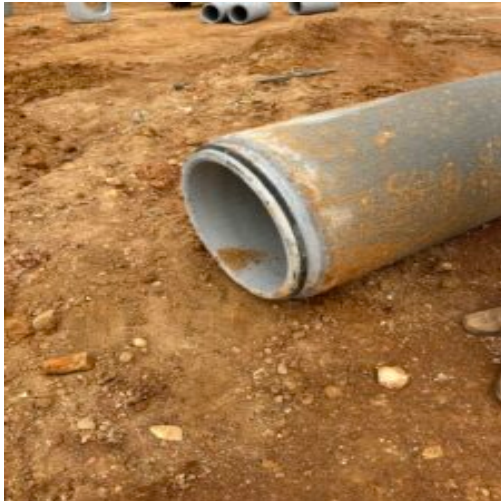
storm drain pipe used with gasket

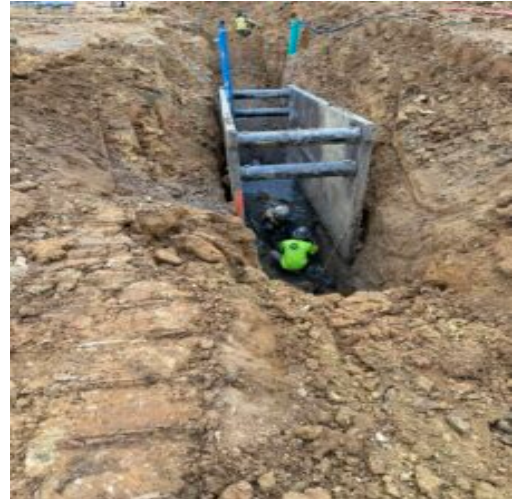
3. Mainline Sanitation Sewer Placement: The mainline sanitation sewer was installed between points 4.4 and 4.5, utilizing a bedding of 57 stone under Ductile Iron pipe. The installation involved lifts approximately 4 feet in depth. Initially, a trench packer was employed for the first lift, followed by a ride-on vibratory sheepsfoot for the final lift.

Sanitation pipe placement in trench box (Ductile iron pipe)

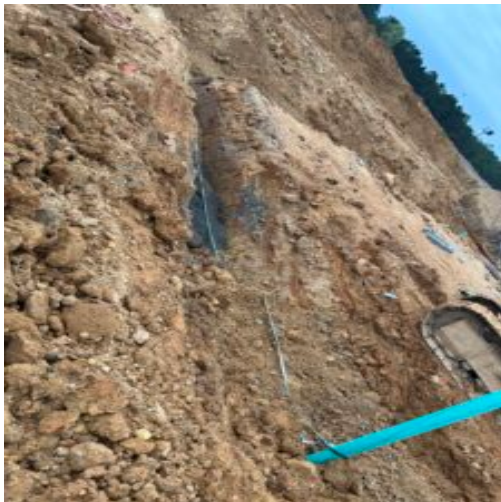
Lateral

2. Excavation and Placement of Sanitation Laterals: Throughout the day, two sanitation laterals, namely 087-02 and 088-02, located between points 4.4 and 4.5, were excavated and placed. The excavation revealed the use of graded aggregate base (GAB) beneath the future roadway, with lifts approximately 2-2.5 feet in depth. (6-12 inch lifts were recommended)

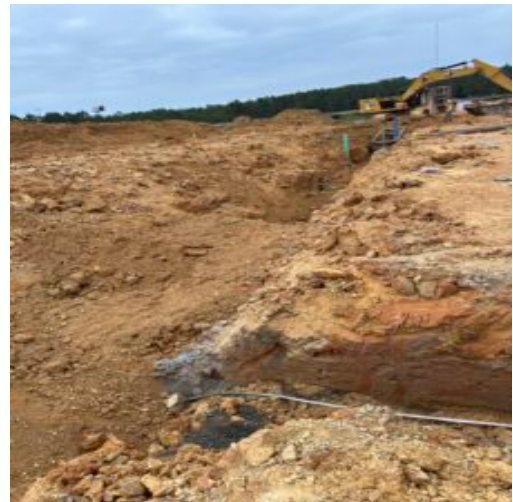
Sanitation pipe with approximately 4-5 foot lift

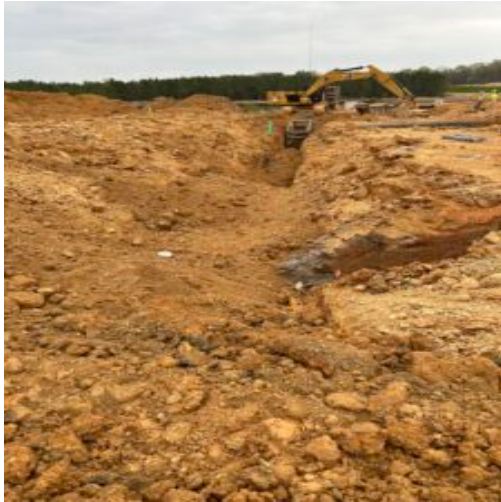
Sanitation pipe with approximately 4-5 foot lifts
