Date : 03/21/2024  
Project No : 2023C180  
Client Company : Artisan Communities  
Arrival Time : 03/21/2024  
Onsite Hours :

ASEC Report ID : 65722  
Name of the Project : Lakeside Sub., Calhoun  
Project Location : Calhoun  
Weather : sunny  
Departure Time : 03/21/2024  
ASEC Technician Name : Russell Hendrix

As requested, the site was visited by our AS Engineering and Consulting (ASEC) representative for the purpose of providing quality control inspection and testing services. Visual observation techniques were employed to verify compliance with project drawing/specifications, applicable codes, and materials submittals. The following observations were observed on site this day.

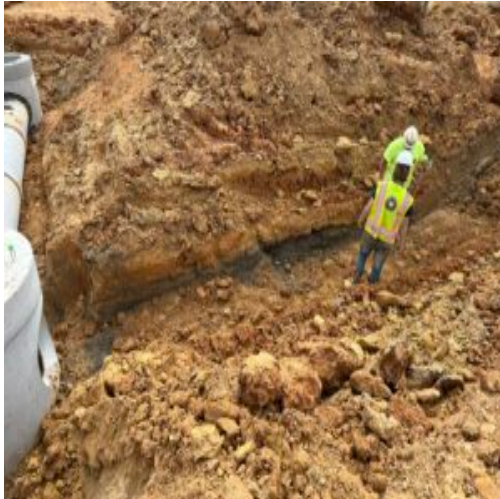
During the reinstallation process, an approximate 4-foot lift was consistently employed, with compaction achieved using a trench packer. As excavation progressed from AH3 to AH4, the presence of topsoil containing organics was discovered. A recommendation was made to the foreman to remove all topsoil. While the topsoil was cleared up to the point of storm drain placement, further investigation into potential implications was not carried out.

AH2-AHAH# Topsoil covered

1. Address concerns raised regarding backfill moisture content and compaction levels promptly to avoid potential issues with the integrity of the storm drain system.
2. Conduct thorough investigations into unexpected findings such as the presence of topsoil with organics to assess any potential impact on the project's performance and longevity.
3. Implement proactive measures to mitigate risks associated with incorrect elevation and soil composition, such as regular quality checks and soil testing.

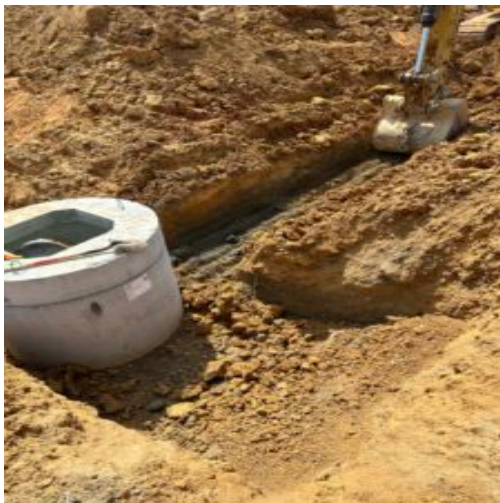
AH3 topsoil exposed

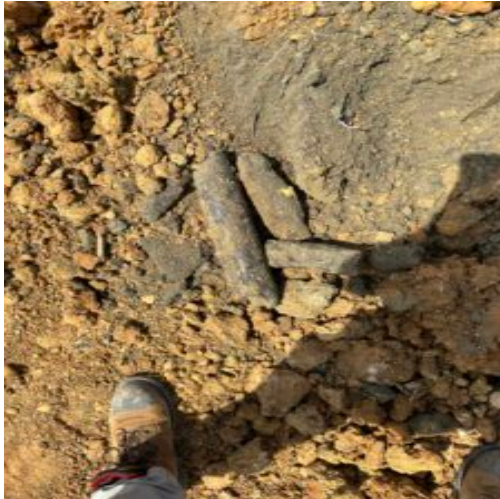
Topsoil with organics AH2-AH3

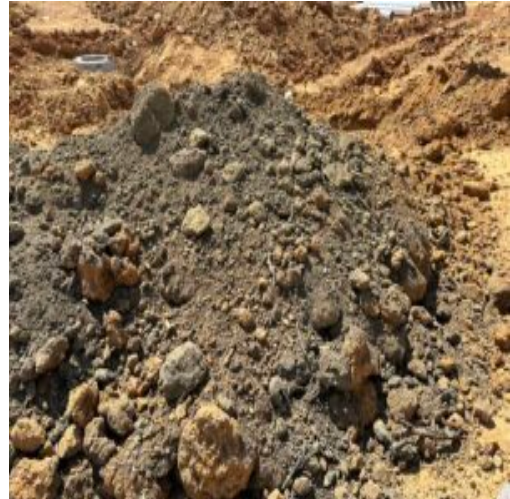
Topsoil removed AH2-AH3
