Date : 05/28/2024  
Project No : 2023C180  
Client Company : Artisan Communities  
Arrival Time : 05/28/2024  
Onsite Hours :

ASEC Report ID : 66869  
Name of the Project : Lakeside Sub. - Lovers Lane, Calhoun  
Project Location : Calhoun  
Weather : sunny  
Departure Time : 05/28/2024  
ASEC Technician Name : Russell Hendrix

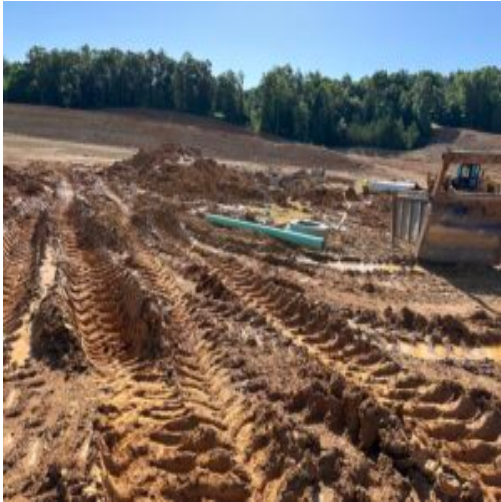
- **Site Conditions:** It was noted that the entire site was excessively wet, making it impractical to perform any additional work at the time of observation.

Surface near AI4

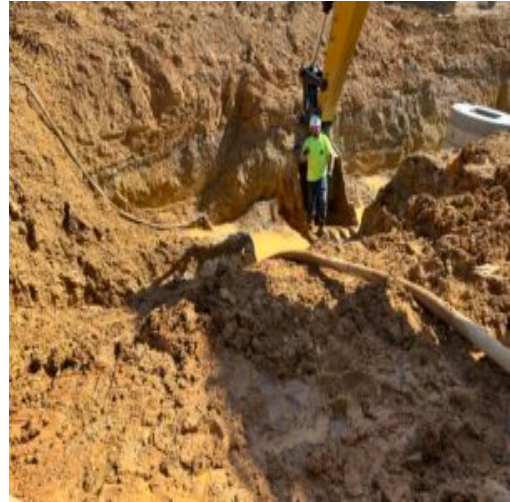
- **Corrugated Metal Pipe Removal:** Upon arrival, it was noted that one piece of 48-inch corrugated metal pipe was being removed at manhole AI4. The trench was open, and multiple rain events had occurred, resulting in water flooding the trench and causing movement of the corrugated pipe.

removing corrugated pipe at AI4

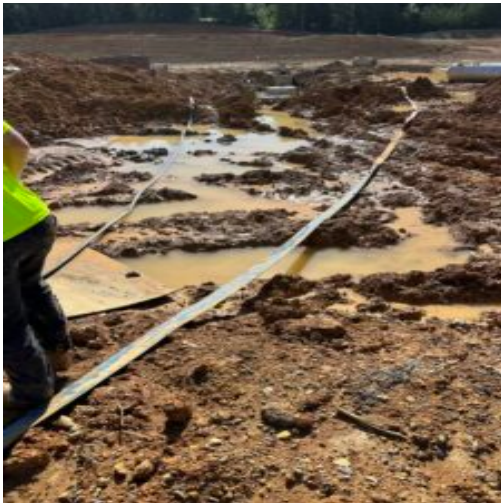
- **Pumping Efforts:** The grading company was actively engaged in pumping out the water from the trench using one 3-inch pump and one 2-inch pump. Efforts were underway to mitigate the water accumulation and facilitate the backfilling process.

Pump water out of trench

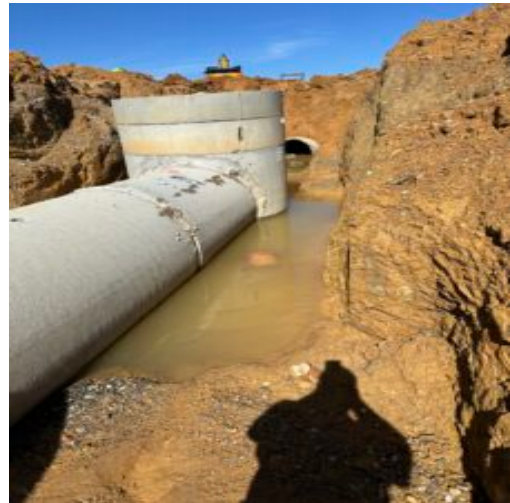
AI4 RCP and corrugated pipe
