Date : 08/13/2024  
Project No : 2023C180  
Client Company : Artisan Communities  
Arrival Time : 08/13/2024  
Onsite Hours :

ASEC Report ID : 68714  
Name of the Project : Lakeside Sub. - Lovers Lane, Calhoun  
Project Location : Calhoun  
Weather : sunny  
Departure Time : 08/13/2024  
ASEC Technician Name : Russell Hendrix

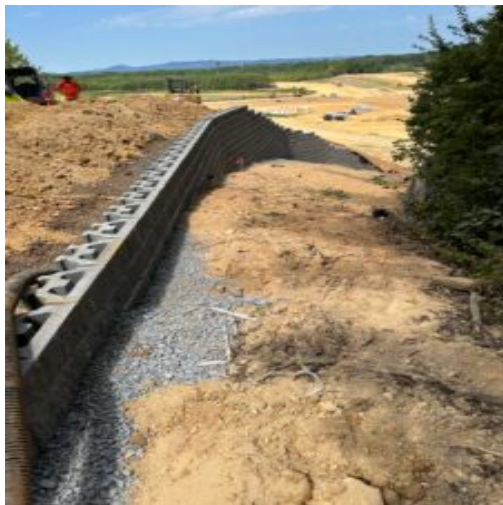
Upon arrival at the site, it was observed that Retaining Walls Company contractor was actively working on the retaining wall (almost completed at the time of this report) located at the 2nd entrance to Lakeside Development (see attached photo). After a discussion with the foreman, it was confirmed that no inspections, testing, or observations were requested from ASEC or the local county inspector. This includes the lack of inspection of the footing and any compaction testing for wall backfill as the wall was constructed.

Retaining wall NOT inspected by ASEC

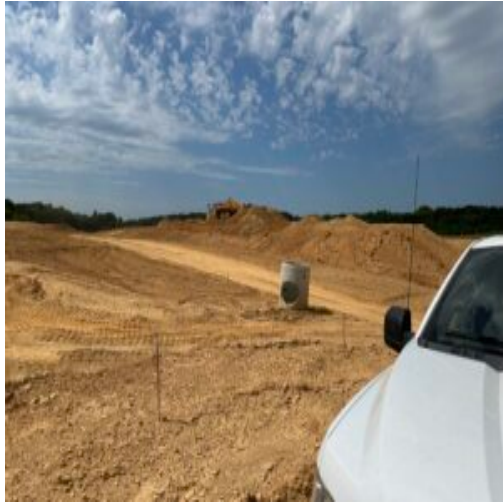
Moving soil stockpile
