ASEC Report ID : 63564  
Name of the Project : Jasons Walk - Era Drive  
Project Location : Era Drive, Cumming, GA  
Weather : sunny  
Departure Time : 01/02/2024 14:00  
ASEC Technician Name : Vidal Dias

## Overview and Observations

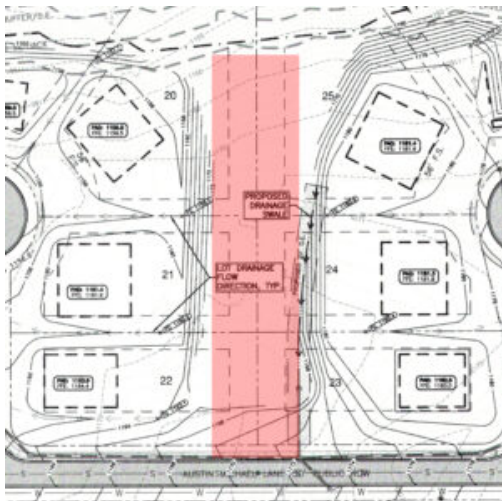
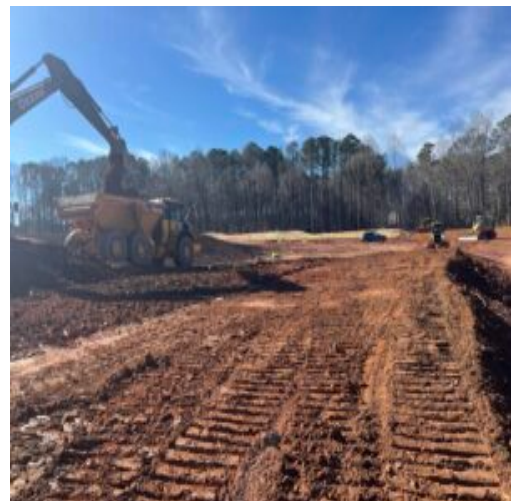
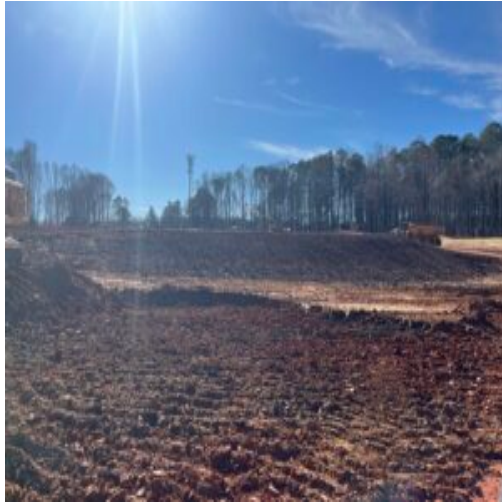
- **Location:** Green space behind lots 20-25.
- **Activity Observed:** Site preparation in response to current soil conditions.

During the site visit on January 2, 2024, key activities included conducting a moisture content test and observing site preparation activities. The in-place moisture content was found to be 30.2%, which is above the optimum level of 20.6%. Consequently, soil placement activities were suspended. Instead, the contractor focused on preparing the green space behind Lots #20-25, as marked in red on the attached drawing. Scarification and aeration of the high moisture soils should be performed prior to their use as fill.

- **Test Conducted:** On-site moisture content measurement.
- **Results:** Moisture content recorded at 30.2%, exceeding the optimum of 20.6%.
