Date : 02/26/2024  
Project No : 2024C112  
Client Company : SR Homes  
Arrival Time : 02/26/2024  
Onsite Hours :

ASEC Report ID : 64363  
Name of the Project : Sterlington  
Project Location : Canton  
Weather : sunny  
Departure Time : 02/26/2024  
ASEC Technician Name : Russell Hendrix

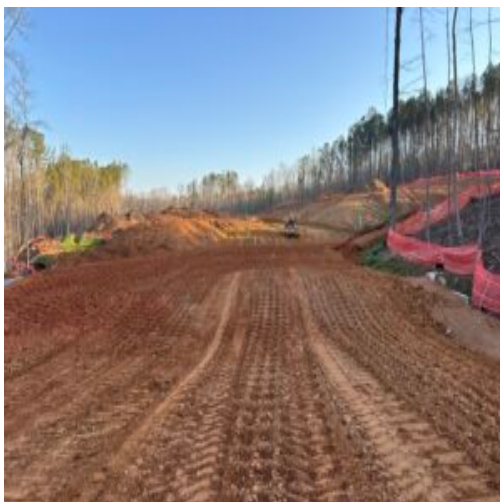
Sterlington drive facing north

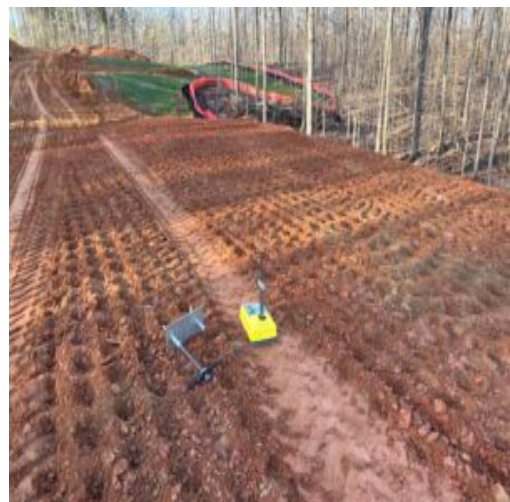
testing

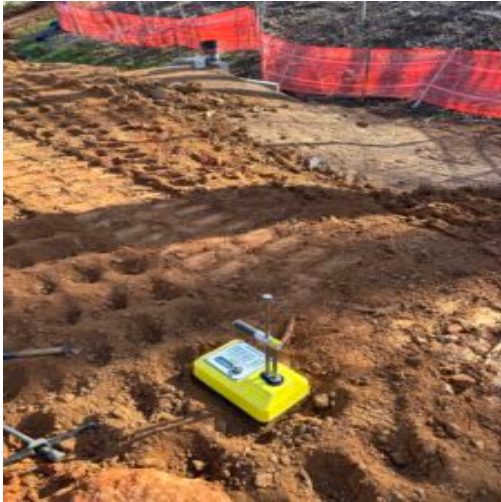
testing

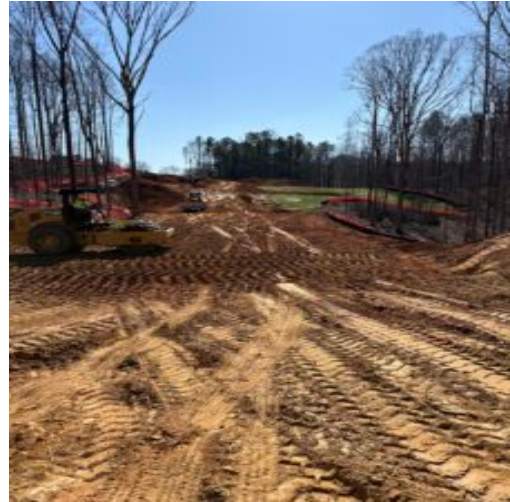
Sterlington drive facing South
