Date : 03/19/2024  
Project No : 2024C112  
Client Company : SR Homes  
Arrival Time : 03/19/2024  
Onsite Hours :

ASEC Report ID : 65376  
Name of the Project : Sterlington  
Project Location : Canton  
Weather : overcast  
Departure Time : 03/19/2024  
ASEC Technician Name : Russell Hendrix

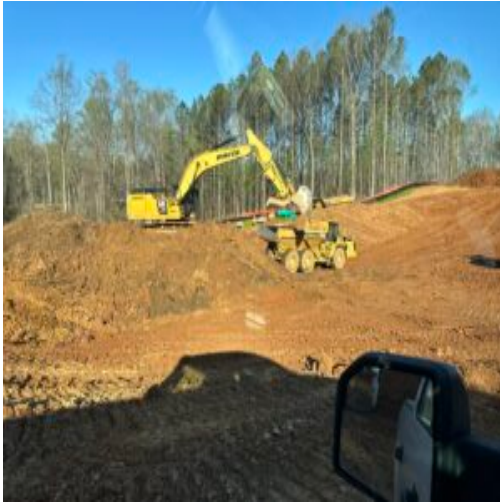
**Site Operations Overview:** Upon arrival, topsoil was being redistributed to slope areas throughout the development. Compaction activities were underway at the main road (Sterlington Drive) between stations 1+00 - 2+50, utilizing a Caterpillar CP54B ride-on vibratory sheeps-foot roller. This area serves as the original soil and starting point for future construction lifts.

Hauling off topsoil

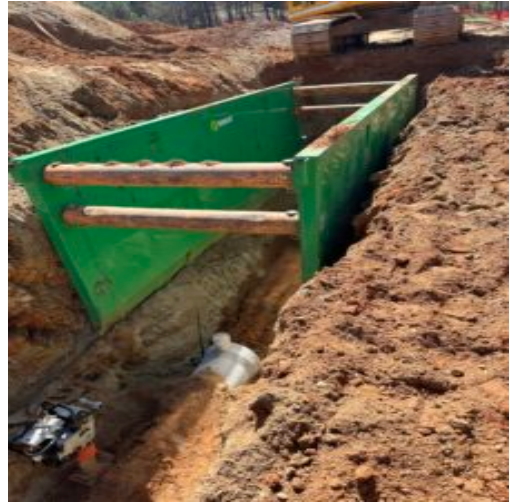
trench box for storm drain placement

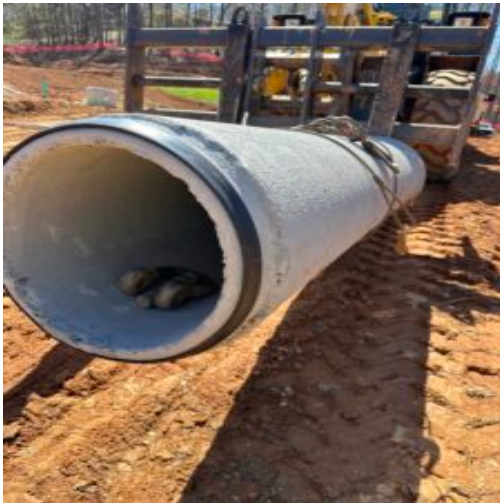
- Storm Drain 12-inch Reinforced Concrete Pipe (RCP) sections, each 8 feet long, were being placed from manhole I4 and moving southward.
- A jumping jack was employed on the first lift alongside the RCP sections.
- However, no backfilling was completed at the time of observation.
- Gaskets were observed to be in place.
- Notably, no stone bedding was utilized in this installation process.

RCP with seal

- It is recommended to complete backfilling around the RCP sections promptly after installation.

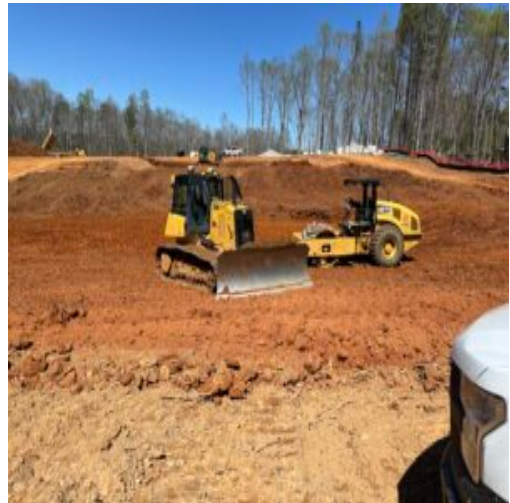
- Compaction activities were focused on the main road (Sterlington Drive) between stations 1.00 - 2+50.
- A Caterpillar CP54B ride-on vibratory sheep's foot roller was utilized to compact.
- No further observations were made in this area on the given day.

Dozer and compactor
