Date : 03/20/2024  
Project No : 2024C112  
Client Company : SR Homes  
Arrival Time : 03/20/2024  
Onsite Hours :

ASEC Report ID : 65440  
Name of the Project : Sterlington  
Project Location : Canton  
Weather : overcast  
Departure Time : 03/20/2024  
ASEC Technician Name : Russell Hendrix

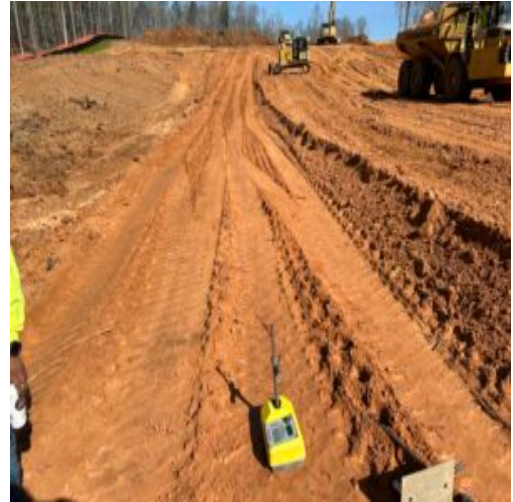
Testing 1+50

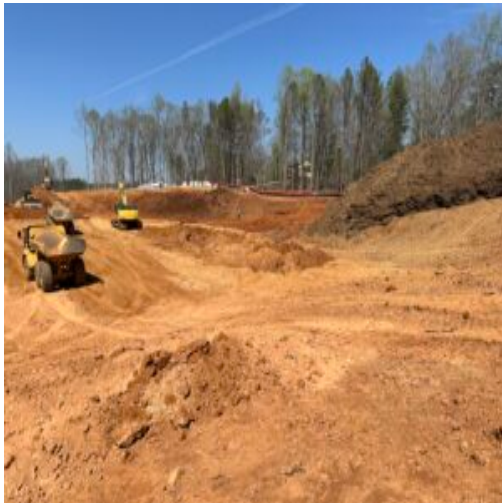
Compacting

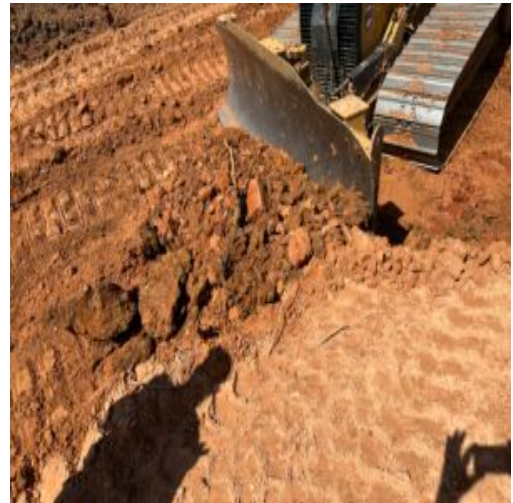
- A meeting with the foreman led to the decision to scarify the soil to lower moisture levels.
- During scarification, a significant amount of topsoil was observed in the underlying soil.
- It was recommended to remove all topsoil from the west side of the entrance area (1.00 to 2.00) to address moisture concerns.
- Additional soil was brought in after the removal of topsoil on the west side.

organic material

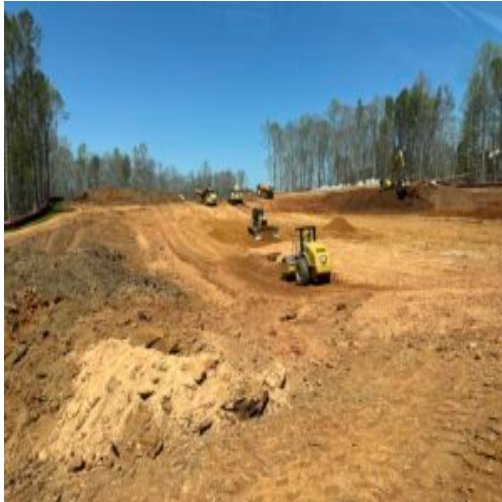
compacting
