Date : 04/16/2024  
Project No : 2024C112  
Client Company : SR Homes  
Arrival Time : 04/16/2024  
Onsite Hours :

ASEC Report ID : 66134  
Name of the Project : Sterlington  
Project Location : Canton  
Weather : overcast  
Departure Time : 04/16/2024  
ASEC Technician Name : Russell Hendrix

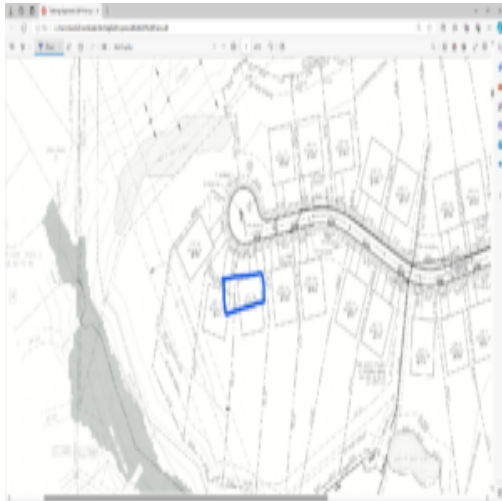
**Summary:** A call from the site superintendent prompted an investigation into a secondary buried pit located at the rear of the property, adjacent to future building lots 14 and 15, near Sterlington Drive. The pit contained burned organic material buried beneath 5 feet of fill, reaching approximately 15 feet deep. The affected area measured approximately 48 feet x 65 feet x 12 feet (as depicted in the blue area on the attached plan). Debris removal occurred the day before, as indicated by the accompanying photographs. The area has been refilled with quality structural material, with the surplus material currently stored onsite. The intention is to sift through this material to eliminate sizable stumps and large organic matter. The finer material will be distributed over the site as topsoil, while the larger organic pieces will be transported offsite.

Burry pit (2nd found on site) location marked in Blue

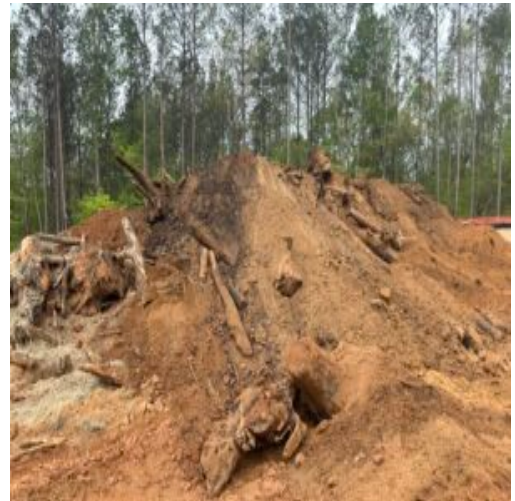
Burry pit debris after removal front view

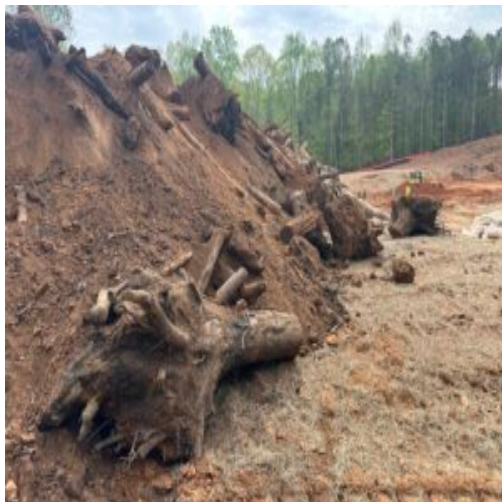
burry pit debris after removal side view

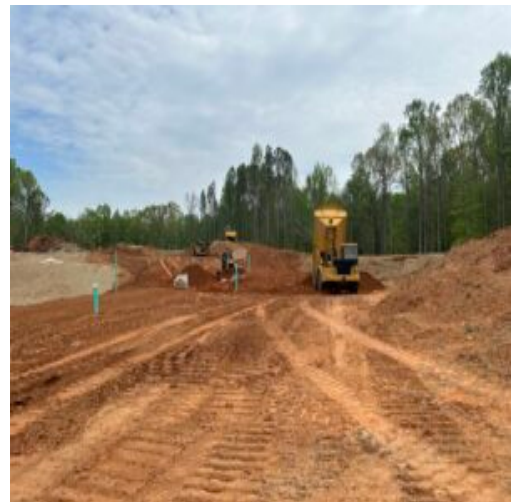
Lift

Additionally, a lift was installed at a depth of minus 4 feet from the surface, extending from Station 15+50 to 17+00 under the proposed Sterlington Drive (refer to the attached photo). A Komatsu PC360 excavator was employed while a Caterpillar CP105 ride-on vibratory sheep's foot compactor was utilized for soil compaction.

- Test #1 yielded a Dry Density (DD) of 94.3 and Moisture (M) content of 18.9% at Station 16+75.
- Test #2 recorded a DD of 75.9 and M of 17.2% at Station 15+75.
- Initial findings indicated that compaction was not achieved, necessitating a recommendation for additional compaction efforts.

- Retest #1 resulted in a DD of 82.4 and M of 20% at Station 16+25. (87% compaction) was prompting another recommendation for further compaction.
- Retest #2 recorded a DD of 84.3 and M of 18.5% at Station 16+00. Similar to the previous retest (89% compaction), additional compaction is recommended to meet desired specifications.

**Conclusion:** No further observations were made on this day. Any areas still deficient in compaction will

undergo further work and testing the following day before proceeding with the backfill process.

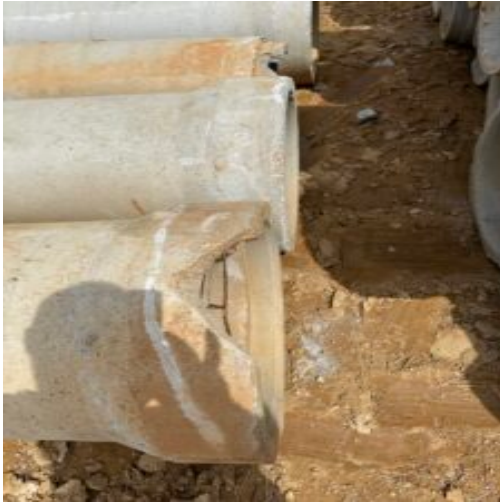
An observation was made in regard to delivered Reinforced Concrete Pipe (RCP) from another Fritz project. A discussion was held with the superintendent. An agreement was made no damaged RCP would be used on this project. (see photo)

Damaged RCP

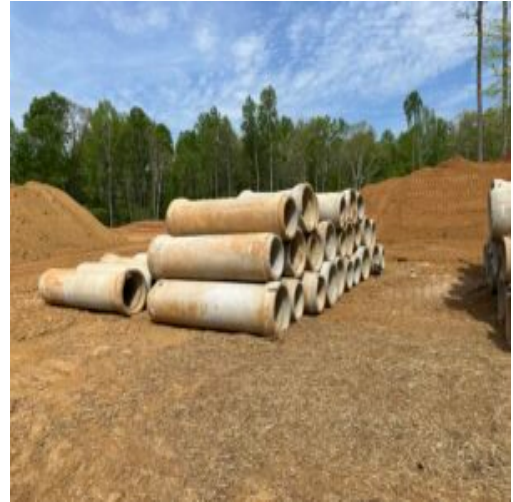
RCP delivered from another job
