Date : 04/23/2024  
Project No : 2024C112  
Client Company : SR Homes  
Arrival Time : 04/23/2024  
Onsite Hours :

ASEC Report ID : 66179  
Name of the Project : Sterlington  
Project Location : Canton  
Weather : sunny  
Departure Time : 04/23/2024  
ASEC Technician Name : Russell Hendrix

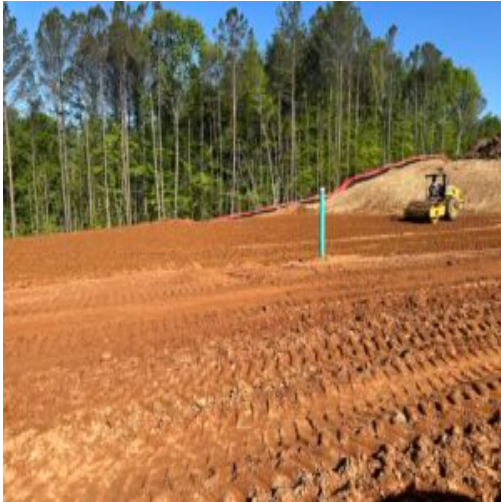
- A 12-inch lift of soil was placed, with Test #1 at -4 feet below the surface showing a DD of 93.4 pcf and 25.2% Moisture.
- Test #2 at the same depth recorded a Dry Density of 85.0 pcf and 28.7% Moisture, prompting a recommendation for scarification and aeration to lower soil moisture and recompacting to achieve optimal compaction.

Lift at lots 10 and 11

**Recommendation:** A recommendation was given to scarify the soil to lower moisture levels and recompact to achieve the desired compaction standards. However, this action was not completed before the end of the shift.

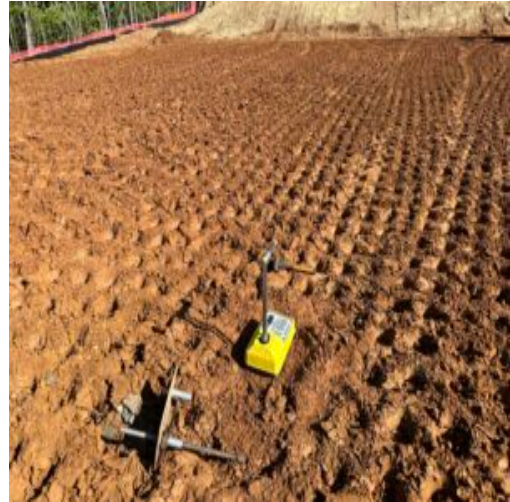
Testing lots 10 and 11

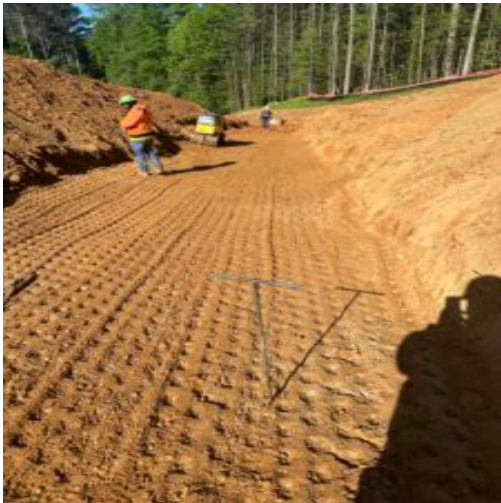
trench packer utilization
