Date : 04/24/2024  
Project No : 2024C112  
Client Company : SR Homes  
Arrival Time : 04/24/2024  
Onsite Hours :

ASEC Report ID : 66188  
Name of the Project : Sterlington  
Project Location : Canton  
Weather : sunny  
Departure Time : 04/24/2024  
ASEC Technician Name : Russell Hendrix

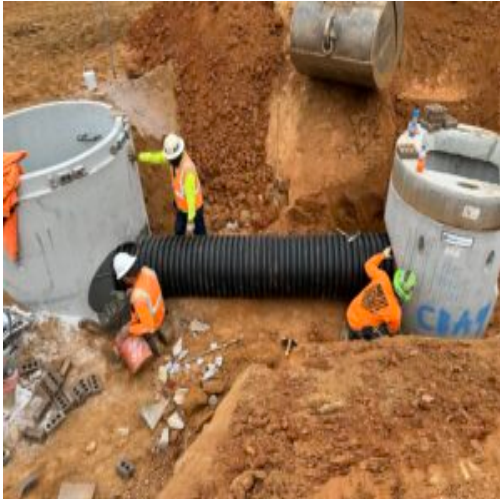
- Storm drain manhole A9 was placed without stone bedding.
- Reinforced Concrete Pipe (RCP) was installed, connecting from B1 to B2, with no stone bedding utilized.
- Using a 3.8-inch probe rod, the deflection depth was approximately 1/2 an inch.
- Manhole B2 was placed without stone bedding.

A9 to B1 with Black corrugated pipe

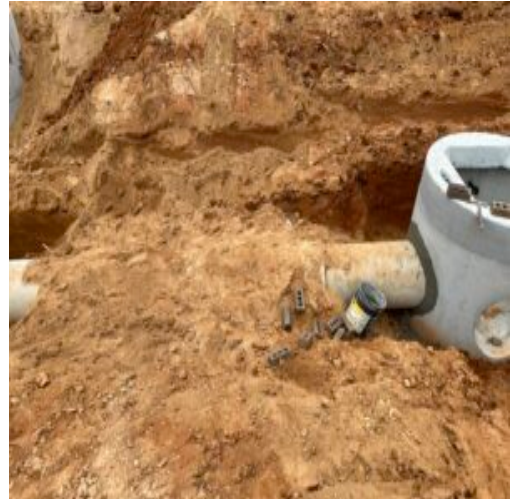
B1 to B2 RCP

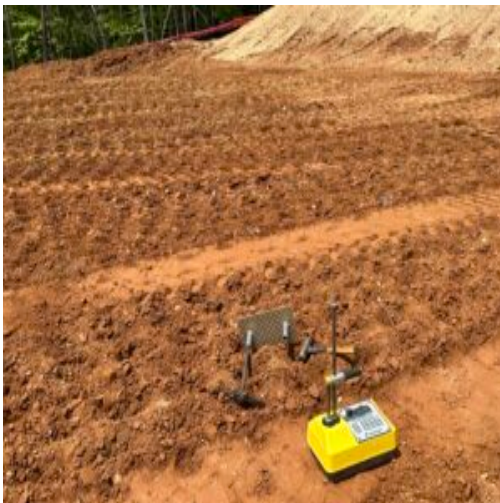
- Test #1 recorded a Dry Density of 103.0 pcf and Moisture content of 18.2%.
- Test #2 yielded a Dry Density of 100.0 pcf and Moisture content of 20.3%. It was determined that natural rock was mixed into the soil testing area, potentially affecting the test results.

Testing

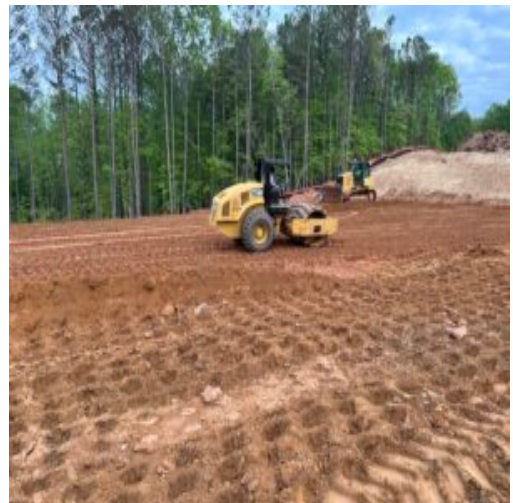
**Summary:** Utilizing a Caterpillar DK6, CP54B sheepsfoot ride-on vibratory compactor, and a D250E off-road tandem dump truck, an approximate 12-inch lift was placed and compacted in an area spanning approximately 74 feet x 150 feet (Lots #9, 10, and 11) at a depth of -3 feet below the surface. Compaction testing was conducted using a Troxler 3430 (Serial #30942) with a moisture-density relationship of 94.8 pcf Dry Density and 25% Moisture.

**Proof Roll:** A proof-roll was conducted using a loaded Tandem off-road dump truck, and Lots #9, 10, and 11 were observed to not display severe rutting/pumping at approximately -3 feet from the surface.

compaction of lots 9, 10 and 11

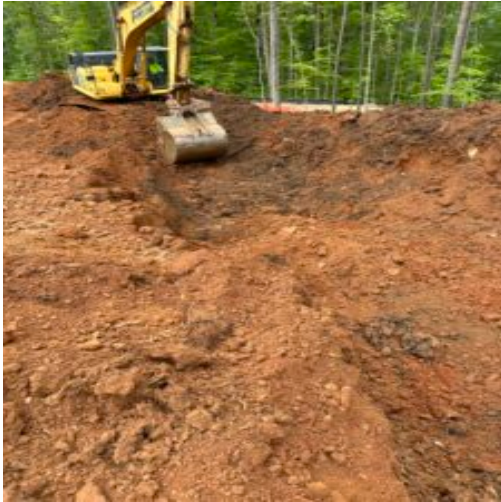
removing organics from back of lots 10 and 11
