Date : 05/02/2024  
Project No : 2024C112  
Client Company : SR Homes  
Arrival Time : 05/02/2024 8:30  
Onsite Hours : 08:30

ASEC Report ID : 66330  
Name of the Project : Sterlington  
Project Location : Canton  
Weather : sunny  
Departure Time : 05/02/2024 17:00  
ASEC Technician Name : Aminullah Azimi

The undersigned arrived onsite to observe CMU block placement for retaining wall #1 and visually inspect the footings.

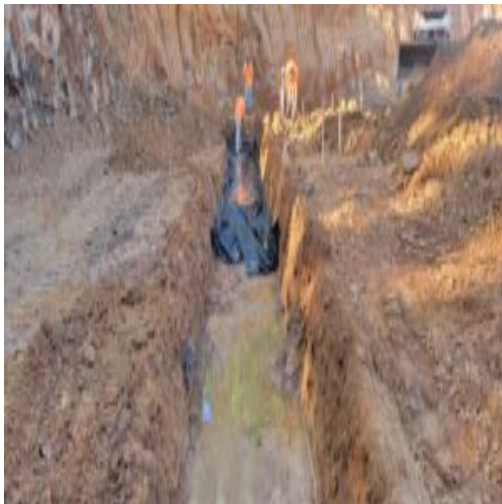
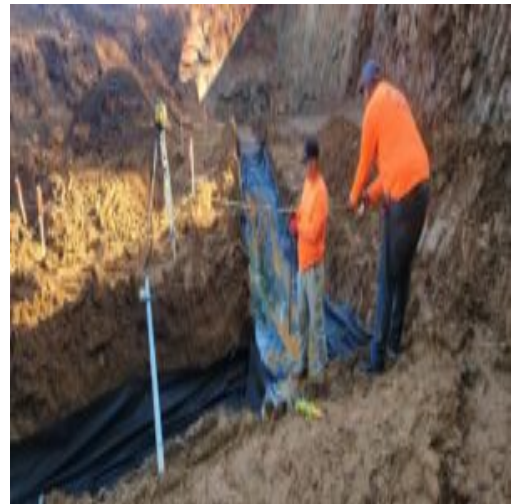
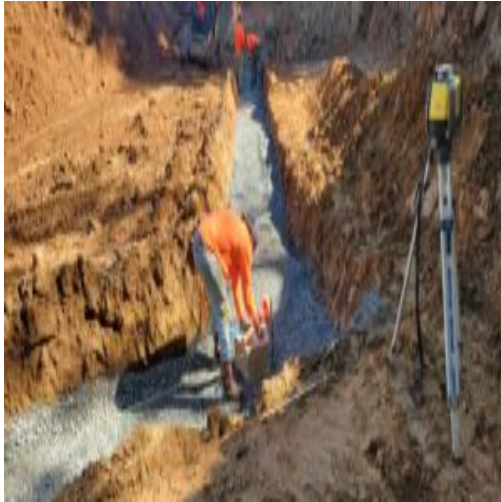
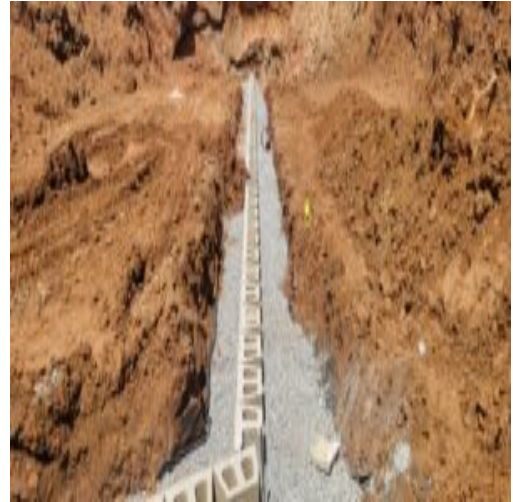
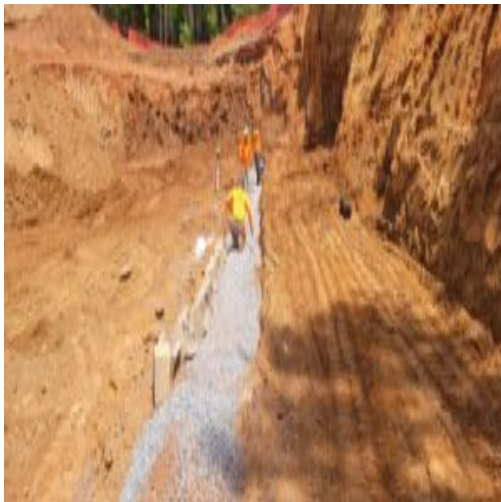
- 1: The footing was observed by our ASEC representative, Russell Hendrix. It was recommended to remove approximately 6 inches of soil and replace with #57 stone to work above the water intrusion.
- 2: Our representative noted the backfill behind the block in the cells was #57 stone.
- 3: The soil backfill was placed in 12-inch compacted lifts.
- 4: No. 57 stone was utilized 1 foot behind the block and within the cells.
