Date : 05/07/2024  
Project No : 2024C112  
Client Company : SR Homes  
Arrival Time : 05/07/2024  
Onsite Hours :

ASEC Report ID : 66467  
Name of the Project : Sterlington  
Project Location : Canton  
Weather : sunny  
Departure Time : 05/07/2024  
ASEC Technician Name : Russell Hendrix

**Overview:** A modular block wall construction project was continued adjacent to (behind) Lots #24 and 25, totaling approximately 200 feet in length with an angle at 90 feet. The following report outlines the activities conducted and observations made during the construction process.

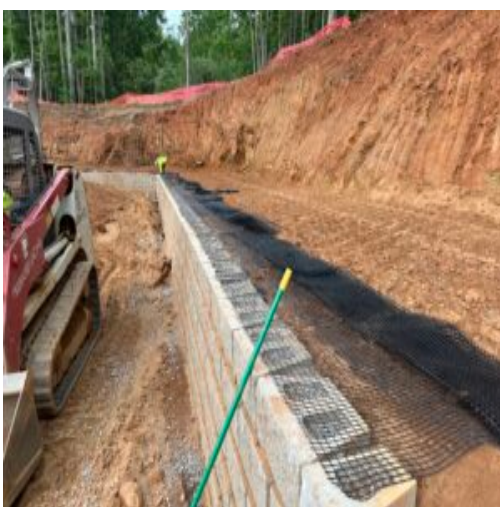
Retaining wall at end of day

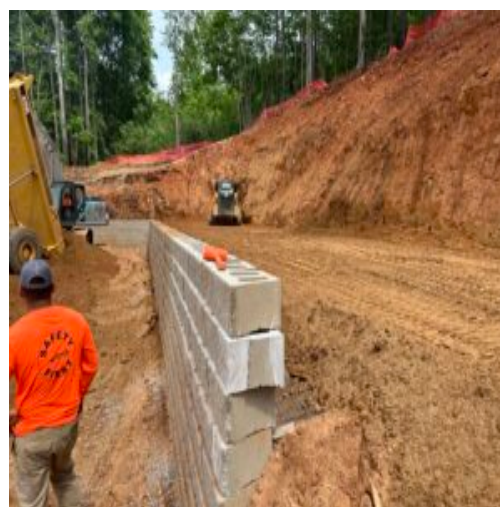
Spreading backfill

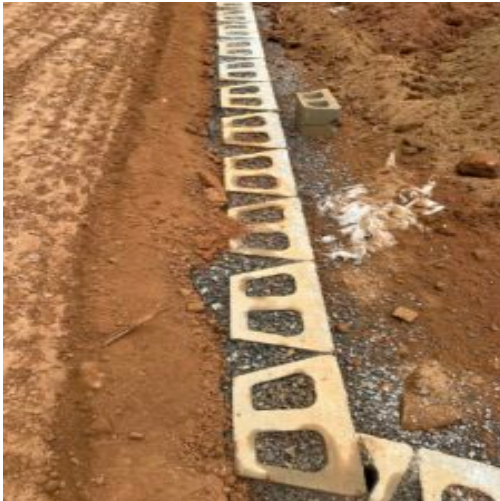
Block filled with 57 stone

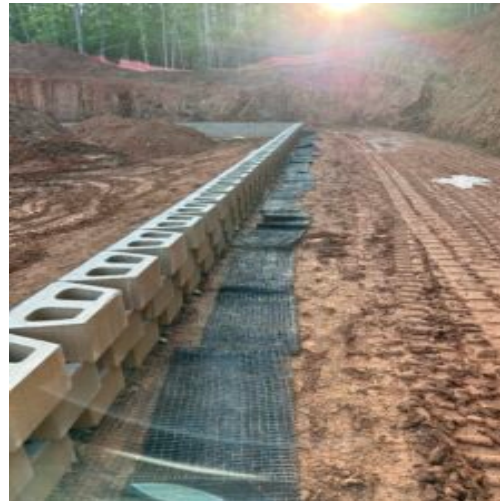
**Observations:** Upon arrival at the site, it was observed that a significant amount of water had accumulated on the existing lift, as depicted in the attached photo. A discussion was initiated with the ASEC PE (Professional Engineer), and it was unanimously agreed upon by all parties to remove 6 inches of the previous lift. This decision was made in response to a prior rain event.

Retaining wall beginning of day with high moisture content on previous days lift.

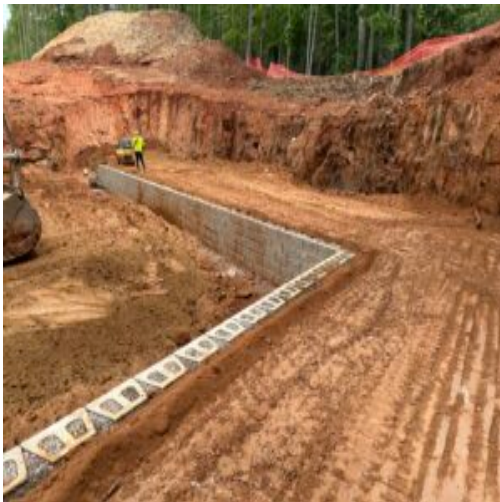
Using trench packer against wall
