Date : 07/17/2024  
Project No : 2024C112  
Client Company : SR Homes  
Arrival Time : 07/17/2024  
Onsite Hours :

ASEC Report ID : 67981  
Name of the Project : Sterlington  
Project Location : Canton  
Weather : overcast  
Departure Time : 07/17/2024  
ASEC Technician Name : Russell Hendrix

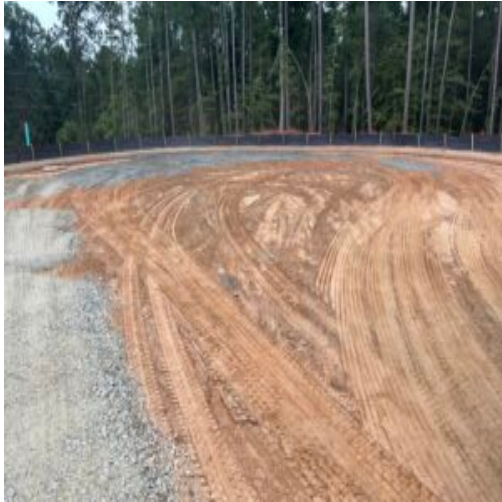
Cul-de-sac at end of main road
