Date : 06/19/2024  
Project No : 2024C112  
Client Company : SR Homes  
Arrival Time : 06/19/2024  
Onsite Hours :

ASEC Report ID : 67352  
Name of the Project : Sterlington  
Project Location : Canton  
Weather : sunny  
Departure Time : 06/19/2024  
ASEC Technician Name : Russell Hendrix

Proof-roll Summary and remediation recommendations:

- **Project Name:** Sterlington Entrance Deceleration Lane
- **Deceleration Lane Dimensions:** 150 feet x 16 feet

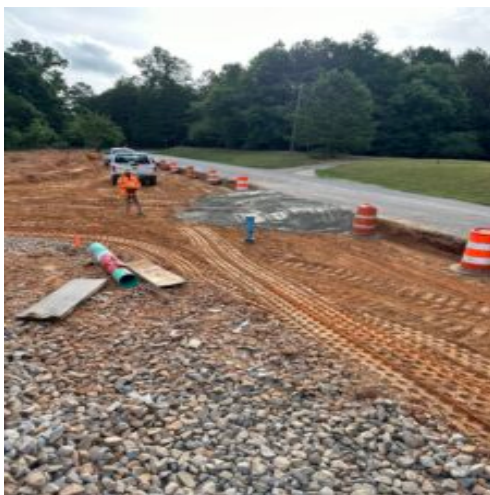
Deceleration lane

- **Acceptable Areas:** Majority of the deceleration lane was found to not exhibit severe pumping and/or deflection.
- **Problematic Area:** An approximately 4-foot-wide section running the length of the deceleration lane exhibited some noticeable deflection.

- **Problem:** Pumping was observed in the 4-foot-wide section.
- **Cause:** The pumping is likely caused by a pre-existing water line buried under current grade, leading to instability in the soils above.

- **Action:** Remove approximately 6 inches of soil over the problematic 4-foot-wide section.
- **Replacement Material:** Backfill the excavated area with No. 57 stone to stabilize the section.
- **Reasoning:** The removal of unstable soil and replacement with No. 57 stone should increase subgrade stability.

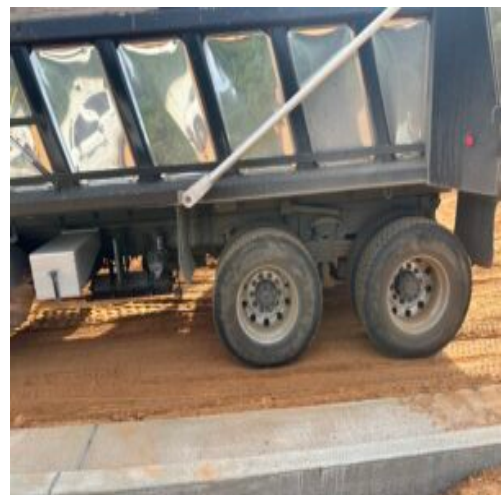
Loaded tandem dump truck proof roll
