Date : 07/17/2024  
Project No : 2024C112  
Client Company : SR Homes  
Arrival Time : 07/17/2024  
Onsite Hours :

ASEC Report ID : 67981  
Name of the Project : Sterlington  
Project Location : Canton  
Weather : overcast  
Departure Time : 07/17/2024  
ASEC Technician Name : Russell Hendrix

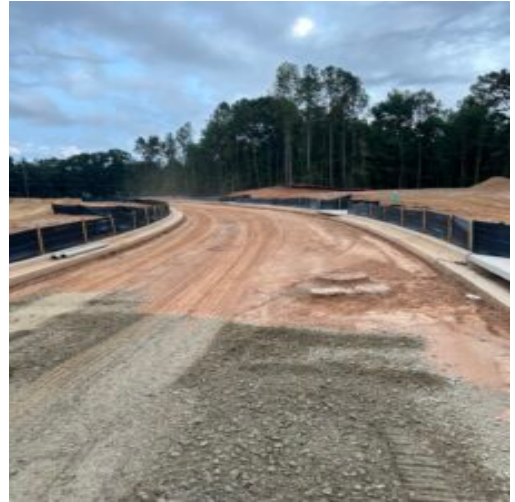
Starting of GAB placement 7/17

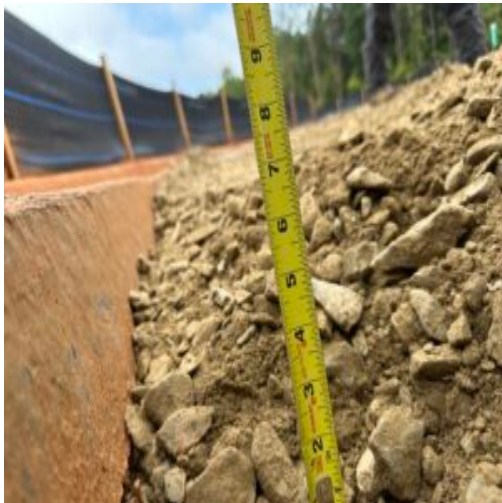
Approximately 6 inches or more of GAB depth.
