ASEC Report ID : 71869  
Name of the Project : Sterlington  
Project Location : Canton  
Weather : sunny  
Departure Time : 10/21/2024  
ASEC Technician Name : Russell Hendrix

### **Footing Inspection Report**

**Location:** Future Entrance Monument, Sterlington (Off Evens Cook Road)

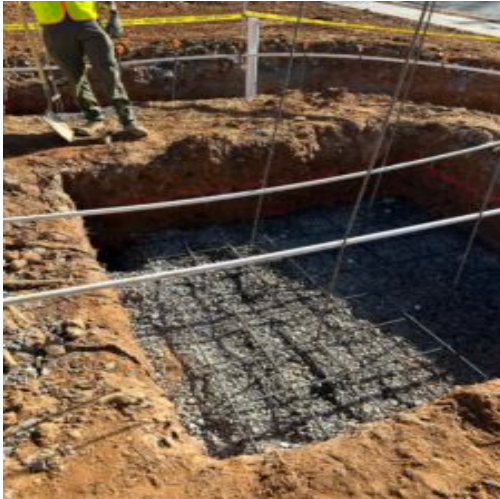
- **Rebar and Stone:** Upon arrival, rebar and #57 stone were already in place, preventing initial probing at some areas.
- **Reinforcement Steel:** The placement of reinforcing steel appeared to be consistent with the specifications provided in Sheet #LS301 titled "Hardscape Details" (dated 11-01-2023, prepared by Brunson & Company Landscape Architects).
- **Compaction Requirement:** Based on the results of the dynamic cone penetrometer testing and the type of soil visually classified in the field, we believe that the compaction requirement, as outlined in the project drawings, appears to have been met.

Unable to perform Bering pressure testing due to rebar and 57 stone already in place.

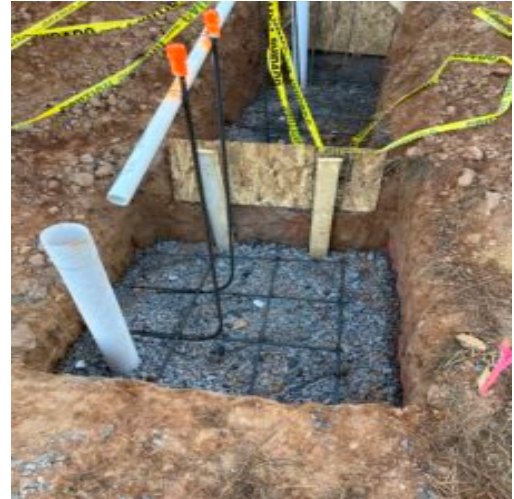
- 1st foot: 20 blows per increment (light brown silty sand)
- 2nd foot: 14 blows per increment (light brown silty sand)
- 3rd foot: 18 blows per increment (light brown silty sand)
- 4th foot: 13 blows per increment (light brown silty sand)

Location of 1st DCP. Rebar and 57 stone was removed.

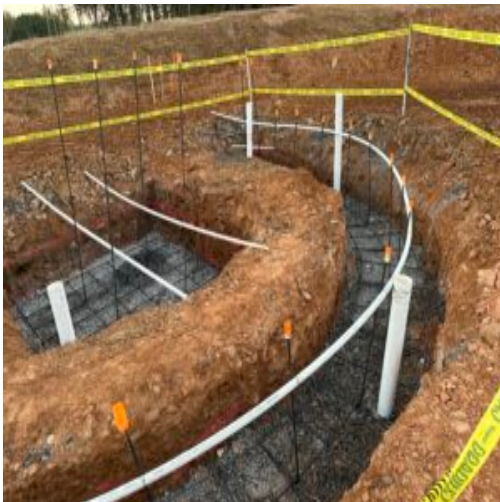
- 1st foot: 14 blows per increment (light tan silty sand)
- 2nd foot: 10 blows per increment (light tan silty sand)
- 3rd foot: 13 blows per increment (light tan silty sand)
- 4th foot: 11 blows per increment (light tan silty sand)

Location of 2nd DCP in curved area (57 stone removed)

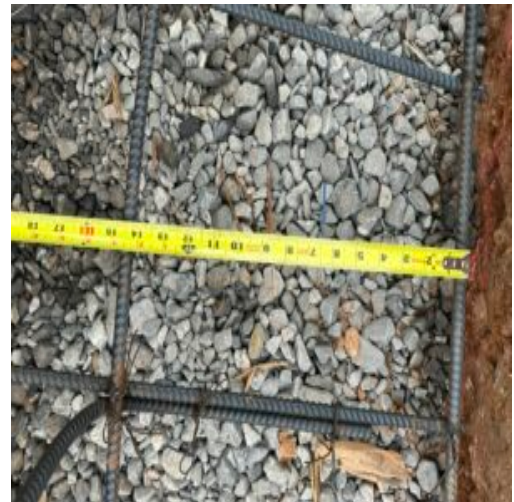
general spacing

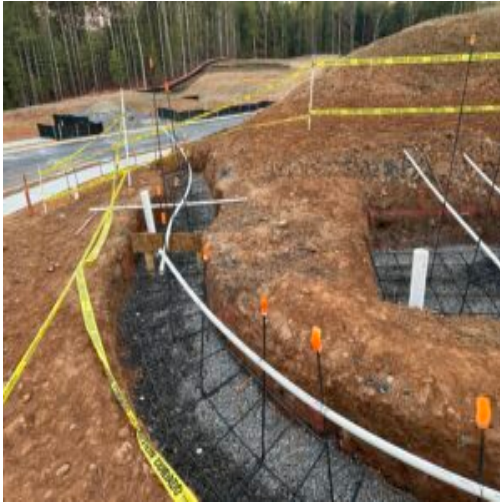
Curved area of monument.
