ASEC Report ID : 66272  
Name of the Project : Peeples Valley Rd, Overlook at Pettit  
Project Location : Cartersville  
Weather : overcast  
Departure Time : 04/29/2024  
ASEC Technician Name : Russell Hendrix

**Subject:** On-Site Meeting Regarding Uncontrolled Groundwater Issues

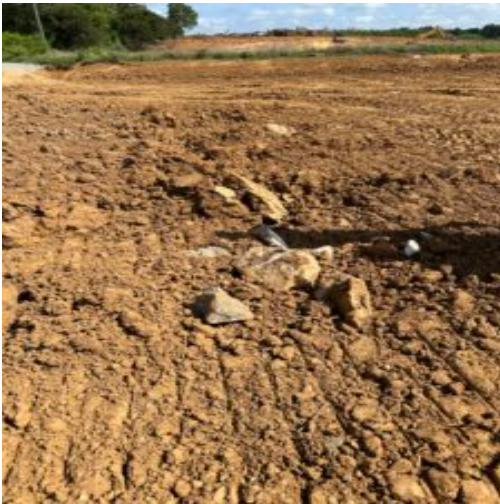
- This area affects Lots #94, 96, and 97, as indicated on the diagram (marked in Blue).
- The recommendation for this area involved utilizing helical piers on the back corner of the homes or making changes to the foundation design to address the groundwater issue effectively.

lots 95,96,97 affected area (since covered with soil)

1. Implement the proposed 1 foot x 1 foot "burrito wrap" using No. 57 stone wrapped in geotextile fabric in the first area to facilitate water drainage and conduct a reevaluation with a proof-roll.
2. Consider the installation of helical piers or modifications to the foundation design in the second area to mitigate groundwater issues impacting specific lots.

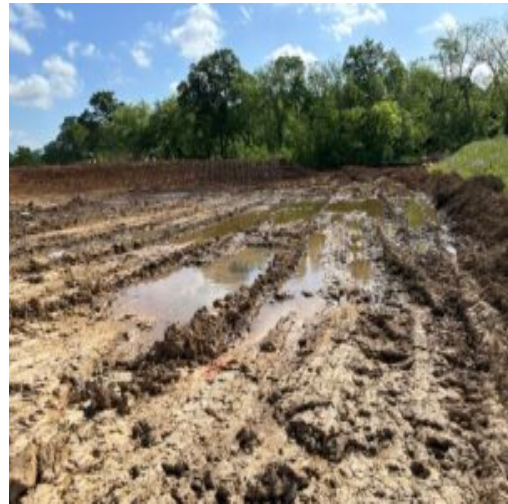
future area of Lots 54-61 plus roadway and sidewalk with uncontrolled ground water

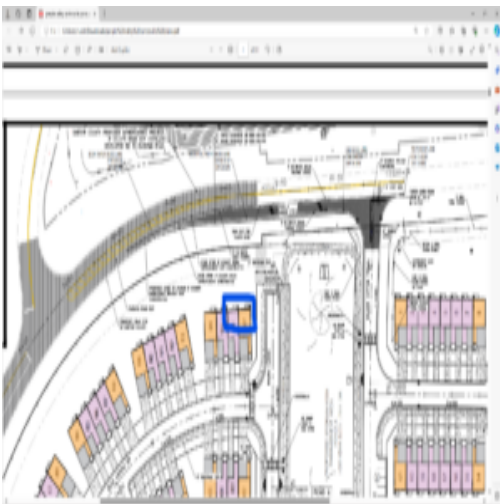
Lots 95,96,97 affected (area 2)

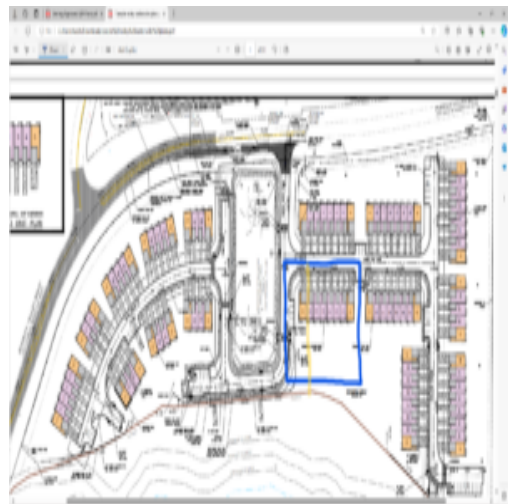
- The approximate problem area is circled in blue on the provided diagram.
- Mr. Ram Mogulla of ASEC recommended removing all water from the affected area.
- One proposed solution involved the installation of a 1 foot x 1 foot "burrito wrap" using No. 57 stone wrapped in geotextile fabric (proposed location marked in yellow on the diagram), to be placed in a slope configuration.
- This method aims to drain water out of the area, following which a reevaluation with a proof-roll was recommended.

Affected area in Blue with Burrito wrap proposed in yellow (area 1)
