Date : 06/19/2024  
Project No : 2024C116  
Client Company : Peeples Owner, LLC  
Arrival Time : 06/19/2024 08:30  
Onsite Hours : 08:30

ASEC Report ID : 67136  
Name of the Project : Peeples Valley Rd, Overlook at Pettit  
Project Location : Cartersville  
Weather : Cloudy  
Departure Time : 06/19/2024 17:00  
ASEC Technician Name : Fawad Shagiwal

As requested, the site was visited by our AS Engineering and Consulting (ASEC) representative for the purpose of providing quality control inspection and testing services.

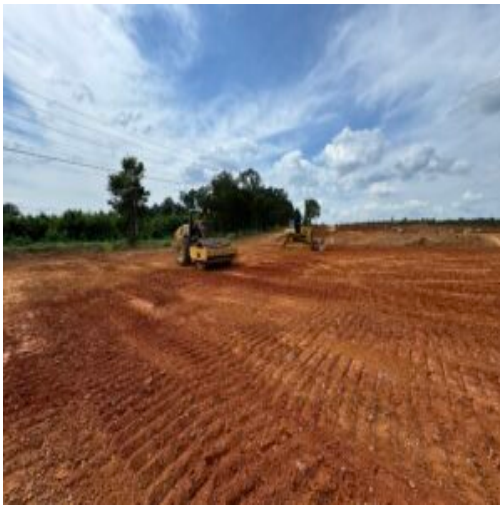
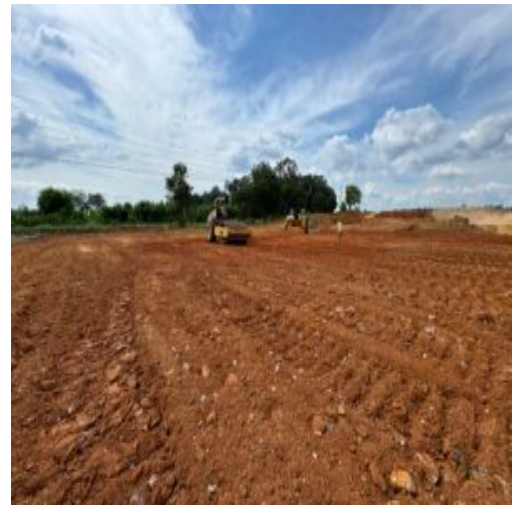
- The placement and compaction of backfill for Section 2 was in progress using CP54B, RA30, D51PX and CAT330 equipment.
- The continued trench was excavated on the northeast side of the existing detention pond with a sewer water line and manhole installed.
- A 1-foot lift was placed and compacted using SAKAI SV 204T compaction equipment.
- At the time of arrival our representative observed that the work was in progress for Section 2 with a 2-foot lift being placed and compacted using CP54B and D51PX compaction equipment.
- Proof-rolling tests were conducted for Section 2. Our representative observed that these soils were pumping/rutting at the surface due to high in-situ moisture contents.
