Date : 04/23/2024  
Project No : 2024C174  
Client Company : Toll Bros. Inc.  
Arrival Time : 04/23/2024 10:00  
Onsite Hours : 07:00

ASEC Report ID : 66744  
Name of the Project : 1260 Park Vista Drive  
Project Location : Brookhaven  
Weather : Sunny  
Departure Time : 04/23/2024 17:00  
ASEC Technician Name : Ramchandra Mogulla

#### **1. Repair Process of Retaining Wall 2A Foundation:**

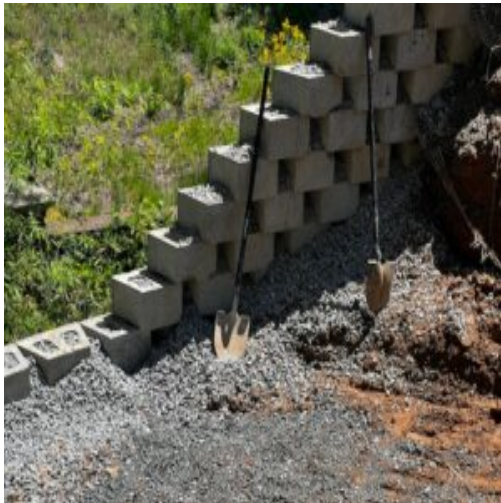
drainage aggregate

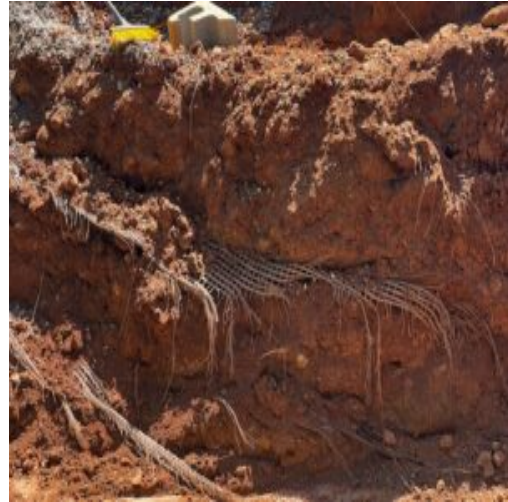
Removal of Geosynthetic reinforcement

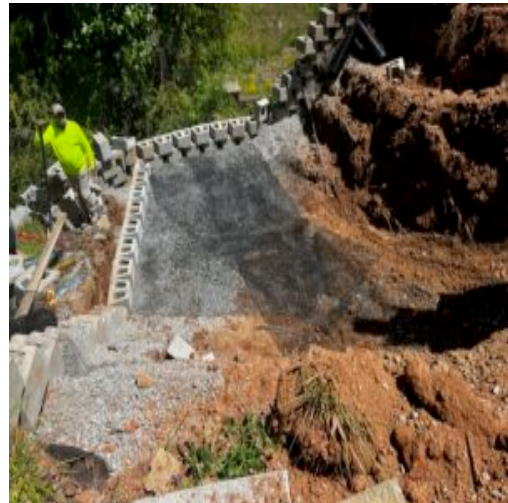
Installation of Geosynthetic reinforcement

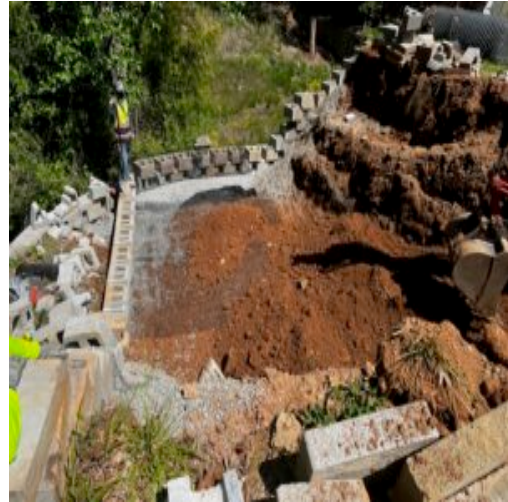
drainage aggregate

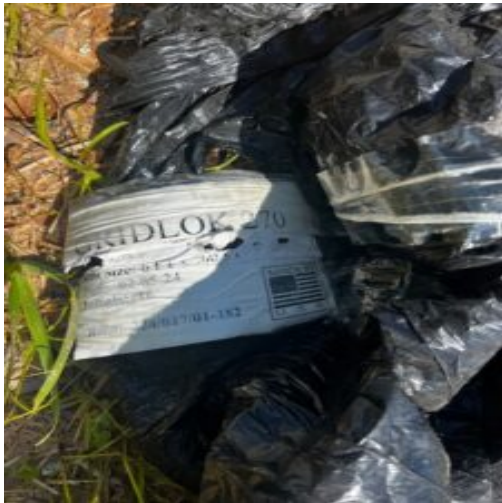
Geosynthetic reinforcement

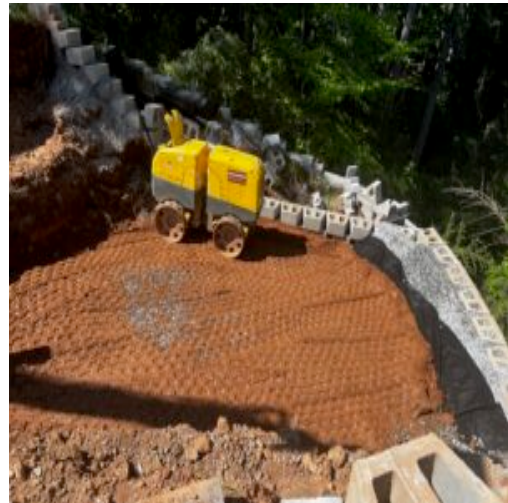
Compaction Efforts
