ASEC Report ID : 69524  
Name of the Project : Old Griffin Road  
Project Location : Dallas  
Weather : sunny  
Departure Time : 09/05/2024  
ASEC Technician Name : Russell Hendrix

**Project:** Hawthorne Reserve (185 Old Griffin Road, Dallas, GA)

**Objective:** Perform Dynamic Cone Penetrometer (DCP) testing to evaluate soil bearing pressures and assess rock depths for four (4) proposed above ground sewer line pier locations.

## Daily Field Report

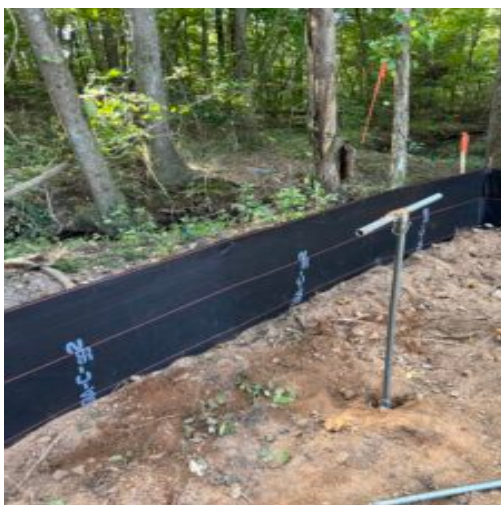
- **Note:** Test location augured 5 feet west from the intended location (which would have been in the creek).
- **1st Foot:** Light brown silty sand. DCP = 10 blows.
- **2nd Foot:** Wet dark brown sandy clay. DCP = 3 blows.
- **3rd and 4th Feet:** Wet dark brown sandy clay. DCP = 10 blows. Note that water seeping into the test location occurred almost immediately.
- **5th Foot:** Immediate auger refusal (small rocks suspected).
- **Auger Refusal @ 5'**

Location of Hole #4 is shown by auger inside silt fence, 5 feet from center of creek (and Pier location).

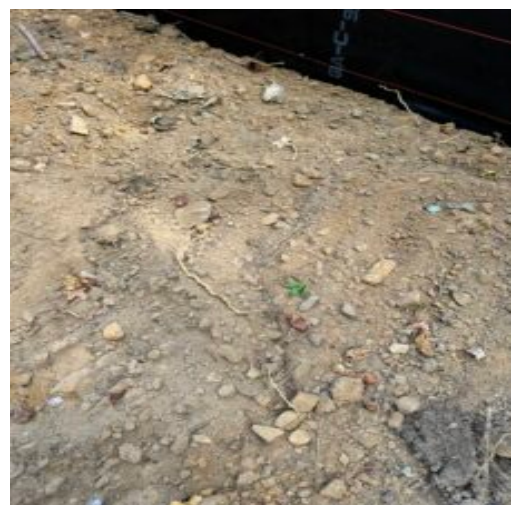
Rock mixed in soil

- Hand auguring within rocky soils (soils with small rock/gravel embedded within the soil matrix) will often hit refusal on these materials. We recommend that test pit excavations be performed to verify the refusal material at these locations.

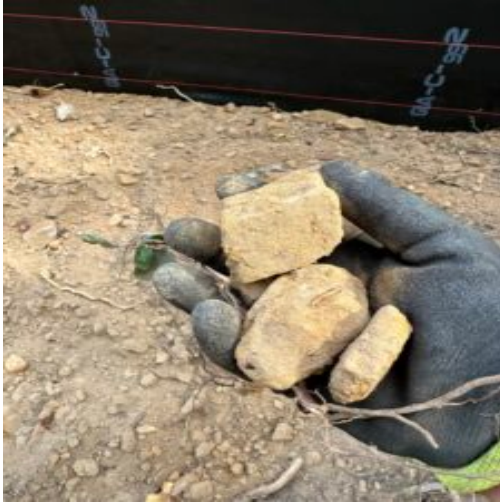
Rock mixed in soil causing Auger refusal.

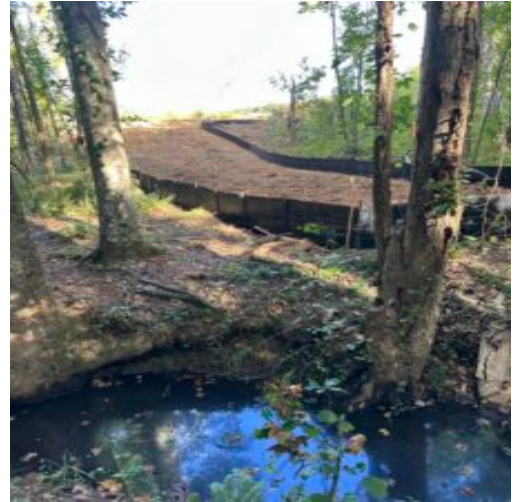
Photo of creek and auger locations, facing west.

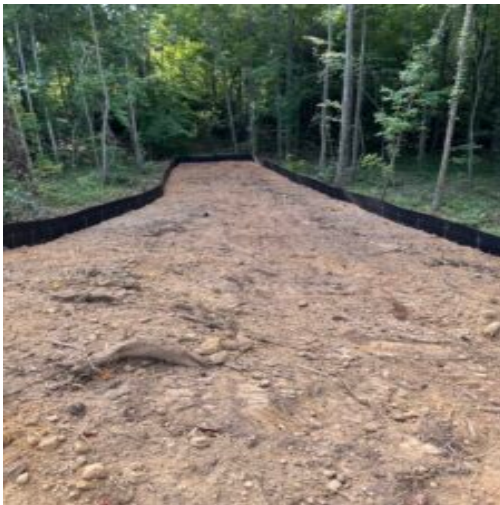
Section cleared containing 3 of the 4 future pier locations.
