Date : 09/23/2025  
Project No : 2024C217  
Client Company : Artisan  
Arrival Time : 09/23/2025 08:30  
Onsite Hours : 03:30

ASEC Report ID : 86243  
Name of the Project : Naturewalk - 7 Hills Amenities  
Project Location : Dallas  
Weather : Sunny  
Departure Time : 09/23/2025 12:00  
ASEC Technician Name : Clyde Smith

On the above date our representative of AS engineering was on site to observe exploratory excavations to locate the existing colonial gas pipelines crossing Seven Hills Boulevard at two locations. The HVAC contractor SHV (Southern Hydro Vac) performed the excavations which was also observed by a member from Colonial Pipeline, these were the findings listed below.

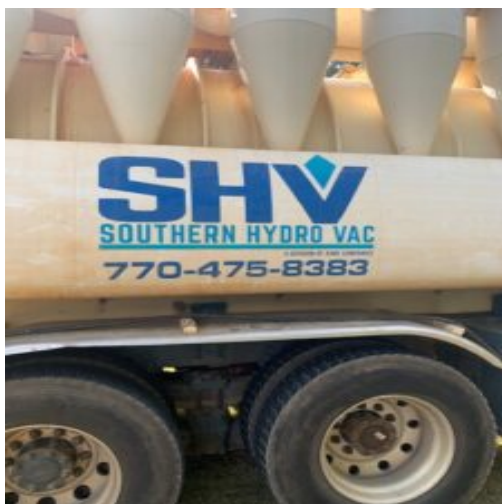
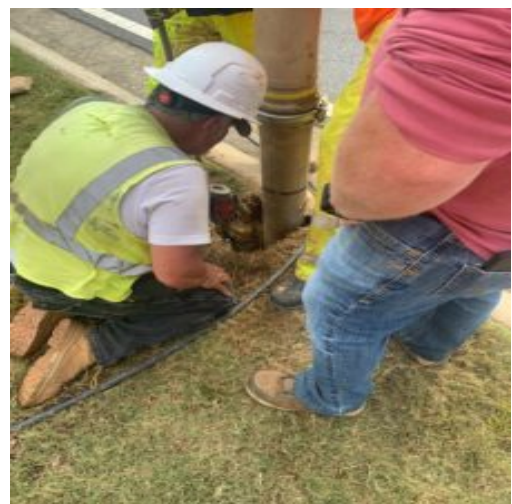
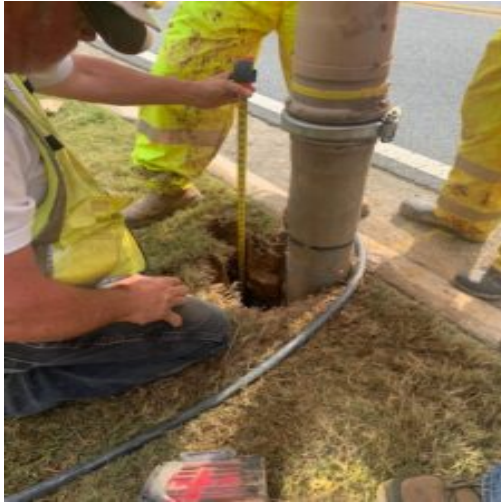
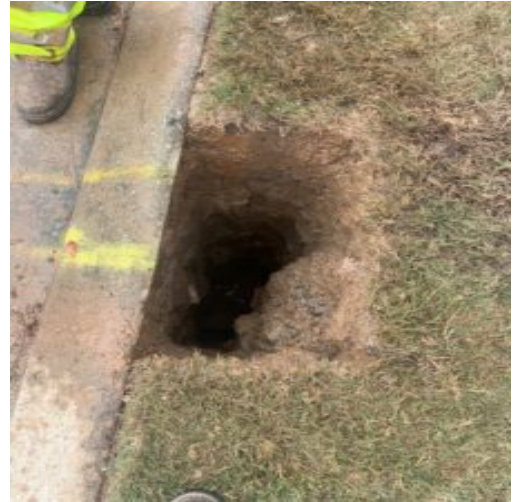
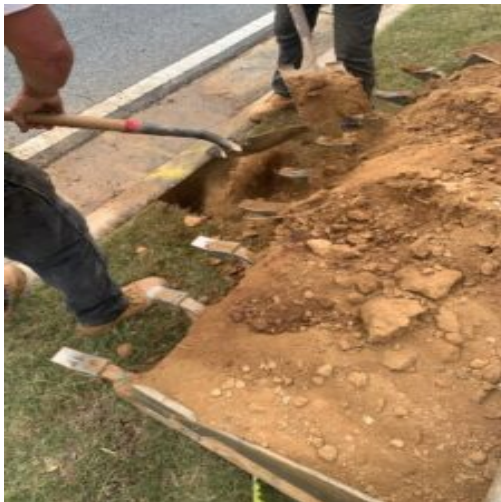
Location #1 = N1462805.219 E2106494.754, pipe encountered at elevation 940.61 (-7.9') below existing grade.

Location #2 = N1462819.854 E2106509.812, pipe encountered at elevation 940.346 (-8.7') below existing grade. The excavations were refilled with soil after observations were made and the sod replaced. The locations were established by Gaskins LeCraw survey team.
