Date : 03/06/2026  
Project No : 2025C149  
Client Company : Davidson Homes  
Arrival Time : 03/06/2026 08:00  
Onsite Hours : 08:30

ASEC Report ID : 90994  
Name of the Project : Grove at E. Thompson Mill Rd  
Project Location : Buford  
Weather : sunny  
Departure Time : 03/06/2026 16:30  
ASEC Technician Name : Samara Simha Reddy Kandi

As requested, the site was visited by our AS Engineering and Consulting (ASEC) representative for the purpose of providing quality control inspection and testing services. Visual observation techniques were employed to verify compliance with project drawing/specifications, applicable codes, and materials submittals. The following observations were observed on site this day.

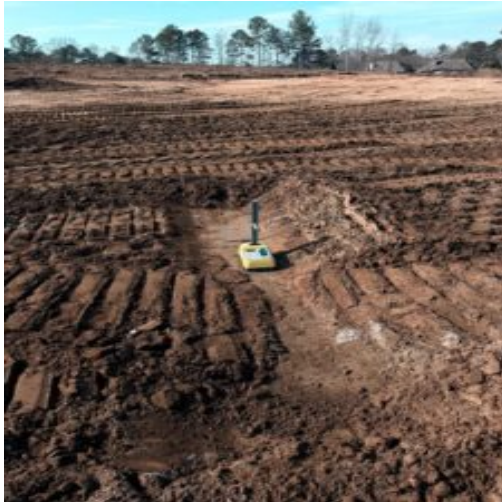
Density tests using Nuclear gauge

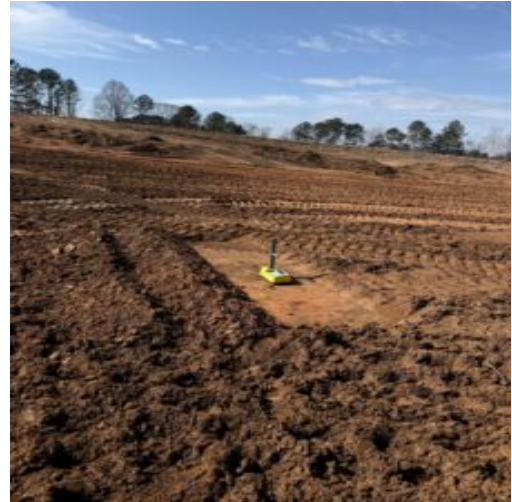
Density tests using Nuclear gauge

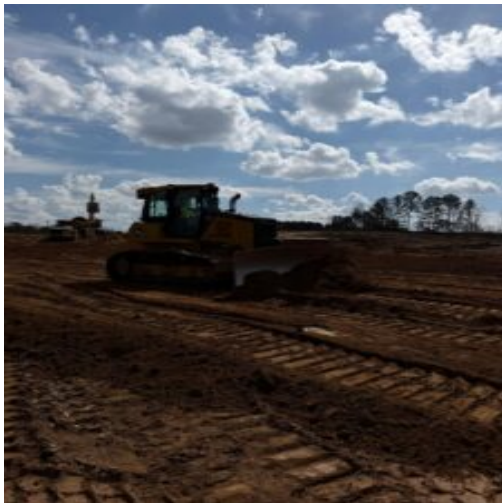
Crew continued site grading and backfilling operations at Lots #53, 52, 51, and 50. Backfill material placed within the lot areas was spread uniformly throughout the lots using a crawler bulldozer and then compacted using a sheep-foot roller and Caterpillar 815 compactor.

Spreading fill material using crawler bulldozer

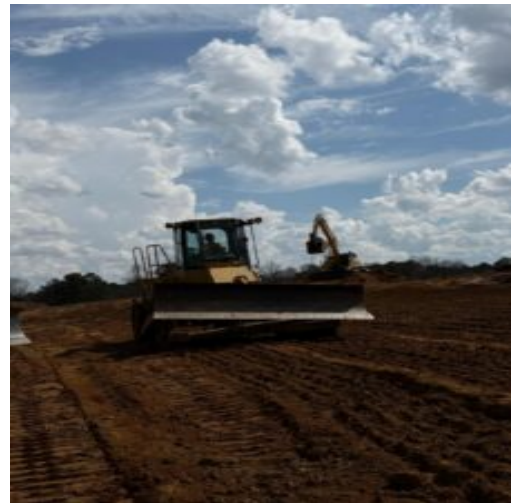
Compacting using pad foot roller 815

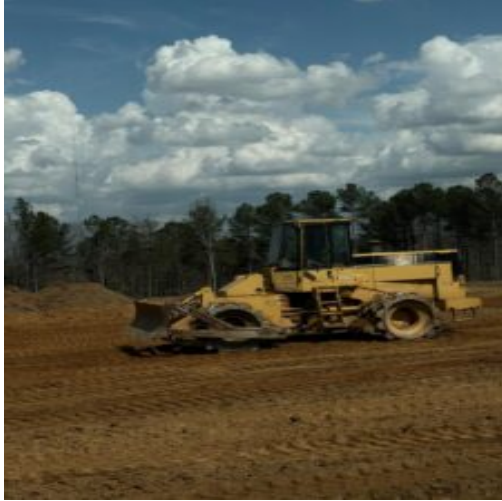
Compacting using pad foot roller 815

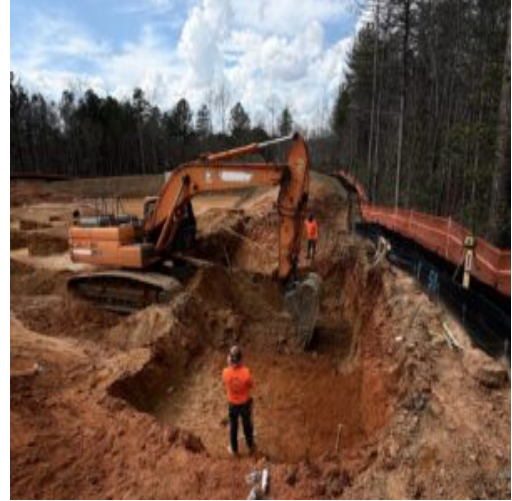
On the other side, at Pond 1, the crew had started leveling and fine grading the subgrade in preparation for the construction of the proposed concrete wall.

Levelling the subgrade for Concrete wall
