Date : 12/03/2025  
Project No : 2025C211  
Client Company : Pulte  
Arrival Time : 12/03/2025 07:30  
Onsite Hours : 08:30

ASEC Report ID : 88301  
Name of the Project : Haley's Bluff - Philadelphia Rd.  
Project Location : Jasper  
Weather : Sunny  
Departure Time : 12/03/2025 16:00  
ASEC Technician Name : Sean Willett

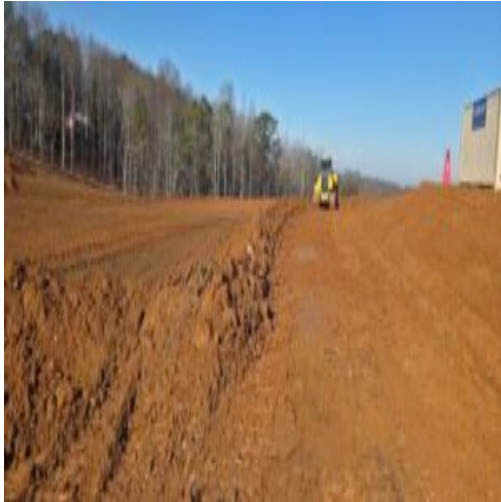
stripping mud in commercial lots

Our ASEC representative was on site as requested by the contractor (NG Grading) for the observation/testing of the placement of fill/backfill. Upon arrival to the site, it appeared that the site had not dried out much from the previous day's rainfall. There was a freeze and most of the water on the surface is now ice. ASEC spoke with the contractor to see how the contractor planned to handle this situation. The contractor insisted on working, so ASEC recommended that the frozen ground should be stripped away before any placement of fill material. The contractor agreed and spent most of the day stripping frozen ground away. As the sun came out in the afternoon, it turned the surface into mud. It was recommended to remove any over-saturated material before placement of fill.

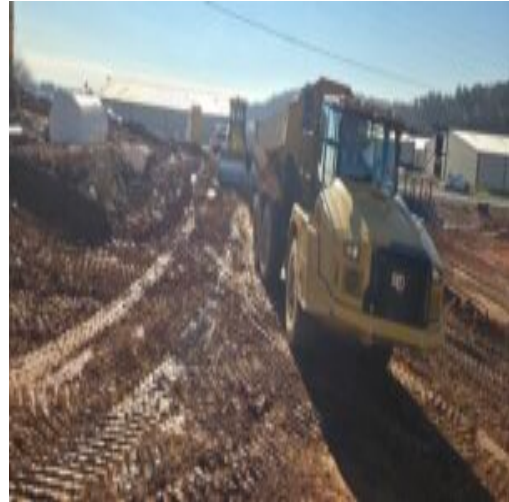
proof rolling the filled area at entrance

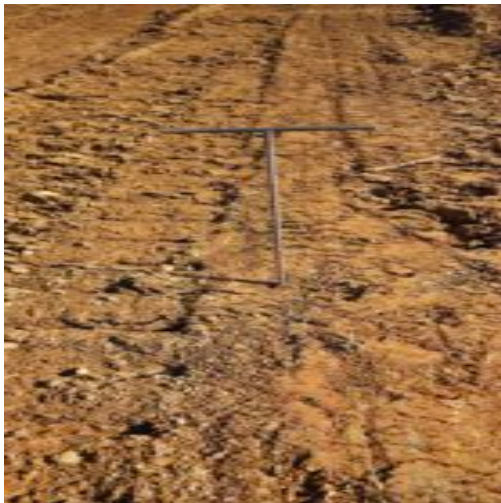
The fill in this entranceway consisted of a high amount of rock (approx. 70% rock and 30% fine material as shown in pictures). ASEC attempted multiple times to density test this area but was unable to conduct density testing due to the large amount of rock present. ASEC probed each lift and used visual inspection in an attempt to determine if the lifts were placed stable. Our representative watched as loaded off-road trucks rolled across the lifts to check for stability. There was one area where pumping was present. ASEC informed the contractor and the contractor cut out the area until firm ground was reached. Once this problem was addressed, the filled area appeared to be stable.

pumping/failed probe rod (addressed by contractor)

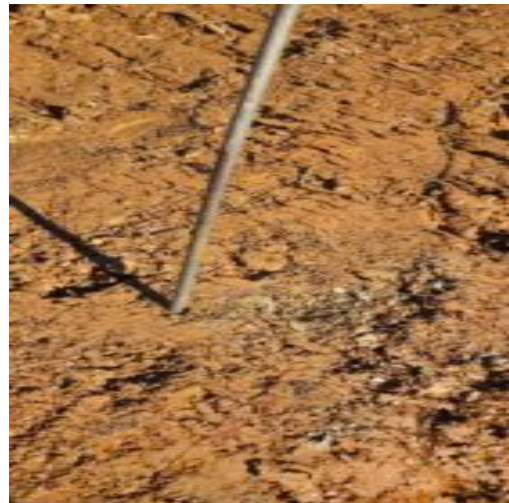
pumping/failed probe rod (addressed by contractor)

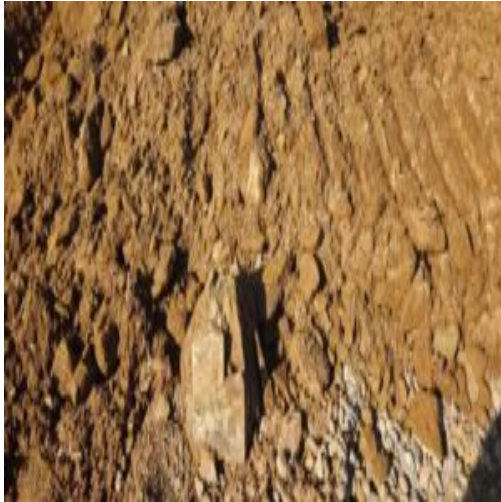
rocky material used for filling

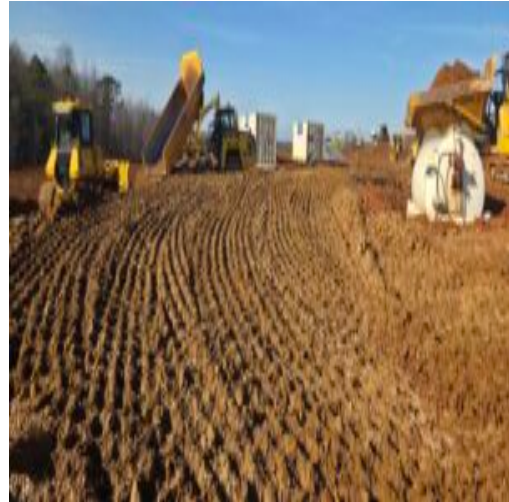
filling entrance way by connexes

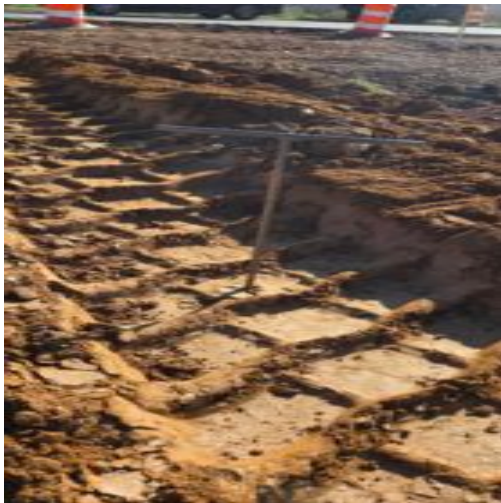
pumping/failed probe rod (addressed by contractor)

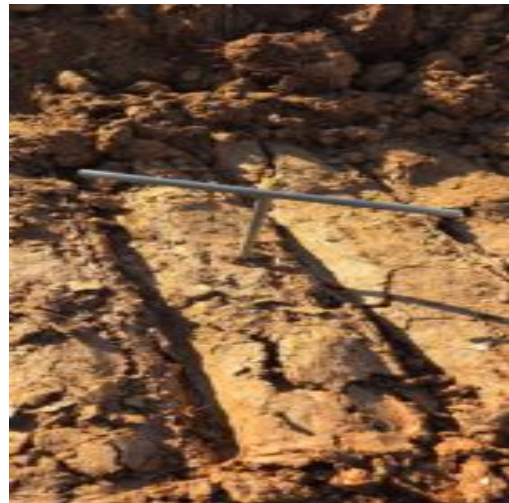
pumping/failed probe rod (addressed by contractor)

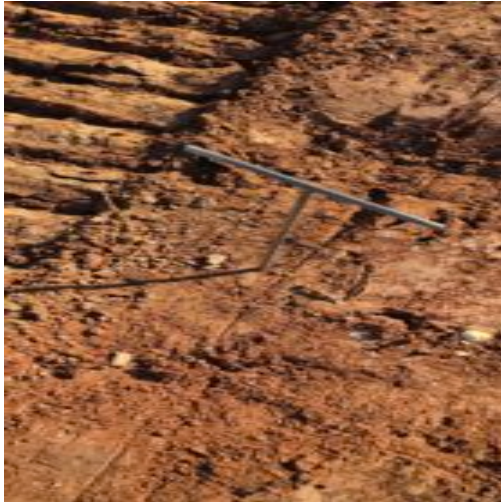
pumping/failed probe rod (addressed by contractor)

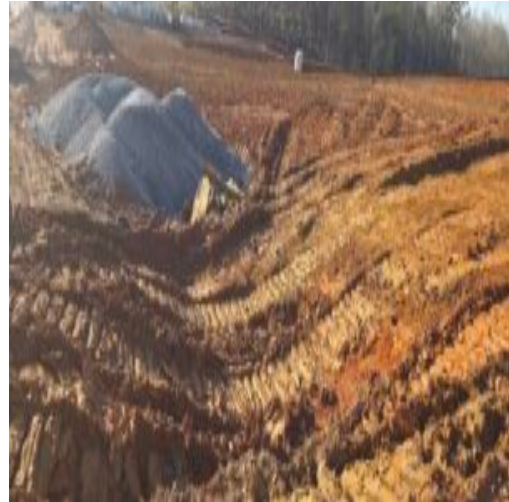
cut from failed probe rod test

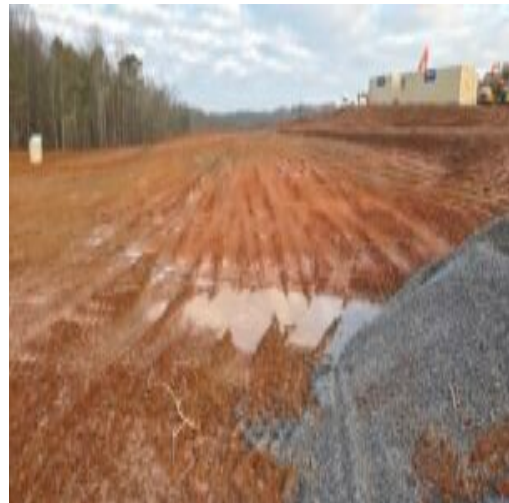
site conditions at beginning of day

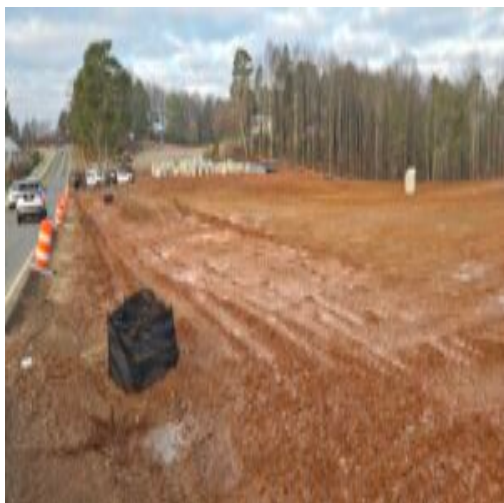
site conditions at beginning of day

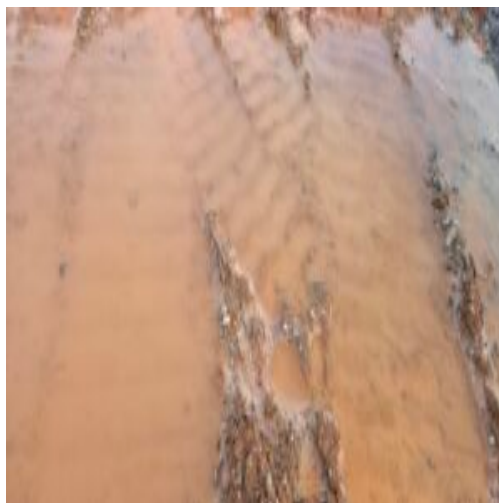
site conditions at beginning of day

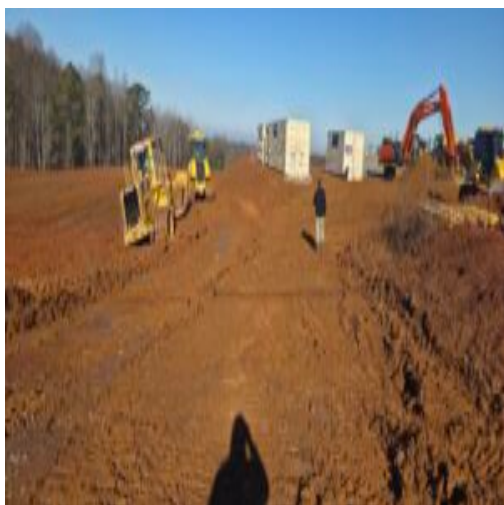
cutting mud/frost out before filling entrance way
