Date : 06/03/2026  
Project No : 2025C211  
Client Company : Pulte  
Arrival Time : 06/03/2026  
Onsite Hours : N/A

ASEC Report ID : 95306  
Name of the Project : Haley's Bluff - Philadelphia Rd.  
Project Location : Jasper  
Weather : overcast  
Departure Time : 06/03/2026  
ASEC Technician Name : Russell Hendrix

### **Proof-Roll Observation Report - Haley's Bluff Development**

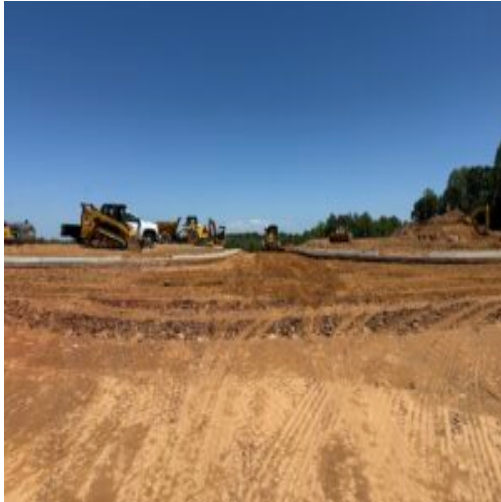
During the inspection, fifteen (15) locations exhibiting minor deficiencies associated with the previous day's rainfall event were identified. The following areas were observed and subsequently scarified to facilitate moisture reduction:

Scarfification

All parties present were in agreement regarding the identified areas and the corrective action required. It was observed that all noted locations had been scarified to reduce moisture content and promote drying. At the time of departure, recompaction activities had not yet been completed. Once aerated, surficial subgrade soils will be recompacted prior to GAB placement.

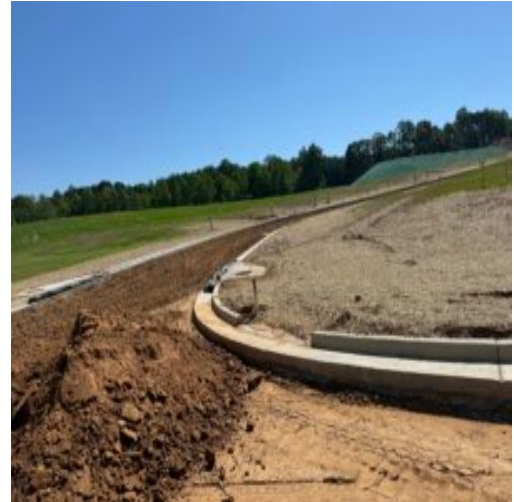
Scarfification

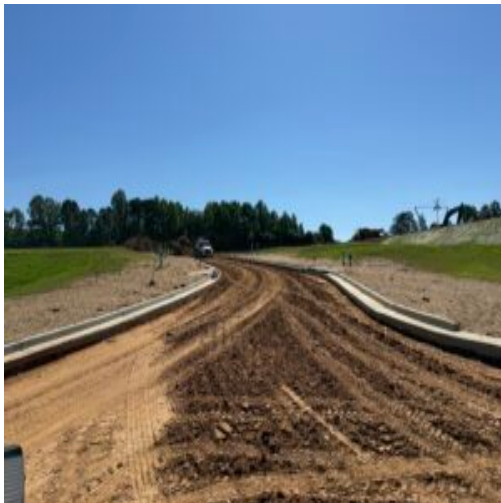
scarification

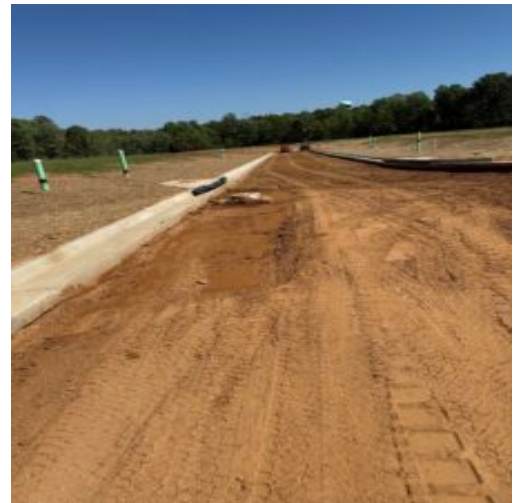
scarification

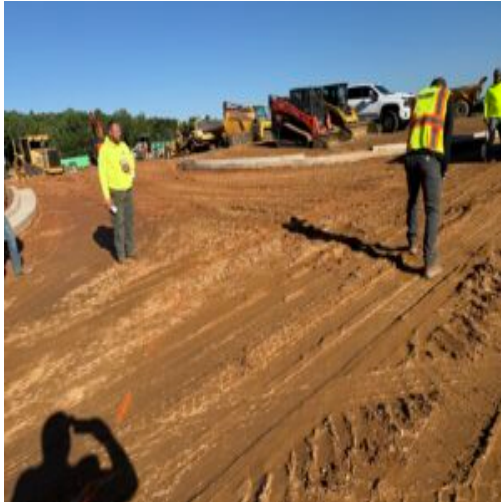
scarification

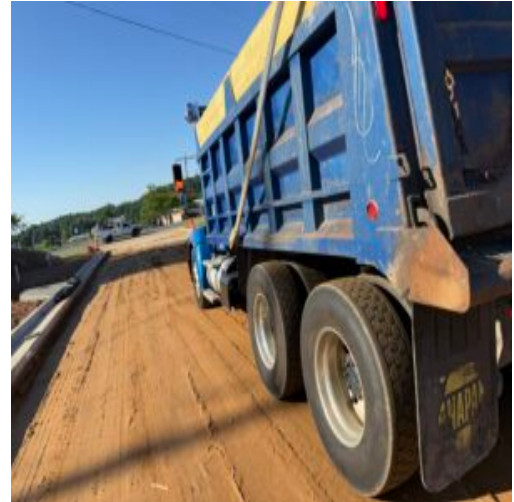
Upon arrival, representatives from the grading contractor, paving contractor, and the owner were present. A loaded tandem dump truck was utilized to proof-roll all proposed roadways and one parking lot area.

Proof roll

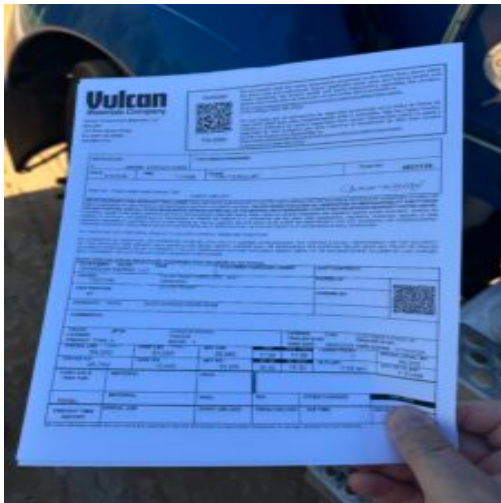
Truck weight
