ASEC Report ID : 94848  
Name of the Project : NW Unit 4 BRIDGE (Materials Testing)  
Project Location : Dallas  
Weather : cloudy  
Departure Time : 05/28/2026 12:00  
ASEC Technician Name : Clyde Smith

On the above date our representative made a site visit to the above site to observe subgrade conditions for the crane pad and bridge wall backfill. Subgrade repairs are recommended for crane pad stabilization.

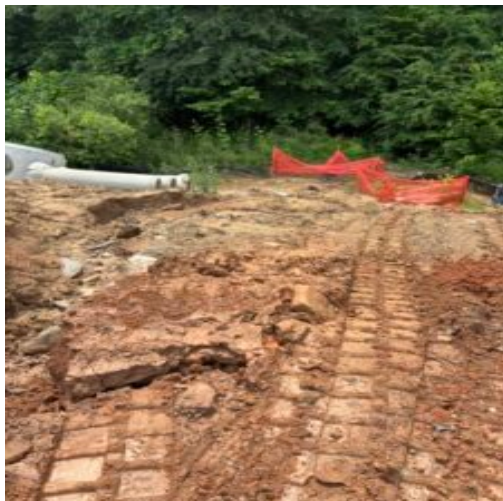
Erosion deficiencies

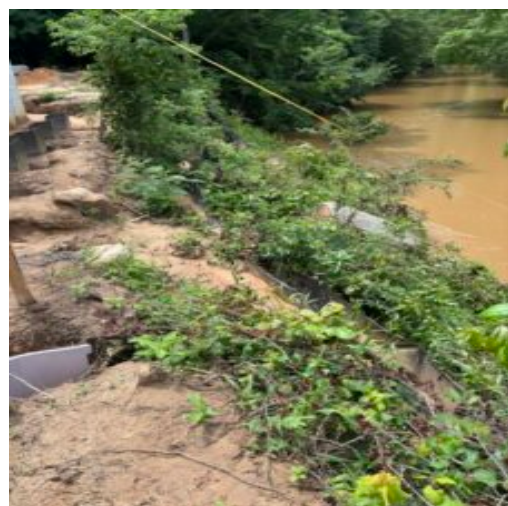
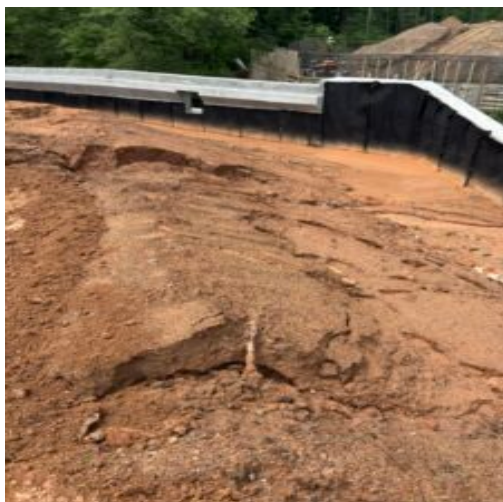
Erosion at wall backfill

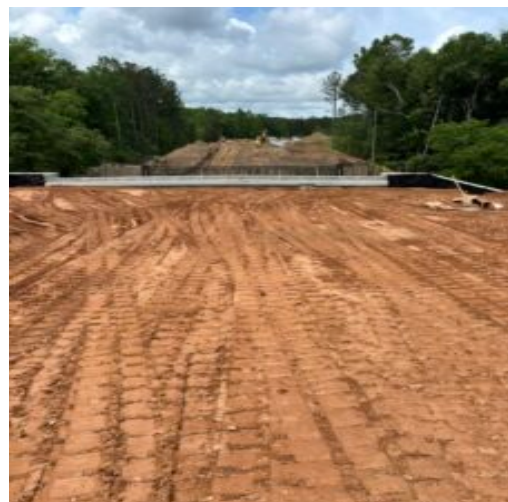
Recommended subgrade repair at crane pad
