Date : 04/27/2026  
Project No : 2025C216  
Client Company : Artisan  
Arrival Time : 04/27/2026 08:00  
Onsite Hours : 03:00

ASEC Report ID : 93585  
Name of the Project : NW (Lots) Unit 4 PH 1A & 1B  
Project Location : Dallas  
Weather : Sunny  
Departure Time : 04/27/2026 11:00  
ASEC Technician Name : Clyde Smith

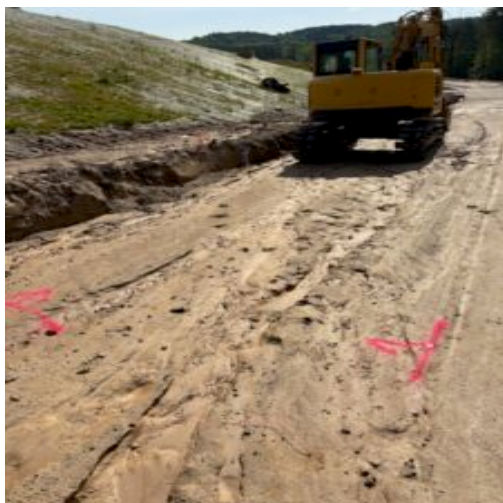
Sub grade requiring -4" clip

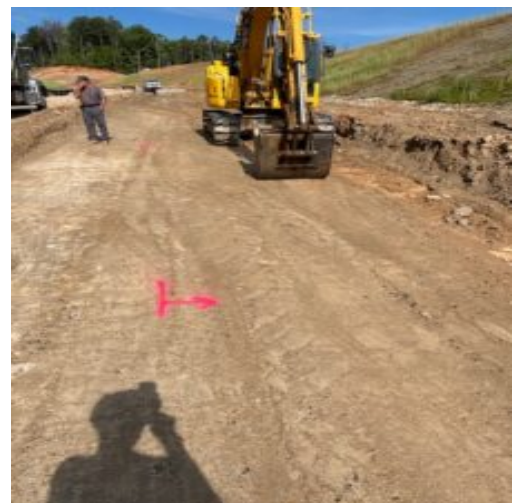
Repair area for clip

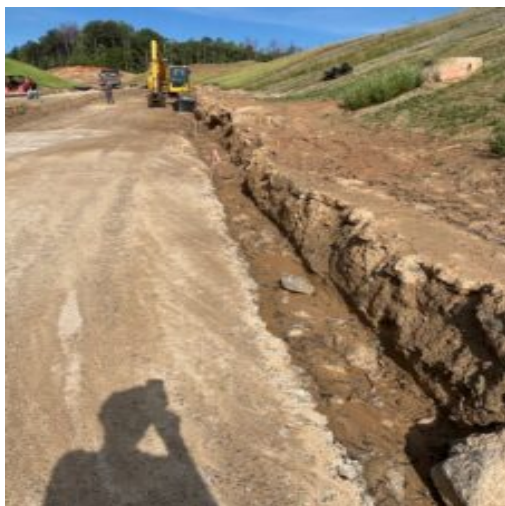
Washed gullies at curb line

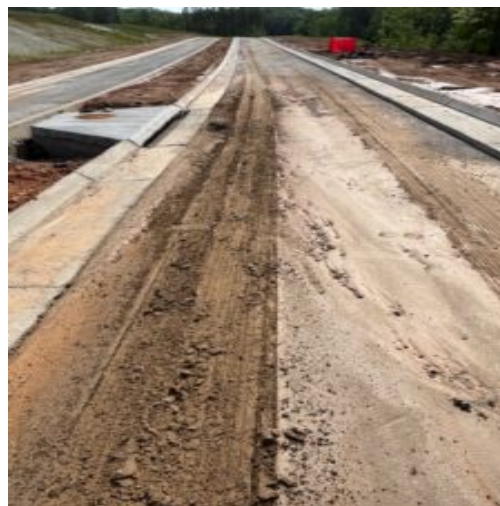
Washed silt over sub base stone

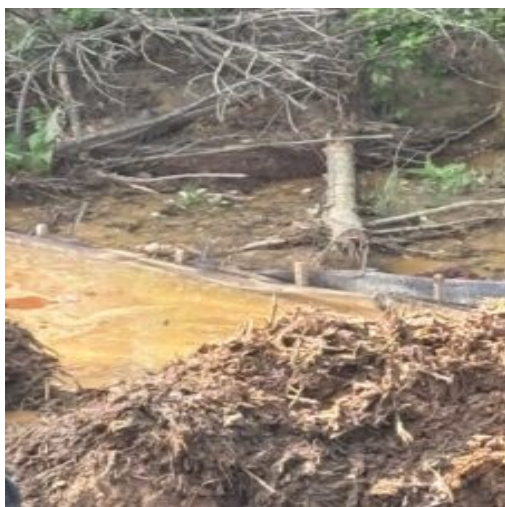
The writer also observed the erosion contractor (Valor) repairing erosion deficiencies at the toe of the slope on Nature Walk Parkway near sanitary sewer manhole #6.

Deficient area due to rain event at toe of slope

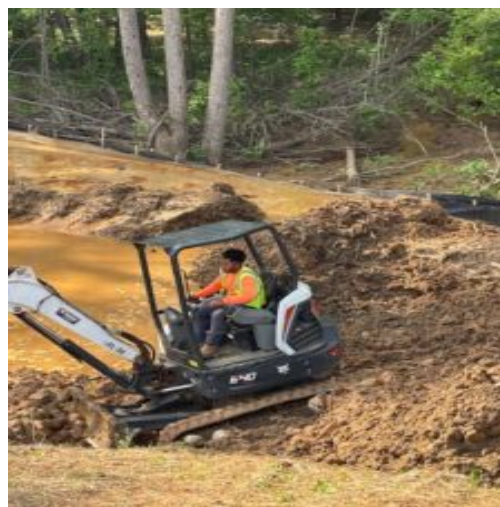
Repairing deficient area at toe of slope

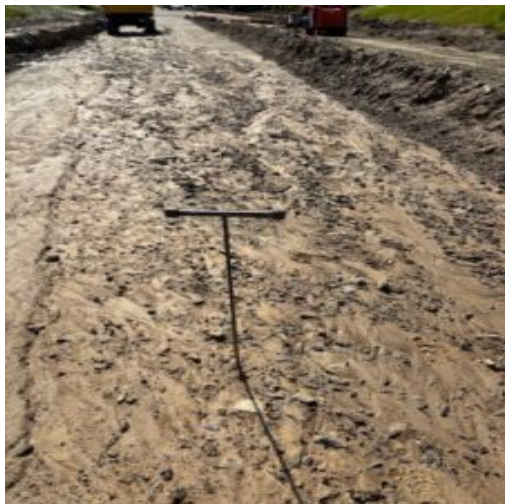
Washed sub grade area approved for stone placement

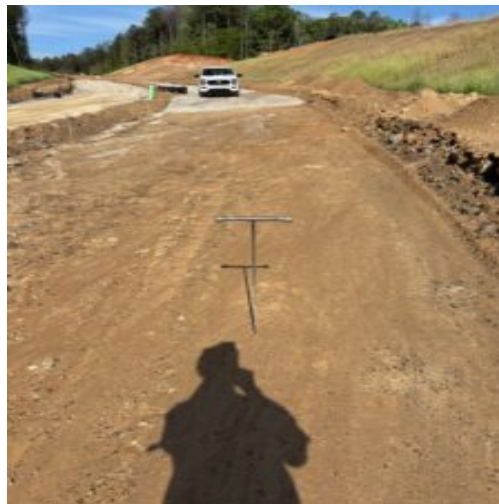
Sub grade approved for base stone placement

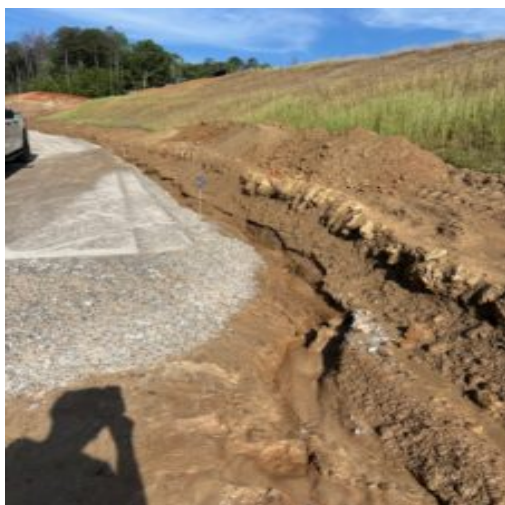
Gullies at curb line after rain event

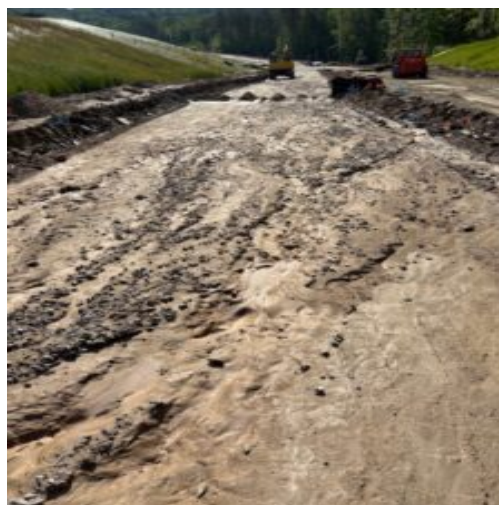
Approved area with rock in place
