Date : 11/13/2025  
Project No : 2025C260  
Client Company : Artisan  
Arrival Time : 11/13/2025  
Onsite Hours : N/A

ASEC Report ID : 87740  
Name of the Project : NW (PHASE 2) Parkway Extension  
Project Location : Dallas  
Weather : sunny  
Departure Time : 11/13/2025  
ASEC Technician Name : Russell Hendrix

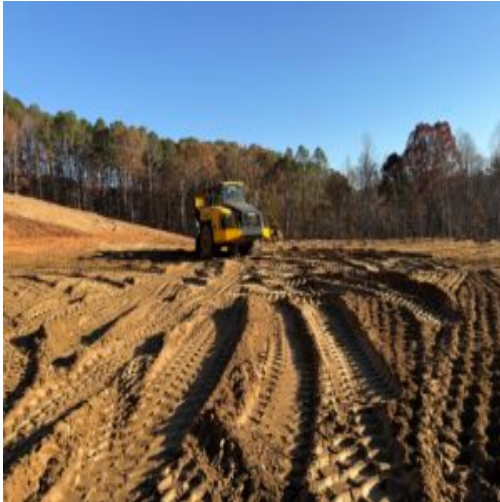
- **Three off-road dump trucks** transporting soil (see photo)
- **Two excavators** loading material
- **One Komatsu 51 PXI dozer** spreading soil
- **One Caterpillar 815 ride-on sheepfoot roller** compacting the placed material

Slope area off road dump truck

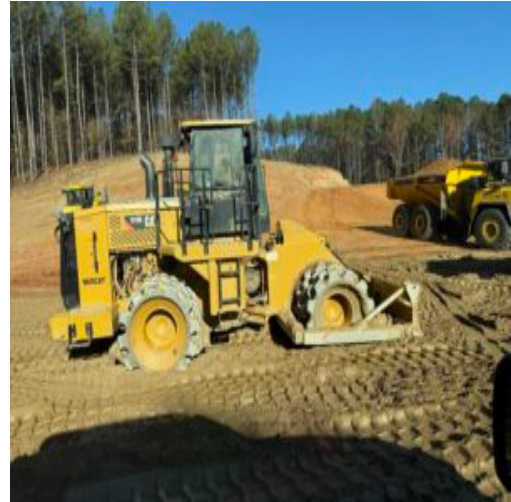
compactor

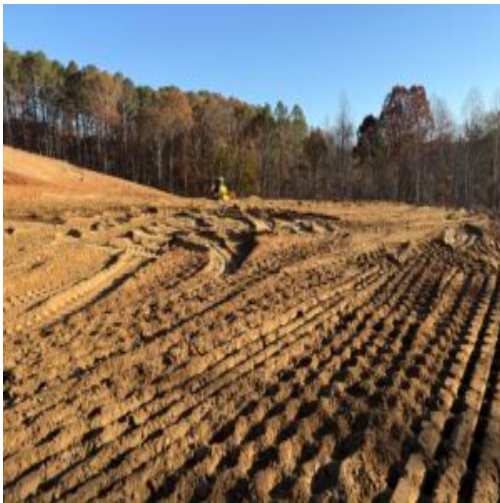
Location of low slope area

Upon arrival, a meeting was held with **Rick**, the **grading foreman**, who stated that **soil from the blasted area** was being **placed on the slopes (see photo)**.
