Date : 12/11/2025  
Project No : 2025C260  
Client Company : Artisan  
Arrival Time : 12/11/2025 11:30  
Onsite Hours : 04:00

ASEC Report ID : 88468  
Name of the Project : NW (PHASE 2) Parkway Extension  
Project Location : Dallas  
Weather : Sunny  
Departure Time : 12/11/2025 15:30  
ASEC Technician Name : Clyde Smith

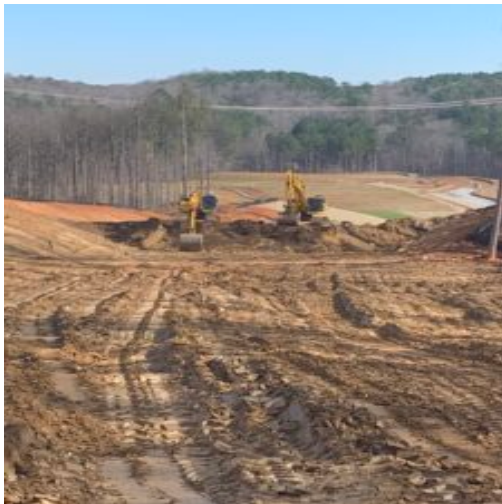
Undercutting rock fill from Nature Walk Parkway near  
sanitary sewer manhole #9

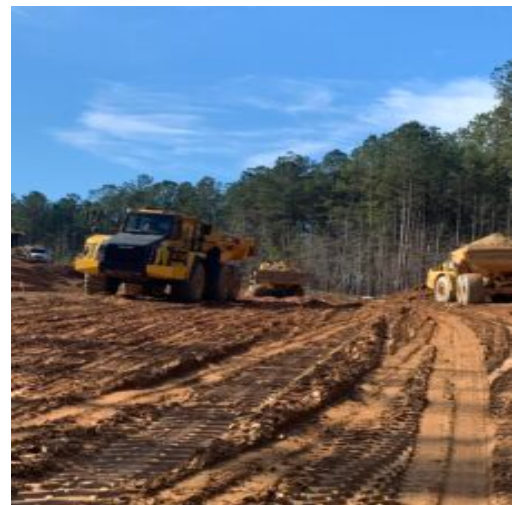
Our representative was on site to observe the grading contractor continue placing rock fill for the slope embankment in compacted lifts using a dozer to spread and a sheep-foot vibratory roller for compacting. The fill was placed in accordance with recommendations and appeared suitably compacted as per job specifications.

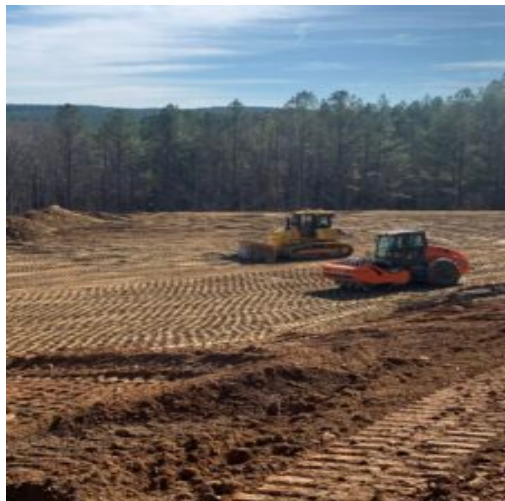
Fill placement at slope embankment

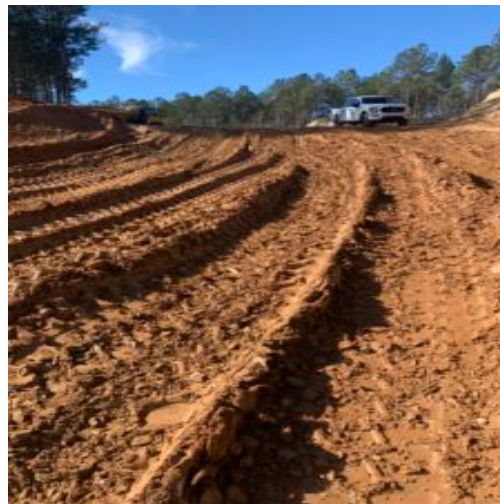
Wet conditions at haul road to slope embankment

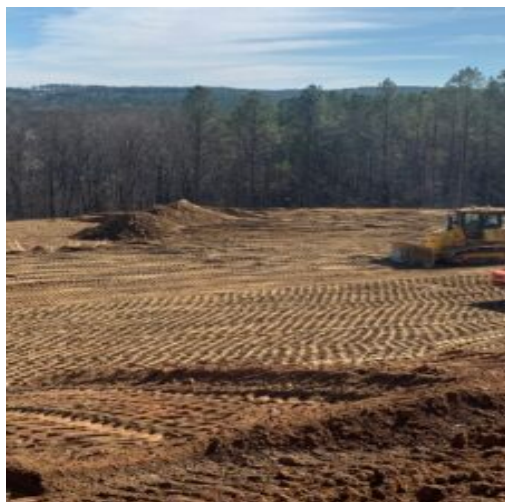
Fill placement at slope embankment
