Date : 06/01/2026  
Project No : 2025C269  
Client Company : Lewis Contracting  
Arrival Time : 06/01/2026 09:00  
Onsite Hours : 02:00

ASEC Report ID : 95008  
Name of the Project : Main St. & First Ave. - Mixed-use  
Project Location : Lilburn  
Weather : Sunny  
Departure Time : 06/01/2026 11:00  
ASEC Technician Name : Sean Willett

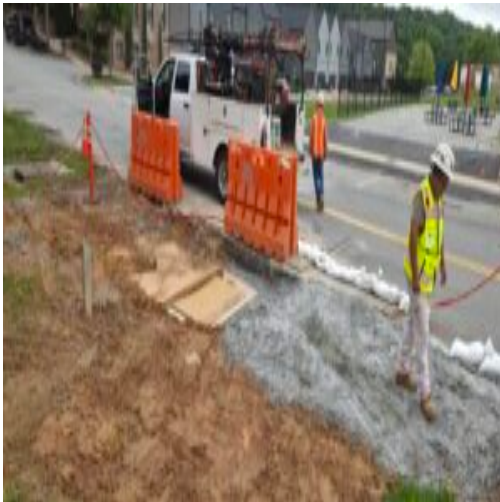
Our ASEC representative was on site to observe the contractor (Lewis Contracting) and for the observation/testing of the placement of fill/backfill. The contractors backfilled the structure located along Main Street with GAB. The contractor used a jumping jack to compact the surface while ASEC was onsite, and then density testing was performed. Test results were provided to the contractor. The contractors are removing a section of the paved roadway by the grease traps located in the middle of the site. This area appears to have not been installed correctly and had not properly drained water from recent rainstorms. This appeared to cause the asphalt to hold water in some sections and crack apart. The contractor is adding more GAB before paving this section again. The grading contractors stated they believed the asphalt possibly got cold during the installation and that the pavers had rushed the install.

backfilled gab

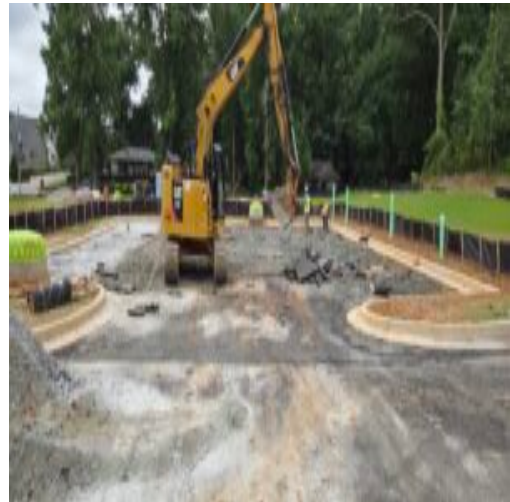
removing asphalt

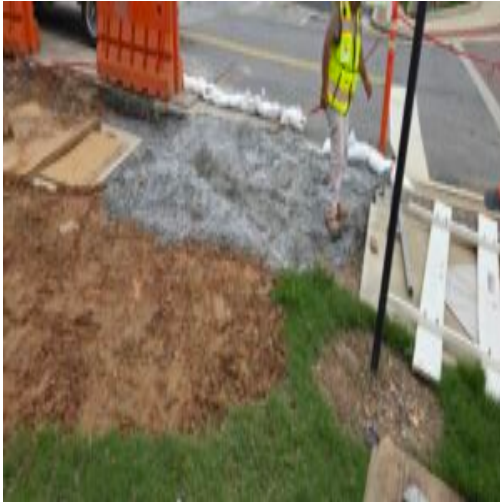
backfilled gab

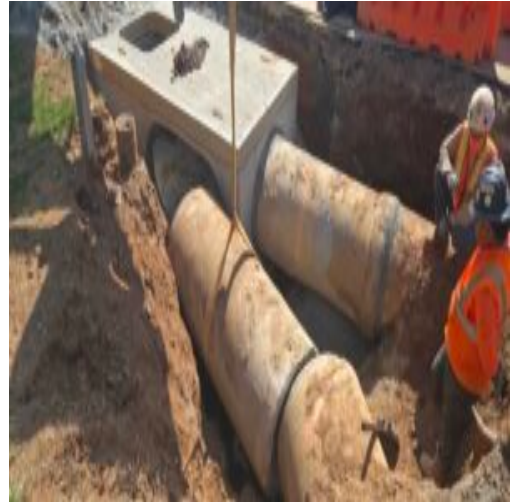
previous visit picture of the structure
