Date : 04/27/2026  
Project No : 2026C103  
Client Company : Artisan  
Arrival Time : 04/27/2026 10:00  
Onsite Hours : 04:00

ASEC Report ID : 93817  
Name of the Project : NW PH 2, UNIT 4  
Project Location : Dallas  
Weather : Sunny  
Departure Time : 04/27/2026 14:00  
ASEC Technician Name : Sean Willett

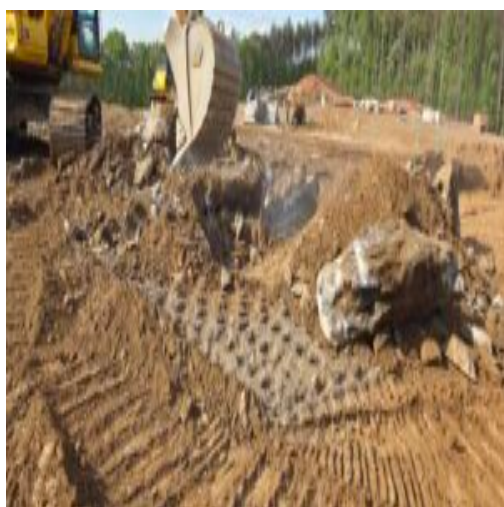
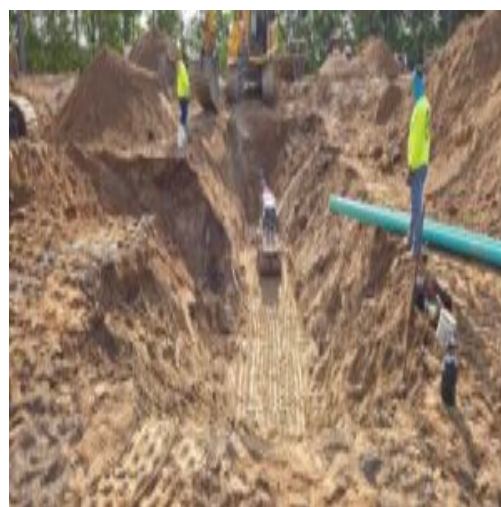
Our ASEC representative was on site to observe the contractor and for the observation/testing of the placement of fill/backfill. The pipe crew continued to work on excavation of sewer line B-16 and clean outs. It does not appear that they will be backfilling this line today. They are placing a thickened lift over the pipe and compacting with a trench roller to protect the pipeline. Backfilling will begin on the following day. The contractors are excavating a large quantity of hard rock and hauling the larger pieces (greater than 2 feet in size) to a deep fill area located near the entrance of the site. At this time, it does not appear that density testing is needed. ASEC recommended to have a water truck on site when they begin to backfill, as it appears to be very dry on the site.
