Date : 04/28/2026  
Project No : 2026C103  
Client Company : Artisan  
Arrival Time : 04/28/2026 08:00  
Onsite Hours : 00:30

ASEC Report ID : 93821  
Name of the Project : NW PH 2, UNIT 4  
Project Location : Dallas  
Weather : Raining  
Departure Time : 04/28/2026 08:30  
ASEC Technician Name : Sean Willett

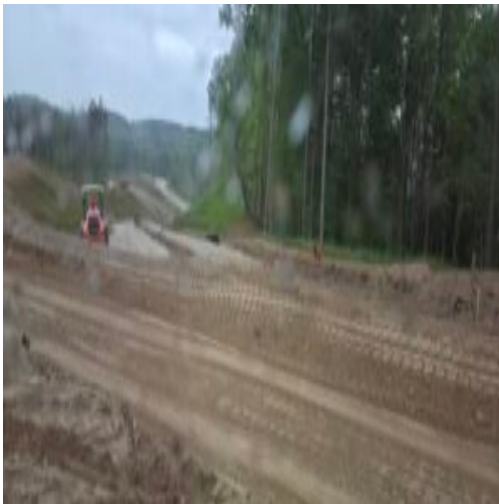
Our ASEC representative was on site to observe the contractor and for the observation/testing of the placement of fill/backfill. Upon arrival to the site, it began to rain. The contractors were sitting at the front of the site and did not appear to be entering the site to begin working today due to the rain. ASEC took pictures and the left the site for the day.
