Date : 05/01/2026  
Project No : 2026C133  
Client Company : Artisan  
Arrival Time : 04/24/2026 08:00  
Onsite Hours : 05:00

ASEC Report ID : 93794  
Name of the Project : Salacoa (AKA Boone Ford Rd) Robert's  
Dam  
Project Location : Calhoun  
Weather : cloudy  
Departure Time : 04/24/2026 13:00  
ASEC Technician Name : Clyde Smith

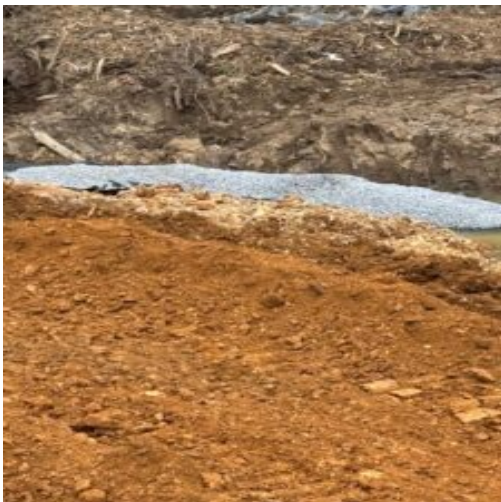
Added french drain at west end of slope

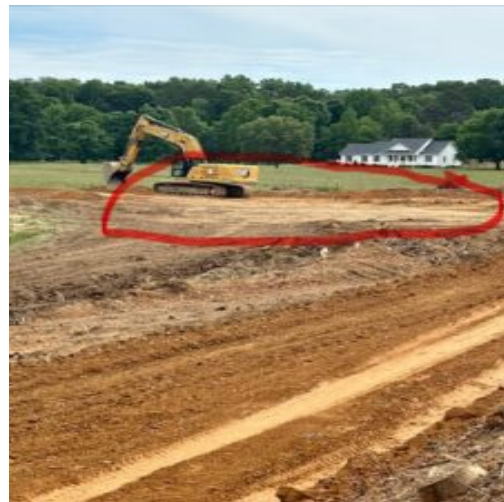
Showing area for borrowed excavated fill materials

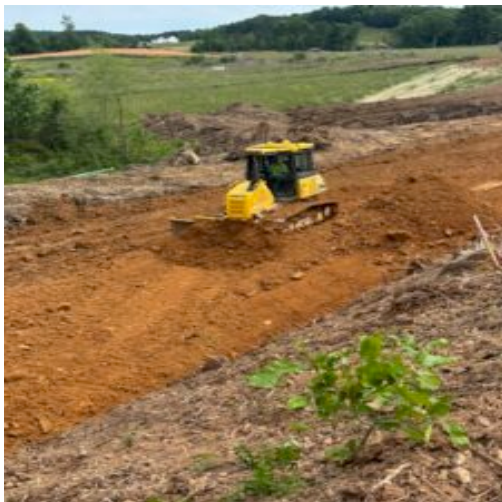
Placing fill at toe of slope

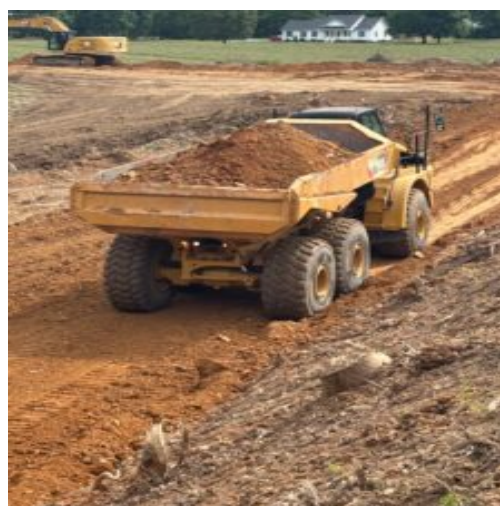
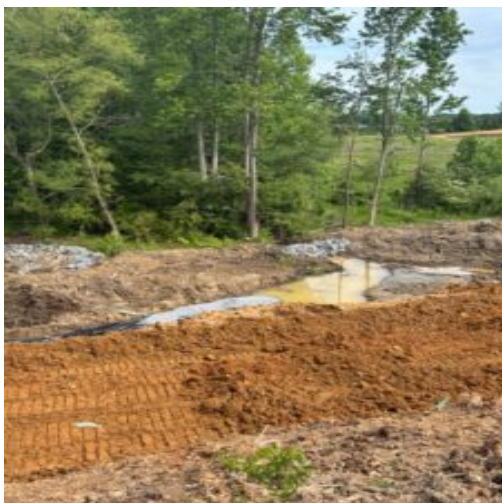
Pushing fill over french drain
