Date : 05/01/2026  
Project No : 2026C133  
Client Company : Artisan  
Arrival Time : 05/01/2026 08:00  
Onsite Hours : 07:00

ASEC Report ID : 93870  
Name of the Project : Salacoa (AKA Boone Ford Rd) Robert's  
Dam  
Project Location : Calhoun  
Weather : sunny  
Departure Time : 05/01/2026 15:00  
ASEC Technician Name : Samara Simha Reddy Kandi

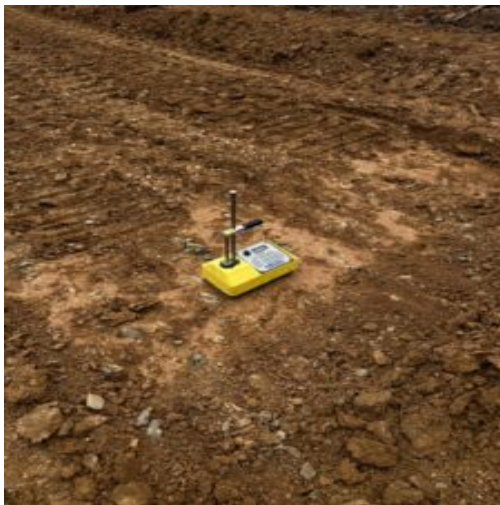
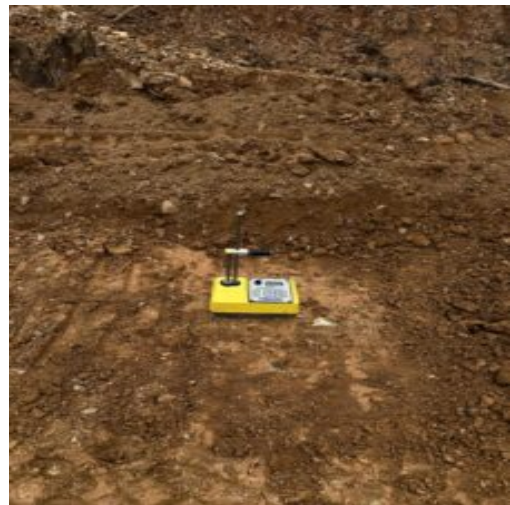
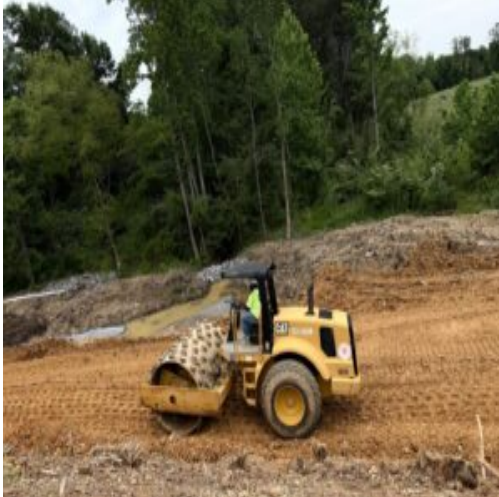
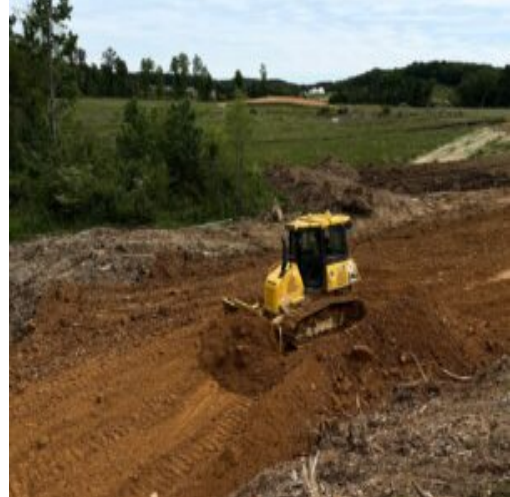
The crew placed fill material along the dam alignment using a tandem-axled dump truck, maintaining the designed 3:1 slope configuration. The dumped material was then spread uniformly using a crawler bulldozer. The fill was placed in controlled lifts, typically 8 to 10 inches thick throughout the embankment. Each lift was compacted using a sheep-foot roller. Density tests were performed on each compacted lift which met required compaction.
