Date : 06/05/2026  
Project No : 2026C133  
Client Company : Artisan  
Arrival Time : 06/05/2026  
Onsite Hours : N/A

ASEC Report ID : 95159  
Name of the Project : Salacoa (AKA Boone Ford Rd) Robert's  
Dam  
Project Location : Calhoun  
Weather : overcast  
Departure Time : 06/05/2026  
ASEC Technician Name : Russell Hendrix

### **Dam Spillway Inspection Report**

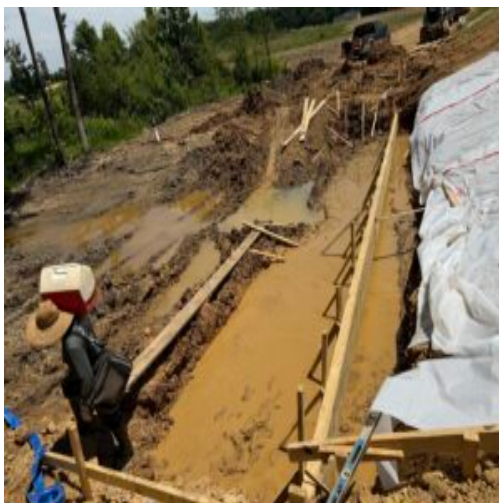
A meeting was held with the onsite superintendent and crew foreman prior to the inspection. During the site visit, it was observed that the bottom of the footing excavation contained water (see attached photos). The contractor was actively pumping the water out at the time of the inspection.

Water at bottom of spillway

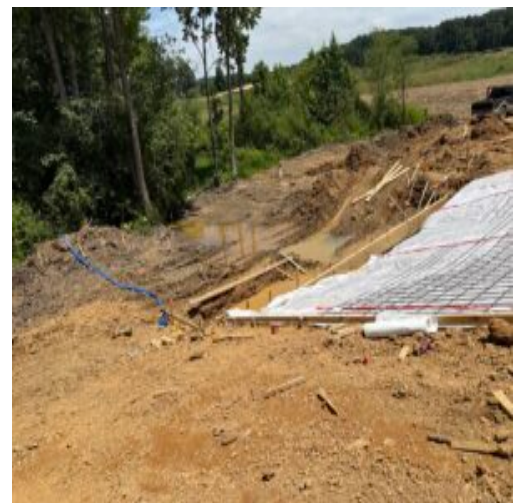
water at bottom of spillway

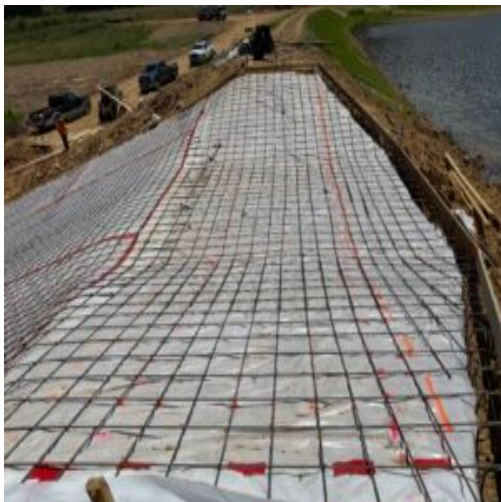
The reinforcing steel installation was approximately 95% complete upon departure from the site. The completed portion of the reinforcement was inspected and found to be in compliance with the project requirements for bar size, spacing and quantity. Plastic sheeting had been placed beneath the reinforcing steel, and the rebar was supported on chairs to provide the required concrete cover (see attached photos).

rebar

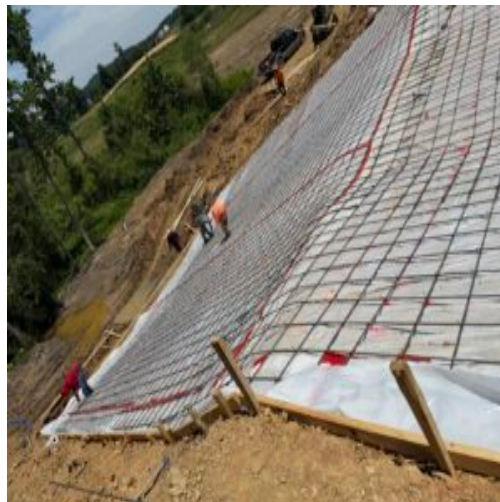
rebar

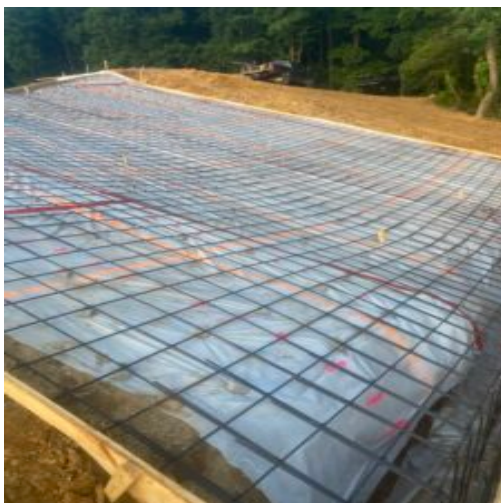
Photographs of the completed reinforcing steel installation were subsequently taken by another ASEC technician and are included with this report.

rebar placed next morning.
