Date : 11/04/2020  
Project No : 2020C009  
Client Company : DR Horton  
Arrival Time : 11/04/2020 9:30  
Onsite Hours : 06:00

ASEC Report ID : 1241  
Name of the Project : Monet Gardens  
Project Location : River Road at Green Pastures Way,  
Ellenwood, GA  
Weather : Sunny  
Departure Time : 11/04/2020 15:30  
ASEC Technician Name : Admin user

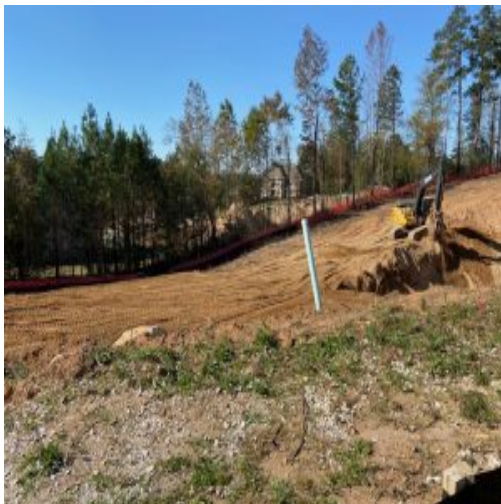
- The contractor continued excavation of Pond B planned to be on the southwest part of the site between Lots #9 and 7.
- Material excavated was used to bring the grade up at and in the vicinity of Lot #9.
- Two lifts were placed in this area today. The undersigned observed the soil being placed in approximately 8-inch lifts and compacted by one CAT CP-433E model padfoot roller.
- Two density tests were performed on the lifts placed to assess compaction efforts. The density test report for this day lists the test results for the work performed on this day.
- Based on the density test results, visual observation of the material placed and random probing of the placed lifts, the fill placed was found to be acceptable.

Pond B Excavation and embankment placement in the vicinity of Lot # 9

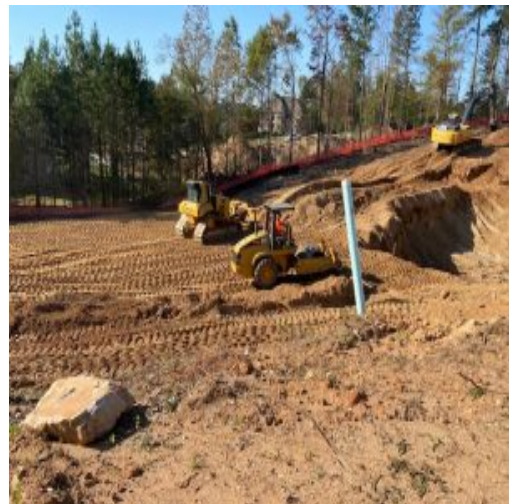
Compaction efforts during embankment placement in the vicinity of Lot # 9
