Date : 11/05/2020  
Project No : 2020C009  
Client Company : DR Horton  
Arrival Time : 11/05/2020 10:00  
Onsite Hours : 06:00

ASEC Report ID : 1316  
Name of the Project : Monet Gardens  
Project Location : River Road at Green Pastures Way,  
Ellenwood, GA  
Weather : Sunny  
Departure Time : 11/05/2020 16:00  
ASEC Technician Name : Ramchandra Mogulla

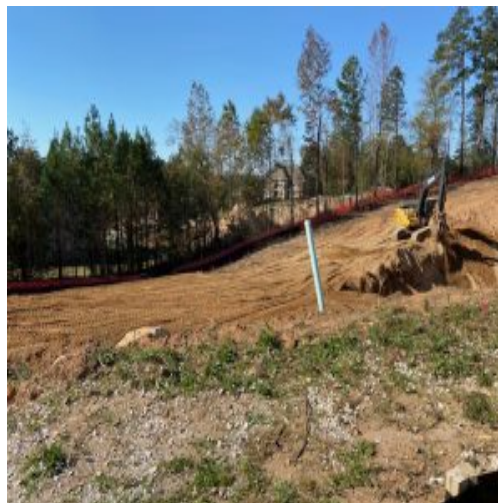
Pond B excavation ongoing
