Date : 12/10/2020  
Project No : 2020C009  
Client Company : DR Horton  
Arrival Time : 12/10/2020 09:00  
Onsite Hours : 06:00

ASEC Report ID : 1474  
Name of the Project : Monet Gardens  
Project Location : River Road at Green Pastures Way,  
Ellenwood, GA  
Weather : Sunny  
Departure Time : 12/10/2020 15:00  
ASEC Technician Name : Dave Bek

The site was visited by the undersigned AS Engineering and Consulting (ASEC) representative for the purpose of providing quality control inspection and testing services. Visual observation techniques were employed to assure compliance with project drawings/specifications, applicable codes, and materials submittals. The following observations were made on site today:

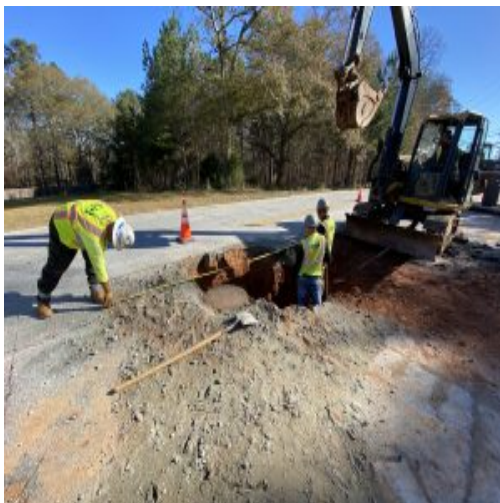
Sewer line A

1. Material from the East side of lot 17 was excavated and stockpiled on Lot 18
2. The contractor began excavation work on the sewer line a along the roadway between the intersection of Green Pasteurs Way-River Rd and Cannon Walk - River Rd.
3. Six lifts were placed in this area today. The undersigned observed the soil being placed in approximately 12 inch lifts and compacted with a CAT Excavator utilizing a padfoot roller attachment.
4. One density test was performed on the second lift to assess compaction efforts. The density test report for this day list the test result for the work performed on this day.
5. Based on the density test results, visual observation of the material placed and random probing of the placed lifts, the fill placed was found to be acceptable

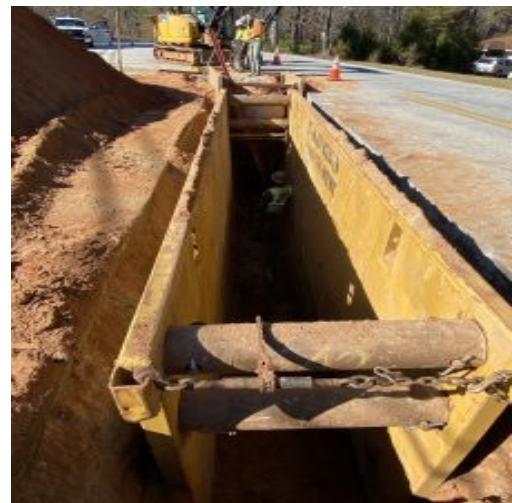
Trench Box Pre-Compaction
