Date : 06/07/2021  
Project No : 2020C002  
Client Company : Toll Bros. Inc.  
Arrival Time : 06/07/2021 08:00  
Onsite Hours : 07:00

ASEC Report ID : 21835  
Name of the Project : Northfields at Polo Fields  
Project Location : 4805 Pittman Road, Forsyth County, Georgia  
Weather : Overcast, Light Rain  
Departure Time : 06/07/2021 15:00  
ASEC Technician Name : Dave Bek

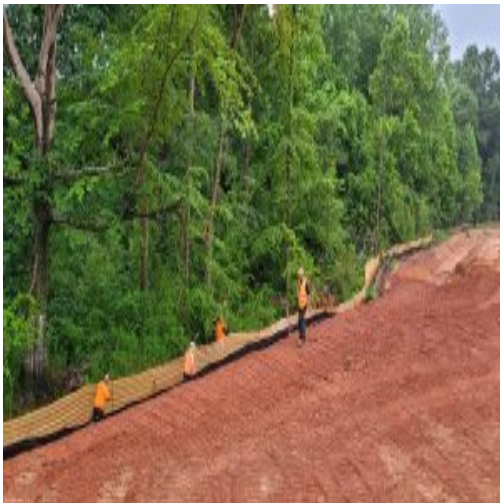
Lot 11

The writer observed that the contractor was in the process of relocating the silt fences along lot 27 and lot 11, back approximately 8 - 10 feet to accommodate the designated slope that was located in an area beyond the current location of the silt fences.

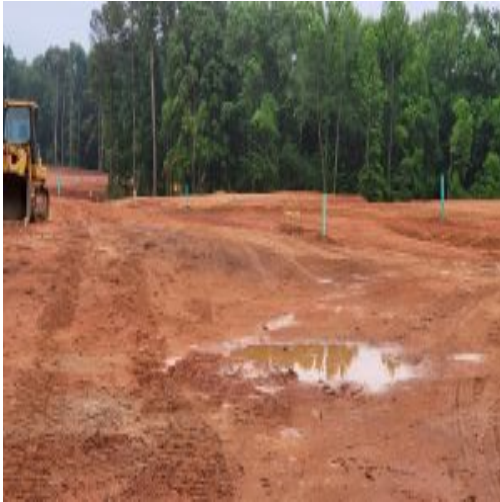
The site superintendent Morris Puckett (CGU) informed the writer that most work would be suspended due to inclement weather (thunderstorms, accompanied by light rain.) Site conditions were very wet and unsuitable for most heavy construction activity.

General site conditions
