Date : 08/23/2021  
Project No : 2020C030  
Client Company : Archer Western Construction  
Arrival Time : 08/23/2021 14:00  
Onsite Hours : 03:00

ASEC Report ID : 33732  
Name of the Project : HJAIA - South Deicing - AWC  
Project Location : HJAIA  
Weather : Sunny  
Departure Time : 08/23/2021 17:00  
ASEC Technician Name : Ramchandra Mogulla

The undersigned AS Engineering and Consulting, LLC (ASEC) representative was on site as requested by Archer Western/Lewis Contracting to perform a visual inspection of the structure designated as CB-27.

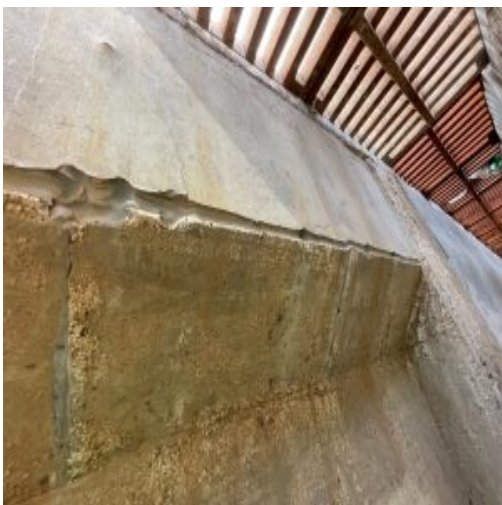
Looking at the top section closest to the grates

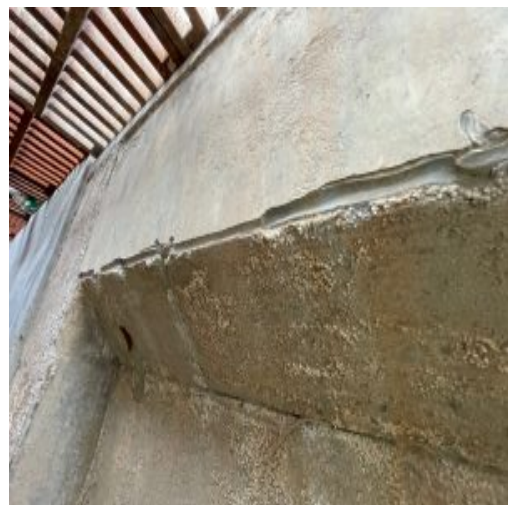
Looking at the top section closest to the grates,

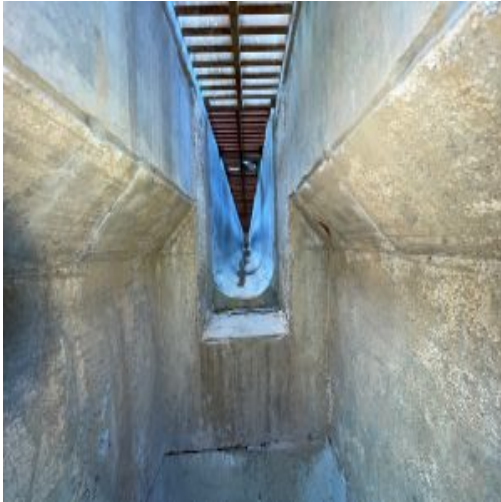
East side of the structure looking towards the trench drain.

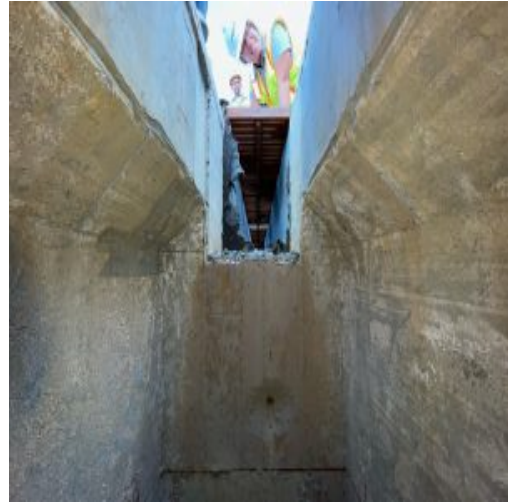
West side of the structure looking towards the trench drain.

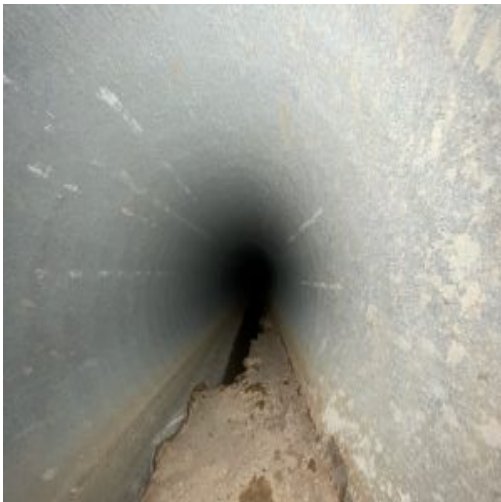
Pipe section in the north side of the structure.

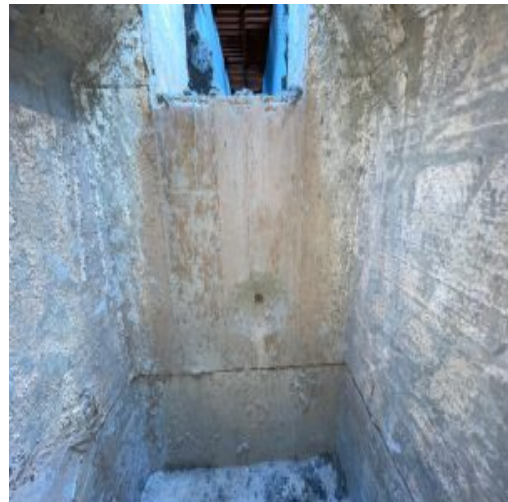
Close up view of the West side of the structure looking towards the trench drain.
