Date : 09/29/2021  
Project No : 2021C073  
Client Company : DR Horton West  
Arrival Time : 09/29/2021 13:00  
Onsite Hours : 03:00

ASEC Report ID : 34280  
Name of the Project : Tributary C2A  
Project Location : Riverside Parkway, City of Douglasville, GA  
Weather : Partly cloudy  
Departure Time : 09/29/2021 16:00  
ASEC Technician Name : Christopher Burrow II

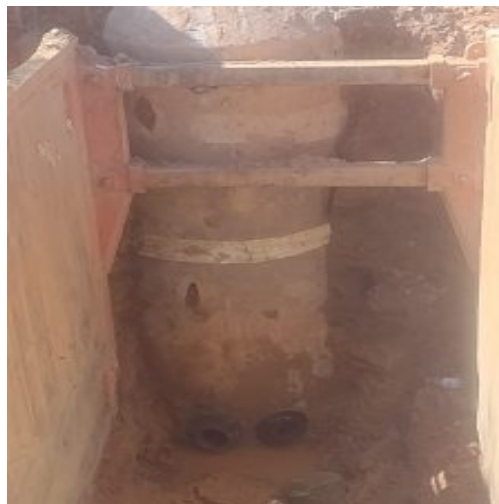
Pipe excavation on site.
