ASEC Report ID : 6987  
Name of the Project : Winslow at Brookstone  
Project Location : 6156 Collins Road, Acworth, GA 30101  
Weather : Overcast  
Departure Time : 04/02/2021 10:00  
ASEC Technician Name : Dave Bek

A rebar and footing inspection was scheduled for the subject property Lot 8 and 9

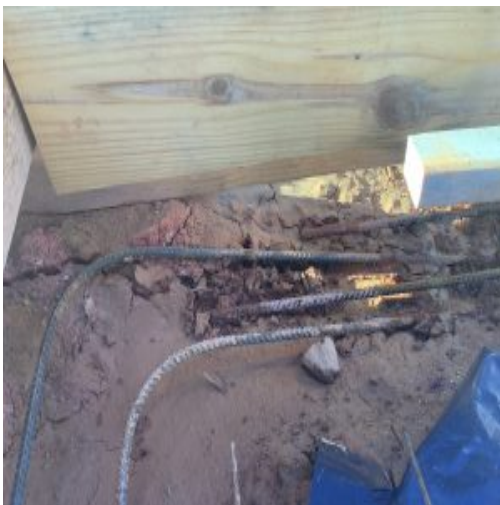
Lot 8 Missing Rebar Ties

- The following suggestions are made for corrective action:
  - Lot 8 Right front corner of property missing bar ties on rebar.
  - Lot 8 WWR along back right side of property requires trimming.
  - Lot 9 Front left corner of property rebar is bent so that placement is outside the acceptable area of the footing.
- If the suggested corrections are made, then rebar placement will be acceptable and within plan specifications

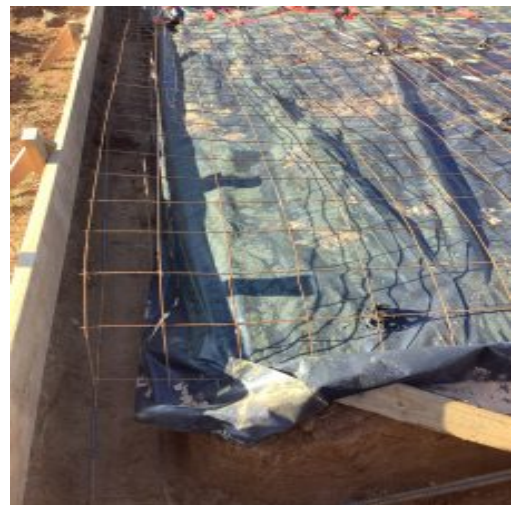
Lot 8 WWR needs trimming

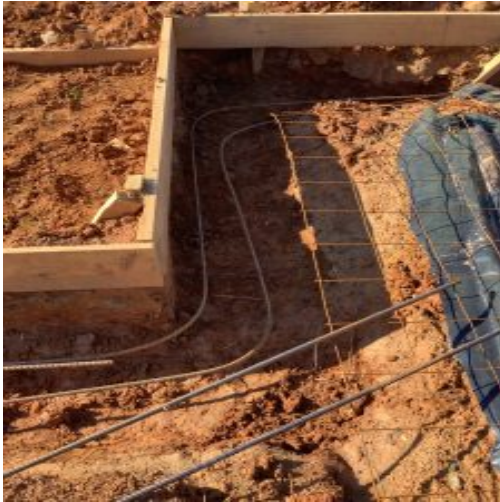
Lot 9 Rebar not aligned with Footing
